Punjab Municipal Development Fund Company

Hiring of Consulting Services for Preparation of Integrated Development and Asset Management Plan (IDAMP) for 16 selected MCs In Punjab under Punjab Cities Program (PCP)

**IDAMP - Municipal Committee Bahawalnagar
May 2023**

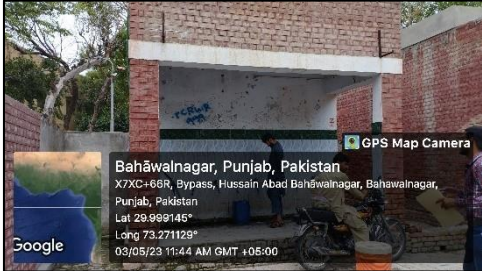
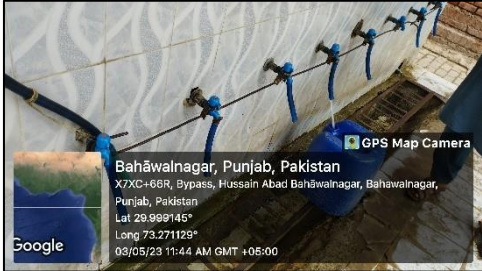
| Integrated Development And Asset Management Plan (IDAMP) | | | | | | |
|---|---|--|---|---|---|---|
| Form: IDAMP-A4 | | Water Filtration Plant Asset Condition Assessment | | | Asset Code: _____ Date: 02-05-2023 | |
| Name | | City Filtration Plant | | Pictures | | |
| Address | | Satluj Park | | | | |
| Plant Type | | RO | UV | | | |

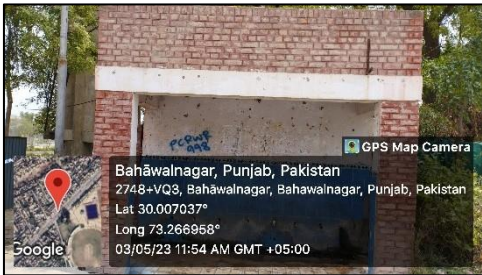
| Integrated Development And Asset Management Plan (IDAMP) | | | | | |
|---|---|--|---|---|--|
| Form: IDAMP-A4 | | Water Filtration Plant Asset Condition Assessment | | | Asset Code: _____ Date: 02-05-2023 |
| Name | | Khadamabad | | | Pictures |
| Address | | Khadamadam, Bahawalnagar | | | |

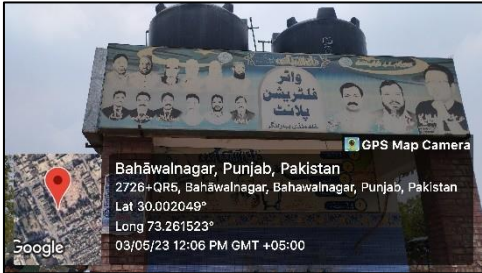
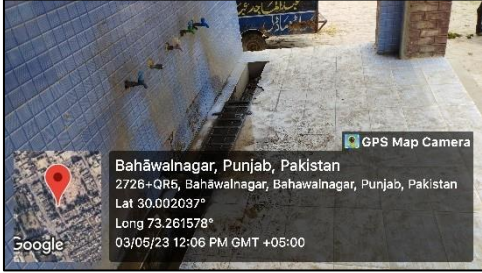
| Integrated Development And Asset Management Plan (IDAMP) | | | | | | |
|---|---|--|---|---|---|---|
| Form: IDAMP-A4 | | Water Filtration Plant Asset Condition Assessment | | | Asset Code: _____ Date: 02-05-2023 | |
| Name | | Ghalla Mandi | | Pictures | | |
| Address | | Ghalla Mandi, Bahawalnagar | | | | |
| Plant Type | | RO | UV | | | |

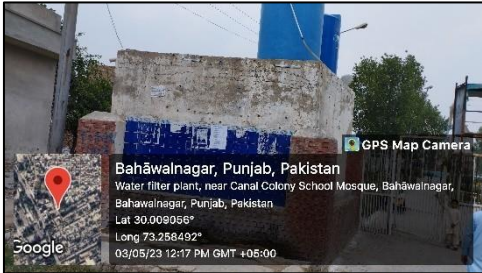
| Integrated Development And Asset Management Plan (IDAMP) | | | | | |
|---|---|--|---|---|--|
| Name | | Aamir Jan Park | | | Pictures |
| Address | | Aamir Jan Park, Bahawalnagar | | | |

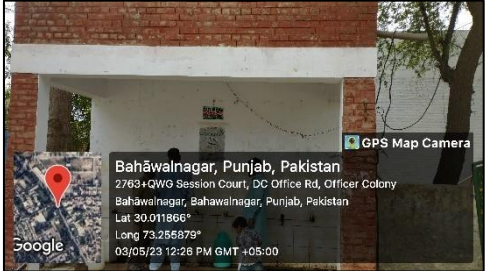
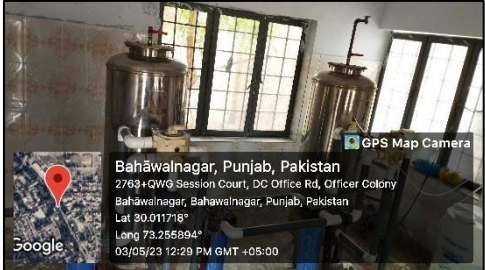
| Integrated Development And Asset Management Plan (IDAMP) | | | | | | |
|---|--|---|---|--|---|---|
| Form: IDAMP-A4 | Water Filtration Plant Asset Condition Assessment | | | Asset Code: _____ Date: 02-05-2023 | | |
| Name | | Civil Club | | Pictures | | |
| Address | | Civil Club, Bahawalnagar | | | | |
| Plant Type | | RO | UV | | | |

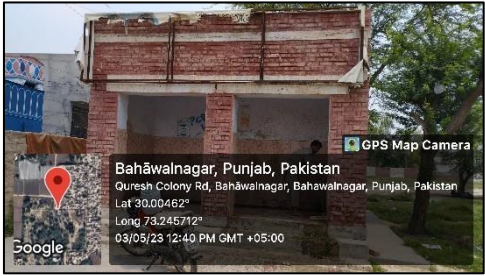
| Integrated Development And Asset Management Plan (IDAMP) | | | | | |
|---|---|--|---|---|--|
| Form: IDAMP-A4 | | Water Filtration Plant Asset Condition Assessment | | | Asset Code: _____ Date: 02-05-2023 |
| Name | | Faisal Colony | | | Pictures |
| Address | | Faisal Colony, Bahawalnagar | | | |

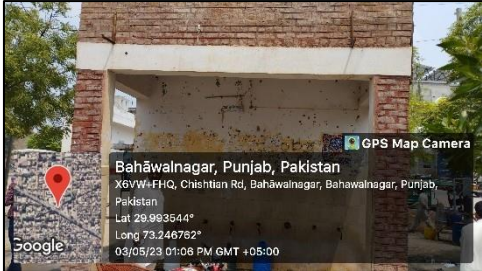
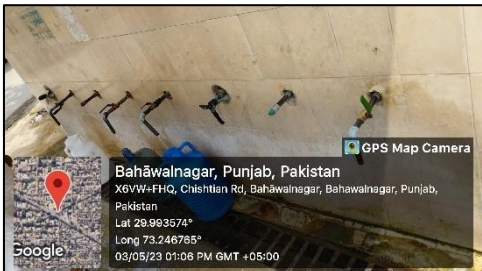
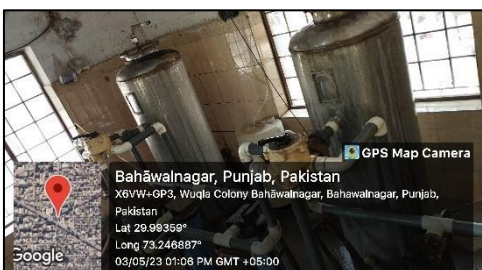
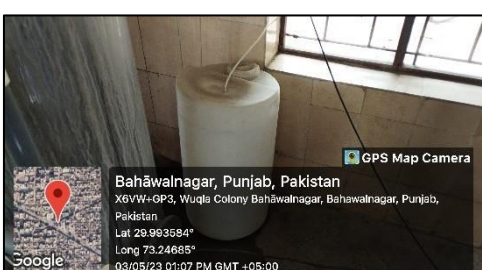
| Integrated Development And Asset Management Plan (IDAMP) | | | | | |
|---|---|--|---|---|--|
| Name | | Z.A Sayyed Filtration Plant | | | Pictures |

| Integrated Development And Asset Management Plan (IDAMP) | | | | | |
|---|---|--|---|---|--|
| Form: IDAMP-A4 | | Water Filtration Plant Asset Condition Assessment | | | Asset Code: _____ Date: 02-05-2023 |

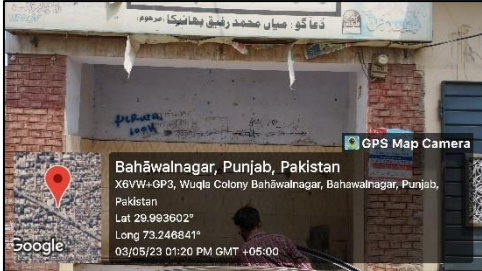
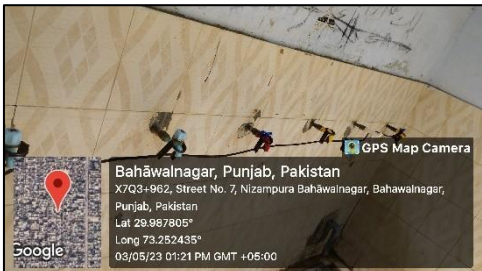
| Integrated Development And Asset Management Plan (IDAMP) | | | | | | | |
|---|---|--|---|--|---|--|--|
| Name | | Nizam Pura Filtration Plant | | Pictures | | | |

| Integrated Development And Asset Management Plan (IDAMP) | | | | | | | |
|---|---|--|---|--|---|--|--|
| Form: IDAMP-A4 | | Water Filtration Plant Asset Condition Assessment | | Asset Code: _____ Date: 02-05-2023 | | | |
| Filtration Capacity (Liter/Hour) | 2000 | | | | | | |
| Operational Hours | | 12 | | | | | |
| No. of Taps | | 6 | | | | | |

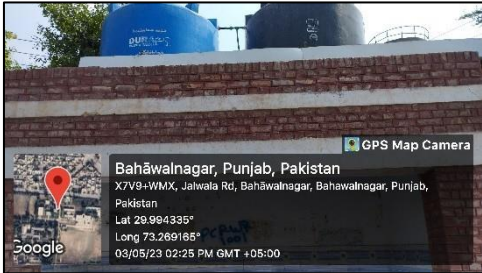
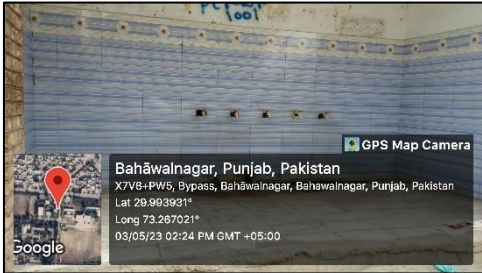
| Integrated Development And Asset Management Plan (IDAMP) | | | | | | | |
|---|--|---|---|--|---|--|--|
| Name | | Hussainabad | | Pictures | | | |

| Integrated Development And Asset Management Plan (IDAMP) | | | | | | | |
|---|--|---|---|--|---|--|--|
| Form: IDAMP-A4 | Water Filtration Plant Asset Condition Assessment | | | Asset Code: _____ Date: 02-05-2023 | | | |
| Filtration Capacity (Liter/Hour) | 2000 | | | | | | |
| Operational Hours | | 12 | | | | | |
| No. of Taps | | 5 | | | | | |

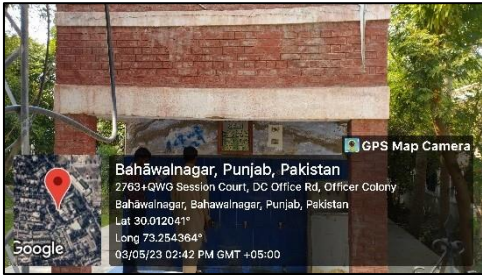
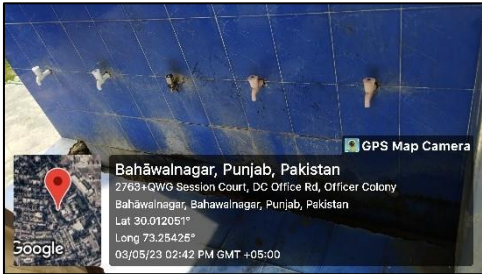
| Integrated Development And Asset Management Plan (IDAMP) | | | | | | |
|---|---|--|---|--|---|---|
| Name | | Civil Court Filtration Plant | | Pictures | | |

| Integrated Development And Asset Management Plan (IDAMP) | | | | | | |
|---|---|--|---|--|---|---|
| Form: IDAMP-A4 | | Water Filtration Plant Asset Condition Assessment | | | Asset Code: _____ | |
| Plant Type | | RO | UV | | | |
| Source of Water | | Local Tube Well | Public Water Supply | | | |

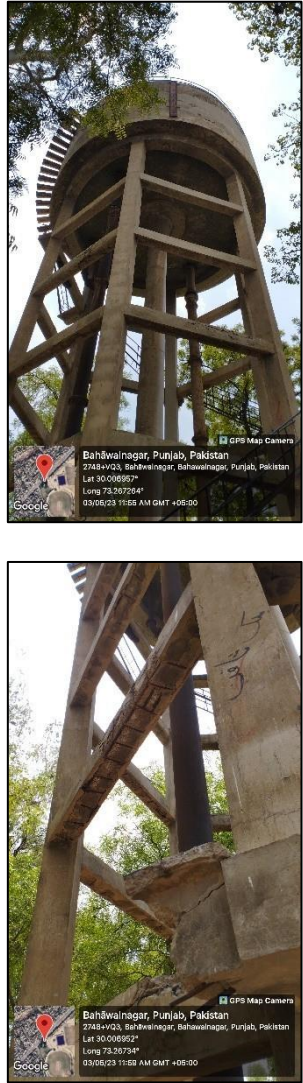
| Integrated Development And Asset Management Plan (IDAMP) | | | | | |
|--|---|---|---|---|---|
| Name | | Khadamabad Tanki | | | Pictures |

| Integrated Development And Asset Management Plan (IDAMP) | | | | | |
|--|---|---|---|---|---|
| Form: IDAMP-A2 | | Over Head Reservoir Asset Condition Assessment | | | Asset Code: _____ Date: 02-05-2023 |

| Sr # | Name | Age (Years) | Capacity (Gallons) | Condition | Status | Book Value (PKR Mil) |
|---|---|---|---|---|---|---|
| 1 | Kadamabad Tanki | 40 | 50,000 | Failing | Abandoned | 0 |

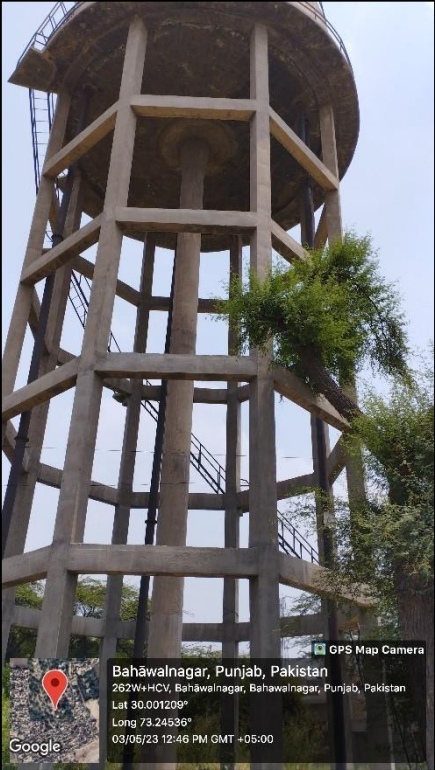
| Integrated Development And Asset Management Plan (IDAMP) | | | | | |
|---|---|---|---|---|---|
| Name | | Al Quresh Colony New | | | Pictures |

| Integrated Development And Asset Management Plan (IDAMP) | | | | | |
|---|---|---|---|---|---|
| Form: IDAMP-A2 | | Over Head Reservoir Asset Condition Assessment | | | Asset Code: _____ |

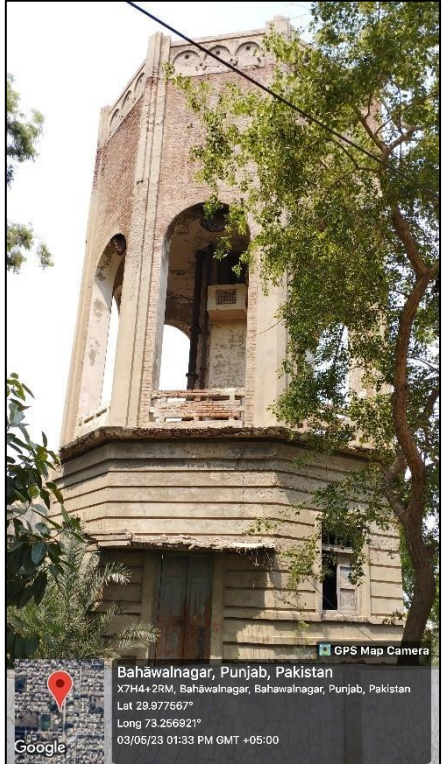
| Name | | Model Town Old | | Pictures | | |

| Form: IDAMP-A2 | | Over Head Reservoir Asset Condition Assessment | | Asset Code: _____ Date: 02-05-2023 | | |

| Sr # | Name | Age (Years) | Capacity (Gallons) | Condition | Status | Book Value (PKR Mil) |
|---|---|---|---|---|---|---|
| 5 | Model Town Old | 58 | 50,000 | Failing | Abandoned | 0 |

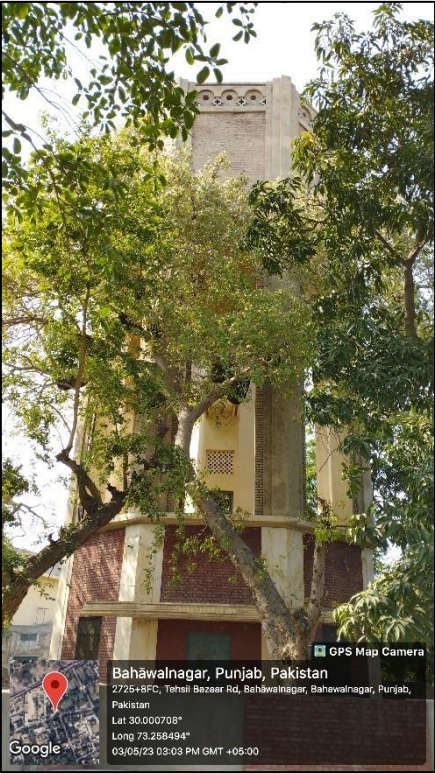
| Integrated Development And Asset Management Plan (IDAMP) | | | | | |
|--|---|---|---|---|---|
| Name | | City Water Tanki | | | Pictures |

| Integrated Development And Asset Management Plan (IDAMP) | | | | | |
|--|---|---|---|---|---|
| Form: IDAMP-A2 | | Over Head Reservoir Asset Condition Assessment | | | Asset Code: _____ Date: 02-05-2023 |

| Sr # | Name | Age (Years) | Capacity (Gallons) | Condition | Status | Book Value (PKR Mil) |
|---|---|---|---|---|---|---|
| 8 | City Tanki | Not Available | 50,000 | Failing | Abandoned | 0 |

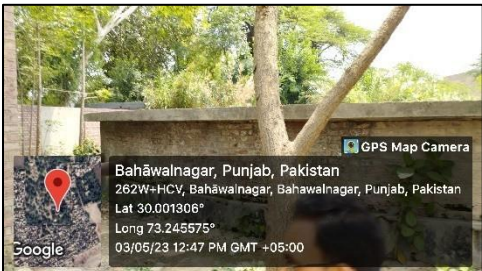
| Integrated Development and Asset Management Plan (IDAMP) | | | | | | | |
|--|---|--|---|---|---|--|---|
| Form: IDAMP-A3 | | Ground Storage Reservoir Asset Condition Assessment | | | Asset Code: _____ Date: 02-05-2023 | | |
| Year of Construction | | | 2007 | | | | |
| Capacity (UK Gallons) | | | 100,000 | | | | |

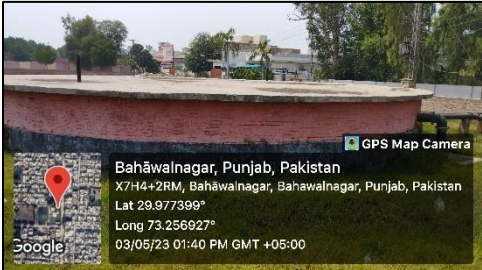
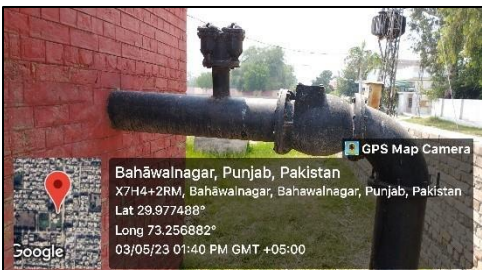
| Integrated Development and Asset Management Plan (IDAMP) | | | | | | | |
|--|---|--|---|---|---|---|---|
| Name | | Model Town 2 | | Pictures | | | |

| Integrated Development and Asset Management Plan (IDAMP) | | | | | | | |
|--|---|--|---|---|---|---|---|
| Form: IDAMP-A3 | | Ground Storage Reservoir Asset Condition Assessment | | Asset Code: _____ Date: 02-05-2023 | | | |
| Incoming Main | Dia | 10" | | | | | |
| | Material | MS | | | | | |
| Delivery Main | Dia | 8" | | | | | |

| Sr. No. | Location | Total No. of pumps | Type | Capacity (cusecs) | Total capacity (cusecs) | Working hour per day | Age (Years) | Condition | Status |
|---|---|---|---|---|---|---|---|---|---|
| 3 | Model Town 02 | 2 (1 Abandoned) | Centrifugal | 2 | 4 | 3 | 10 | Fair | Functional |

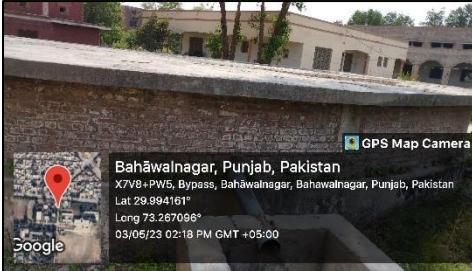
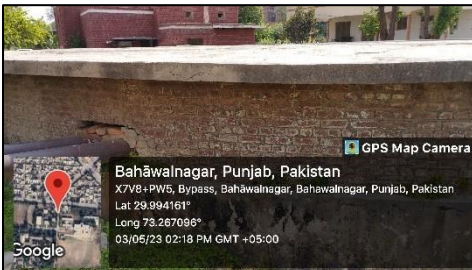
| Integrated Development and Asset Management Plan (IDAMP) | | | | | | | |
|--|---|--|---|---|---|---|---|
| Name | | Degree College | | Pictures | | | |

| Integrated Development and Asset Management Plan (IDAMP) | | | | | | | |
|--|---|--|---|---|---|---|---|
| Form: IDAMP-A3 | | Ground Storage Reservoir Asset Condition Assessment | | Asset Code: _____ Date: 02-05-2023 | | | |
| Number of Valves | Sluice Valve | 4 | | | | | |
| | Non-Returning Valve | 1 | | | | | |
| Incoming Main | Dia | 10" | | | | | |
| | Material | MS | | | | | |

| Sr. No. | Location | Total No. of pumps | Type | Capacity (cusecs) | Total capacity (cusecs) | Working hour per day | Age (Years) | Condition | Status |
|---|---|---|---|---|---|---|---|---|---|
| 5 | Degree College | 2 | Centrifugal | 1.5 | 3 | 3 | 16 | Fair | Functional |

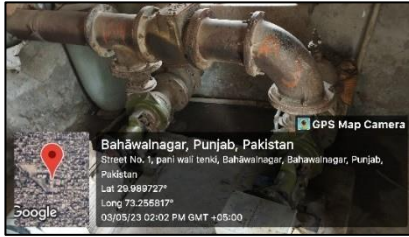
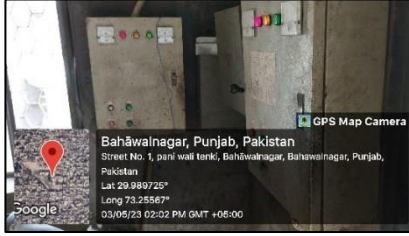
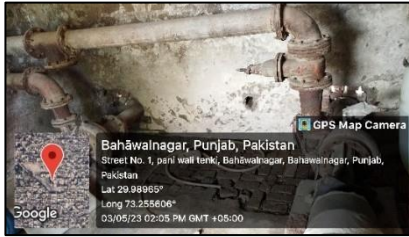
| Integrated Development and Asset Management Plan (IDAMP) | | | | | | | |
|---|---|--|---|---|---|---|--|
| Name | | Shahzad Nagar | | | | | |

| Integrated Development and Asset Management Plan (IDAMP) | | | | | | | |
|---|---|--|---|---|---|---|--|
| Form: IDAMP-A1 | | Intermediate Pumping Station Asset Condition Assessment | | | Asset Code: _____ Date: 02-05-2023 | | |
| Pump Type | | Centrifugal | Centrifugal | Centrifugal | Centrifugal | | |
| Pump Make | | MECO | MECO | BECO | BECO | | |

| Sr. No. | Location | Total No. of pumps | Type | Capacity (cusecs) | Total capacity (cusecs) | Working hour per day | Age (Years) | Condition | Status |
|---|---|---|---|---|---|---|---|---|---|
| 4 | Shahzad Nagar | 4 | Centrifugal | 3 | 12 | 3 | 40 | Fair | Functional |

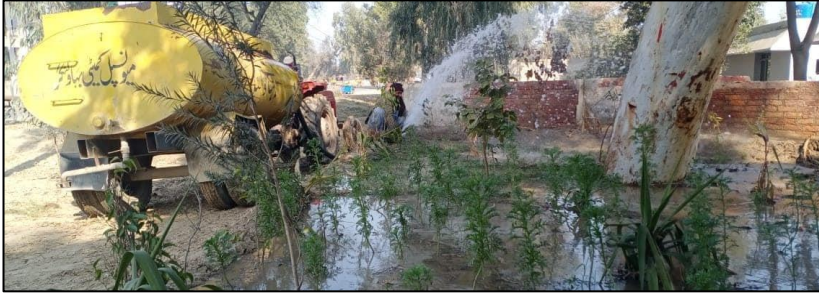
| Integrated Development and Asset Management Plan (IDAMP) | |
|--|---|
| Water Bowser | |
| Capacity | 500 Gallons |
| Purpose | Water Supply |

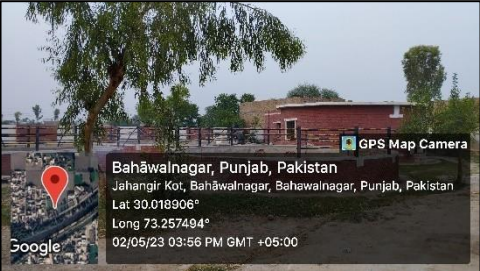
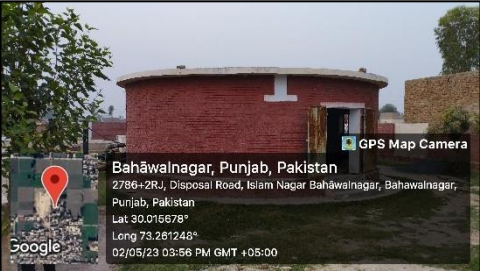
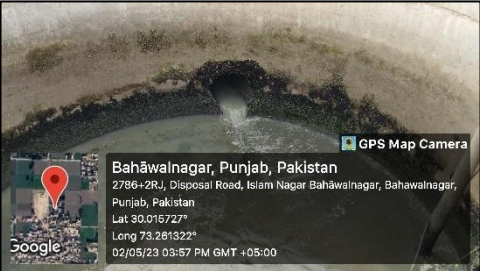
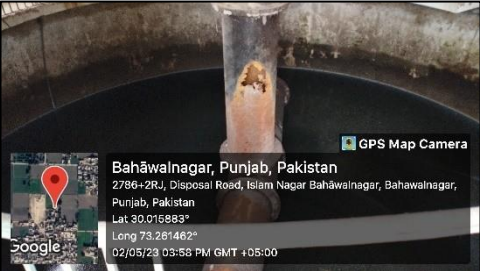
| Integrated Development and Asset Management Plan (IDAMP) | | | | | |
|--|---|---|---|---|--|
| Form: IDAMP-A7 | Sewerage Disposal Station Asset Condition Assessment | Asset Code: _____ Date: 02-05-2023 | | | |
| Name | | Islam Nagar | | | |

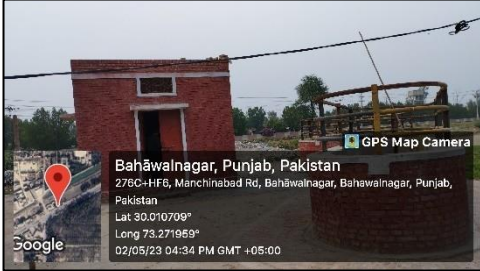
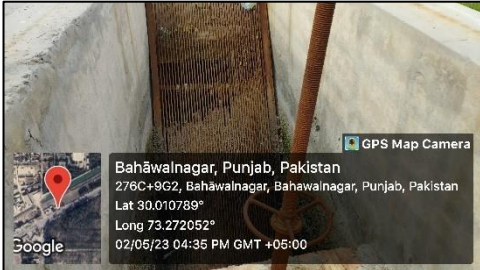
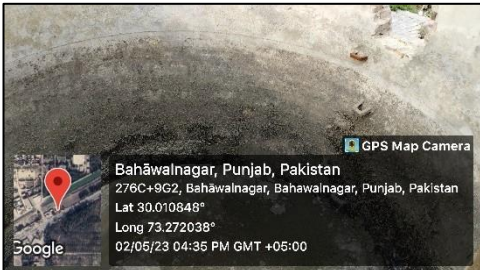
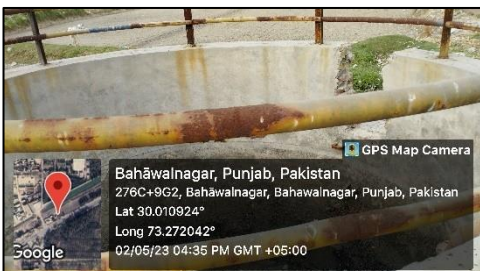
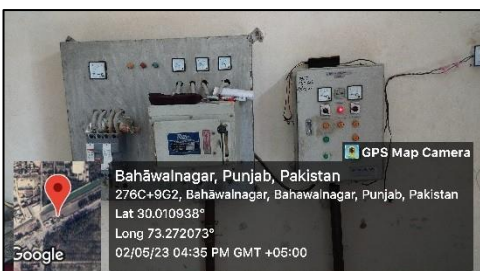
| Integrated Development and Asset Management Plan (IDAMP) | | | | | |
|--|---|---|---|---|--|
| Form: IDAMP-A7 | | Sewerage Disposal Station Asset Condition Assessment | | Asset Code: _____ Date: 02-05-2023 | |
| Name | | Karmanwala Disposal Station | | | |

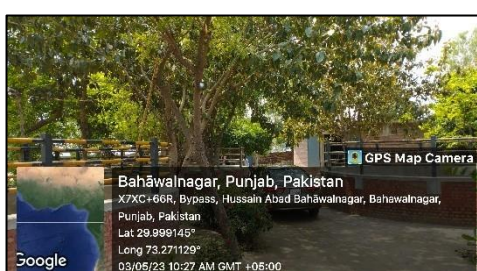
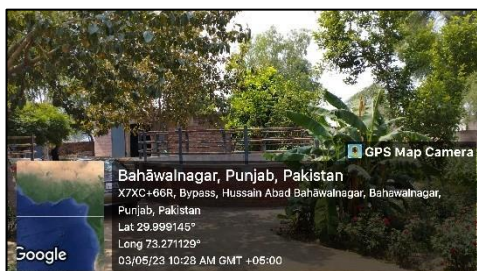
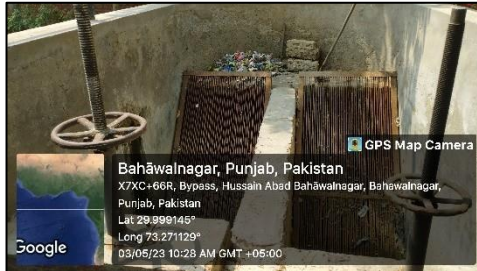
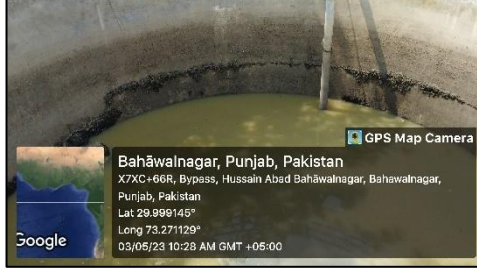
| Integrated Development and Asset Management Plan (IDAMP) | | | | | |
|--|---|---|---|---|---|
| Form: IDAMP-A7 | Sewerage Disposal Station Asset Condition Assessment | | | Asset Code: _____ Date: 02-05-2023 | |
| Name | | Madni Colony | | | |

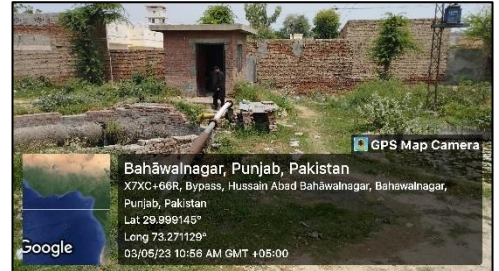
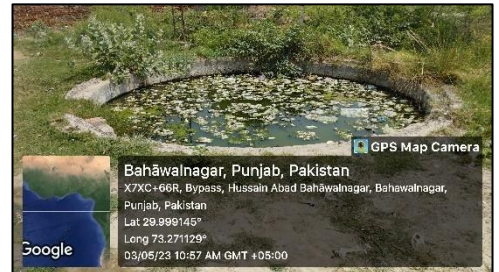
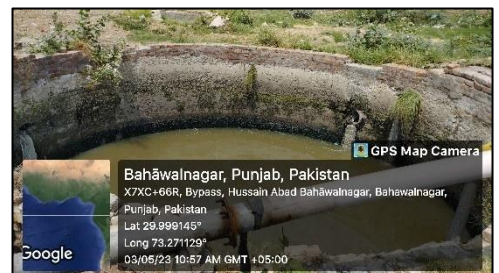
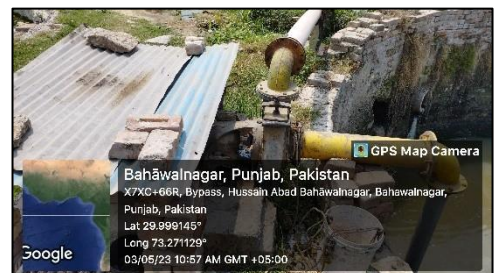
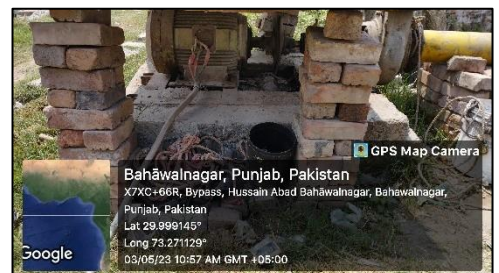
| Integrated Development and Asset Management Plan (IDAMP) | | | | | |
|--|---|---|---|---|---|
| Civil Structure Condition | | Good | Fair | Poor | |
| Control Room Structure | | Good | Fair | Poor | |
| Discharge Box Structure | | Good | Fair | Poor | |

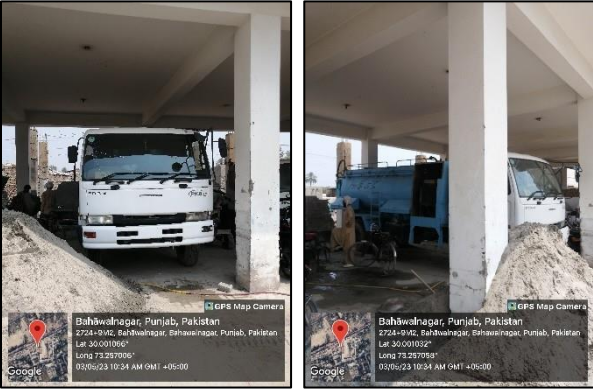
| Integrated Development and Asset Management Plan (IDAMP) | | |
|--|--|---|
| Sucker & Jetting Machine | | |
| | Suction Machine | Jetting Machine |

| Capacity | 4500 liters | 4500 liters |
| Condition | Fair | Fair |

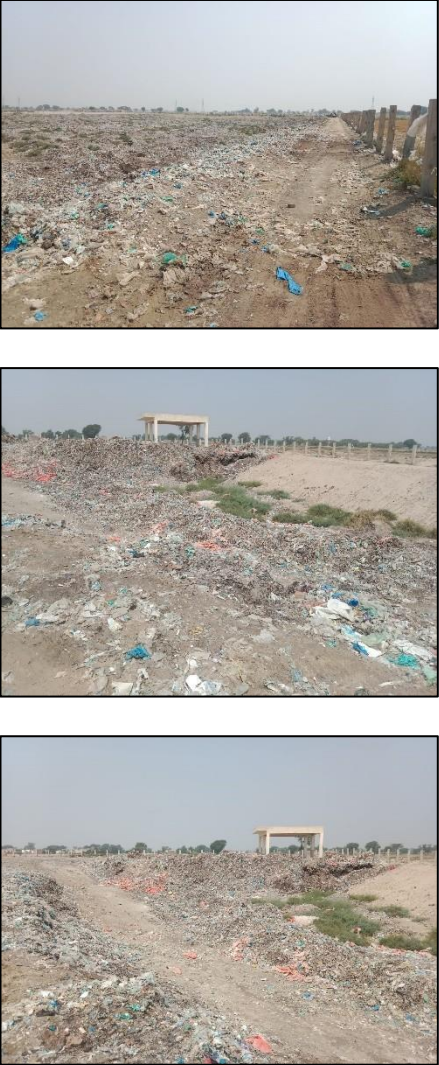
| Integrated Development And Asset Management Plan (IDAMP) | | | | | | |
|--|---|--|---|---|---|--|
| Form: IDAMP-A11 | | Solid Waste Dumping Site Asset Condition Assessment | | | Asset Code: _____ Date: 02-05-2023 | |
| Name | | Landfill Site | | Pictures | | |
| Location | Latitude | 30.010315 | | | | |

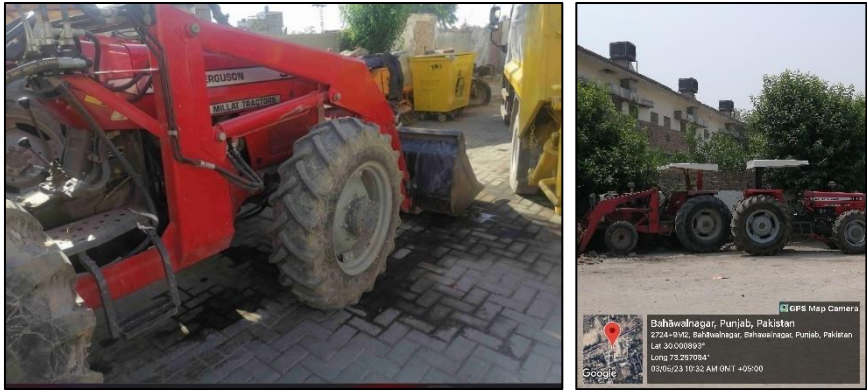
| Integrated Development and Asset Management Plan (IDAMP) | | | | | | | | |
|--|--|---|---|---|---|---|---|---|
| Tractor-Millat | | | | | | | | |
| | Tractor- Millat 1 | Tractor- Millat 2 | Tractor- Millat 3 | Tractor- Millat 4 | Tractor- Millat 5 | Tractor- Millat 6 | Tractor- Millat 7 | Tractor- Millat 8 |
| Capacity | 50HP | 50HP | 85HP | 50HP | 50HP | 50HP | 50HP | 50HP |
| Condition | Poor | Poor | Fair | Fair | Fair | Poor | Fair | Fair |

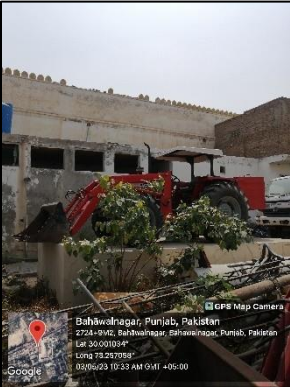
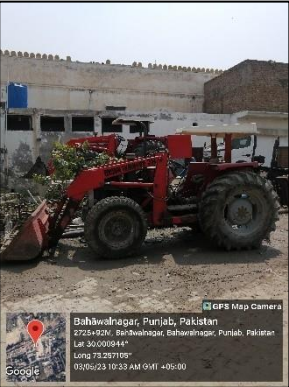
| Integrated Development and Asset Management Plan (IDAMP) | | | |
|--|---|---|---|
| Tractor-FIAT | <div style="display: flex; justify-content: space-around;"> </div> | | |
| | Tractor-FIAT 1 | Tractor-FIAT 2 | Tractor-FIAT 3 |
| Capacity | 85HP | 55HP | 55HP |
| Condition | Fair | Fair | Fair |

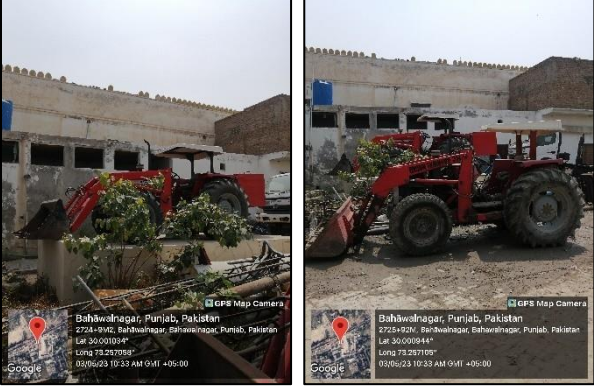
| Integrated Development and Asset Management Plan (IDAMP) | | | |
|--|--|---|---|
| Tractor | | | |
| | Front Blade Tractor | Front End Loader 1 | Front End Loader 2 |
| Capacity | 85HP | 85HP | 85HP |
| Condition | Fair | Fair | Fair |

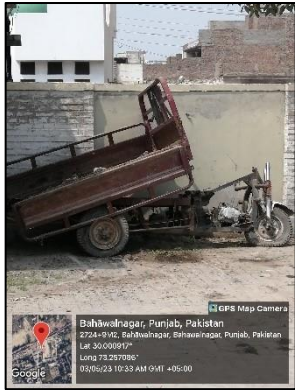
| Integrated Development and Asset Management Plan (IDAMP) | | | | | |
|--|--|---|---|---|---|
| Loader Rickshaw | | | | | |
| | Loader Rickshaw 1 | Loader Rickshaw 2 | Loader Rickshaw 3 | Loader Rickshaw 4 | Loader Rickshaw 5 |
| Capacity | 1.5 m ³ | 1.5 m ³ | 1.5 m ³ | 1.5 m ³ | 1.5 m ³ |
| Condition | Good | Good | Good | Good | Good |

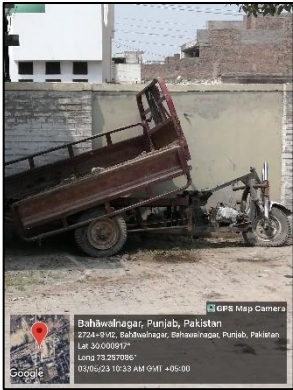
| Integrated Development and Asset Management Plan (IDAMP) | | | | | | |
|--|--|---|---|---|---|---|
| Loader Rickshaw | | | | | | |
| | Loader Rickshaw 6 | Loader Rickshaw 7 | Loader Rickshaw 8 | Loader Rickshaw 9 | Loader Rickshaw 10 | Loader Rickshaw 11 |
| Capacity | 1.5 m ³ | 1.5 m ³ | 1.5 m ³ | 1.5 m ³ | 1.5 m ³ | 1.5 m ³ |
| Condition | Good | Good | Good | Good | Good | Poor |

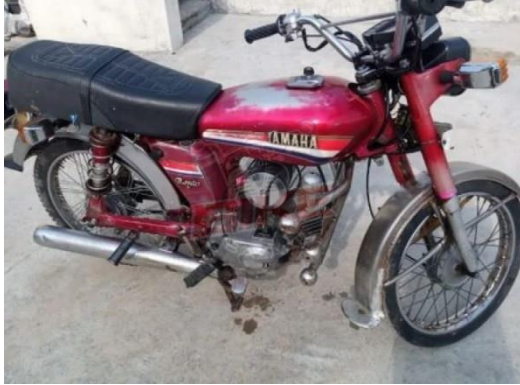
| Integrated Development and Asset Management Plan (IDAMP) | | |
|--|--|---|
| Bike-Yamaha | | |
| Capacity | 100 CC | |
| Purpose | Staff | |
| Condition | Poor | |

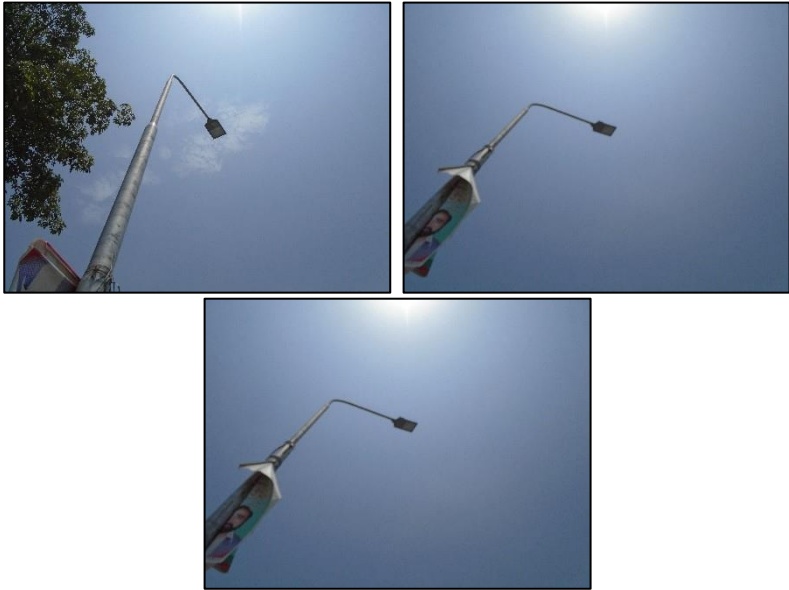
| Integrated Development and Asset Management Plan (IDAMP) | | | |
|---|--|---|---|
| Form: IDAMP-A9 | Street Lights Asset Condition Assessment | | Asset Code: _____ Date: 02-05-2023 |
| Pictures | | | |

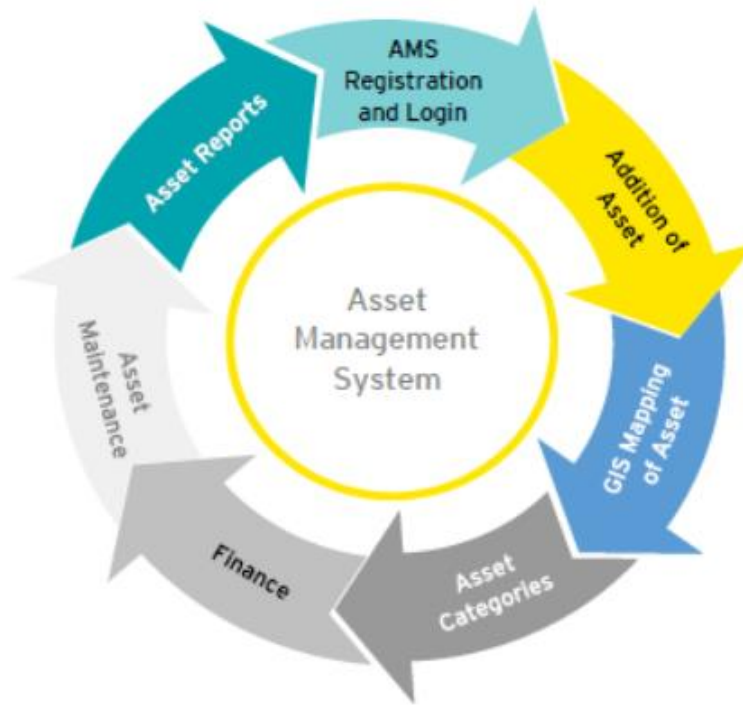
The coordinated system for carrying out life cycle asset management in an effective and efficient manner is the one known as 'Asset Management System' (AMS). A standard AMS has various components which include asset registration, asset categories, finance, asset maintenance and asset related reports.
