Punjab Municipal Development Fund Company

Hiring of Consulting Services for Preparation of Integrated Development and Asset Management Plan (IDAMP) for 16 selected MCs In Punjab under Punjab Cities Program (PCP)

**IDAMP – Municipal Committee Bahawalnagar
May 2024**

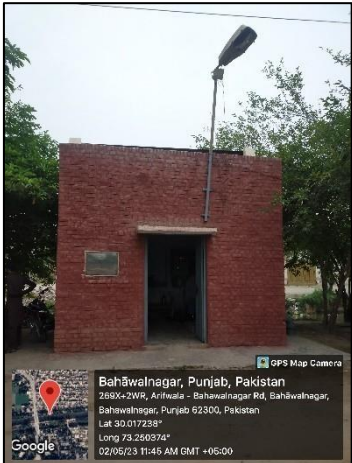
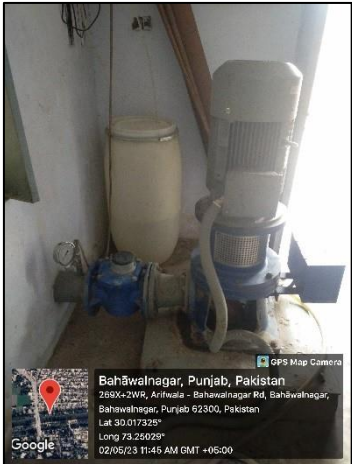
Integrated Development and Asset Management Plan (IDAMP)				
Municipal Committee Bahawalnagar				
Form: IDAMP-A1	Tube Well Asset Condition Assessment			Asset Code: _____ Date: 02-05-2023
Asset Detail			Pictures	
Name		Ford Wah Old # 0		
Location	Latitude	30.017325		
	Longitude	73.250290		
Address		Arifwala Road, Ford wah Canal, Bahawalnagar		
Area (Marla)		1		
Working Status		Functional	Non-Functional	
Installation Year of Tube Well		1980 (Bore), 2020 (Civil Structure Renovation)		
Installation Year of Pump		2020		
Capital Cost of Machinery				
Operational Hours		6		
Delivery Pipe	Dia	6"		
	Material	MS		
Chlorinator		Yes	No	
Chlorination Schedule		Once in a Year	After 6 Months	No Schedule
Apron Around Pump House		Yes	No	
Hoisting Girder		Yes	No	
Civil Structure Condition		Good	Fair	Poor
Approach to Pump House		Good	Fair	Poor
Pump Details				
Pump Type		Turbine		
Pump Make		KSB		
Discharge Capacity (Cusec)		0.5		
Rotational Speed (RPM)		1460

Housing Dia (inches)		12		
Bore Depth (ft.)		180		
Head (ft.)		200		
Impeller Installation Depth (ft.)		60		
Paint of Pumping Unit		Good	Fair	Poor
Number of Valves	Gate Valve	0		
	Non-Returning Valve	1		
Base Plate		Yes	No	
Electro-Mechanical Equipment Details				
Transformer Capacity (kVA)		50		
Sanctioned Load (Kwh)		29.8		
Motor Power (HP)		20		
Motor Make		Siemens		
MCU		Yes	No	
Earthing of Motor		Yes	No	
Power Wiring		Yes	No	
Service Cable		Yes	No

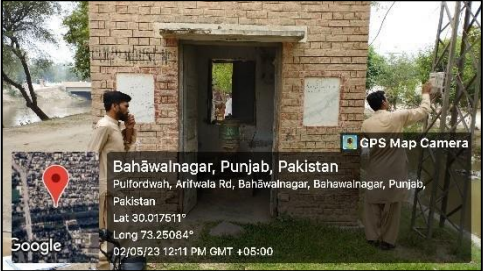
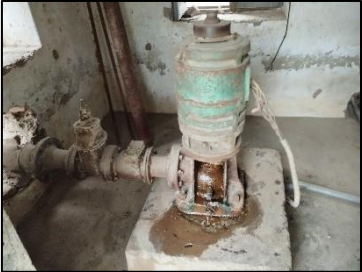
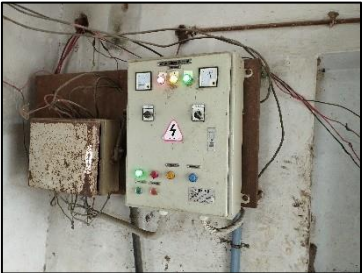
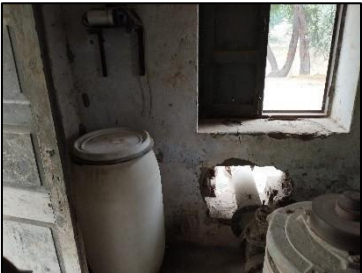
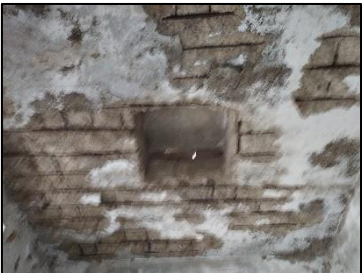
Integrated Development and Asset Management Plan (IDAMP)				
Municipal Committee Bahawalnagar				
Form: IDAMP-A1	Tube Well Asset Condition Assessment			Asset Code: _____ Date: 02-05-2023
Asset Detail				Pictures
Name		Ford Wah Old # 01		
Location	Latitude	30.017511		
	Longitude	73.250840		
Address		Arifwala Road, Ford wah Canal, Bahawalnagar		
Area (Marla)		1		
Working Status		Functional	Non-Functional	
Installation Year of Tube Well		1984		
Installation Year of Pump		1984		
Capital Cost of Machinery				
Operational Hours		6		
Delivery Pipe	Dia	6"		
	Material	MS		
Chlorinator		Yes	No	
Chlorination Schedule		Once in a Year	After 6 Months	No Schedule
Apron Around Pump House		Yes	No	
Hoisting Girder		Yes	No	
Civil Structure Condition		Good	Fair	Poor
Approach to Pump House		Good	Fair	Poor
Pump Details				
Pump Type		Turbine		
Pump Make		PECO		
Discharge Capacity (Cusec)		0.5		
Rotational Speed (RPM)		1460		
Housing Dia (inches)		12

Bore Depth (ft.)		180		
Head (ft.)		200		
Impeller Installation Depth (ft.)		50		
Paint of Pumping Unit		Good	Fair	Poor
Number of Valves	Gate Valve	1		
	Non-Returning Valve	1		
Base Plate		Yes	No	
Electro-Mechanical Equipment Details				
Transformer Capacity (kVA)		50		
Sanctioned Load (Kwh)		29.8		
Motor Power (HP)		20		
Motor Make		Siemens		
MCU		Yes	No	
Earthing of Motor		Yes	No	
Power Wiring		Yes	No	
Service Cable		Yes	No	
Earthing of MCU		Yes	No

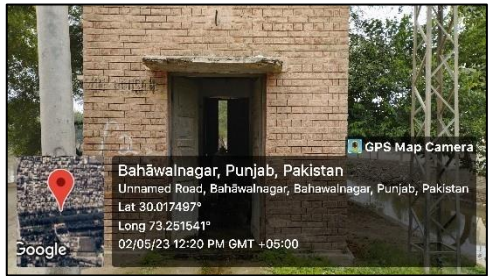
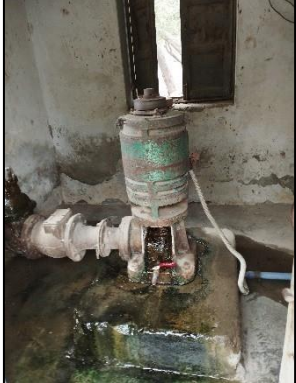
Integrated Development and Asset Management Plan (IDAMP)				
Municipal Committee Bahawalnagar				
Form: IDAMP-A1	Tube Well Asset Condition Assessment			Asset Code: _____ Date: 02-05-2023
Asset Detail			Pictures	
Name		Ford Wah Old # 02		
Location	Latitude	30.017497		
	Longitude	73.251541		
Address		Arifwala Road, Ford wah Canal, Bahawalnagar		
Area (Marla)		1		
Working Status		Functional	Non-Functional	
Installation Year of Tube Well		1984		
Installation Year of Pump		1984		
Capital Cost of Machinery				
Operational Hours		6		
Delivery Pipe	Dia	6"		
	Material	MS		
Chlorinator		Yes	No	
Chlorination Schedule		Once in a Year	After 6 Months	No Schedule
Apron Around Pump House		Yes	No	
Hoisting Girder		Yes	No	
Civil Structure Condition		Good	Fair	Poor
Approach to Pump House		Good	Fair	Poor
Pump Details				
Pump Type		Turbine		
Pump Make		PECO		
Discharge Capacity (Cusec)		0.5		
Rotational Speed (RPM)		1460		
Housing Dia (inches)		12

Bore Depth (ft.)		180		
Head (ft.)		200		
Impeller Installation Depth (ft.)		60		
Paint of Pumping Unit		Good	Fair	Poor
Number of Valves	Gate Valve	1		
	Non-Returning Valve	1		
Base Plate		Yes	No	
Electro-Mechanical Equipment Details				
Transformer Capacity (kVA)		25		
Sanctioned Load (Kwh)		29.8		
Motor Power (HP)		20		
Motor Make		Siemens		
MCU		Yes	No	
Earthing of Motor		Yes	No	
Power Wiring		Yes	No	
Service Cable		Yes	No	
Earthing of MCU		Yes	No

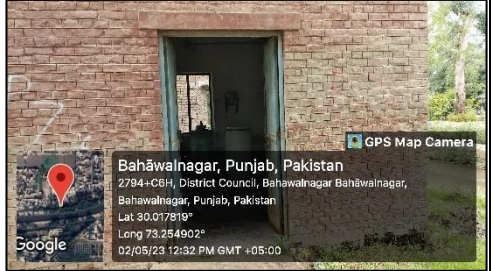
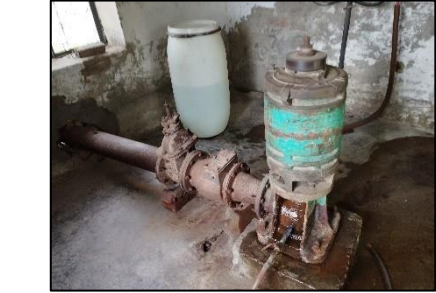
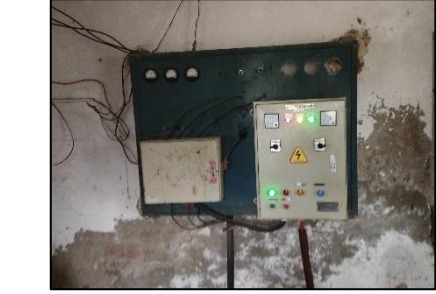
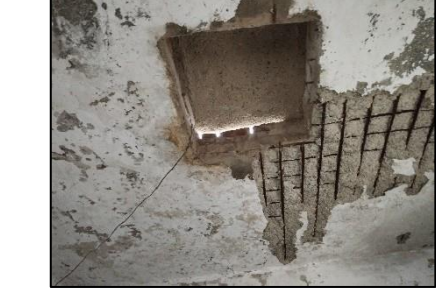
Integrated Development and Asset Management Plan (IDAMP)				
Municipal Committee Bahawalnagar				
Form: IDAMP-A1	Tube Well Asset Condition Assessment			Asset Code: _____ Date: 02-05-2023
Asset Detail			Pictures	
Name		Ford Wah Old # 07		
Location	Latitude	30.017819		
	Longitude	73.254902		
Address		Arifwala Road, Ford wah Canal, Bahawalnagar		
Area (Marla)		1		
Working Status		Functional	Non-Functional	
Installation Year of Tube Well		1990		
Installation Year of Pump		1990		
Capital Cost of Machinery				
Operational Hours		6		
Delivery Pipe	Dia	6"		
	Material	MS		
Chlorinator		Yes	No	
Chlorination Schedule		Once in a Year	After 6 Months	No Schedule
Apron Around Pump House		Yes	No	
Hoisting Girder		Yes	No	
Civil Structure Condition		Good	Fair	Poor
Approach to Pump House		Good	Fair	Poor
Pump Details				
Pump Type		Turbine		
Pump Make		PECO		
Discharge Capacity (Cusec)		0.5		
Rotational Speed (RPM)		1460		
Housing Dia (inches)		12

Bore Depth (ft.)		180		
Head (ft.)		200		
Impeller Installation Depth (ft.)		60		
Paint of Pumping Unit		Good	Fair	Poor
Number of Valves	Gate Valve	1		
	Non-Returning Valve	1		
Base Plate		Yes	No	
Electro-Mechanical Equipment Details				
Transformer Capacity (kVA)		25		
Sanctioned Load (Kwh)		29.8		
Motor Power (HP)		20		
Motor Make		PECO		
MCU		Yes	No	
Earthing of Motor		Yes	No	
Power Wiring		Yes	No	
Service Cable		Yes	No	
Earthing of MCU		Yes	No

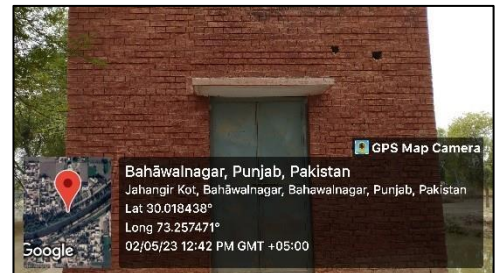
Integrated Development and Asset Management Plan (IDAMP)					
Municipal Committee Bahawalnagar					
Form: IDAMP-A1	Tube Well Asset Condition Assessment			Asset Code: _____ Date: 02-05-2023	
Asset Detail				Pictures	
Name		Ford Wah Old # 09			
Location	Latitude	30.018438			
	Longitude	73.257471			
Address		Arifwala Road, Ford wah Canal, Bahawalnagar			
Area (Marla)		1			
Working Status		Functional	Non-Functional		
Installation Year of Tube Well		1990			
Installation Year of Pump		1990			
Capital Cost of Machinery					
Operational Hours		0			
Delivery Pipe	Dia	6"			
	Material	MS			
Chlorinator		Yes	No		
Chlorination Schedule		Once in a Year	After 6 Months	No Schedule	
Apron Around Pump House		Yes	No		
Hoisting Girder		Yes	No		
Civil Structure Condition		Good	Fair	Poor	
Approach to Pump House		Good	Fair	Poor	
Pump Details					
Pump Type		Turbine			
Pump Make		PECO			
Discharge Capacity (Cusec)		0.5			
Rotational Speed (RPM)		-

Housing Dia (inches)		12			
Bore Depth (ft.)		180			
Head (ft.)		200			
Impeller Installation Depth (ft.)		60			
Paint of Pumping Unit		Good	Fair	Poor	
Number of Valves	Gate Valve	0			
	Non-Returning Valve	0			
Base Plate		Yes	No		
Electro-Mechanical Equipment Details					
Transformer Capacity (kVA)		No Motor			
Sanctioned Load (Kwh)					
Motor Power (HP)					
Motor Make					
MCU		Yes	No		
Earthing of Motor		Yes	No		
Power Wiring		Yes	No		
Service Cable		Yes	No		
Earthing of MCU		Yes	No

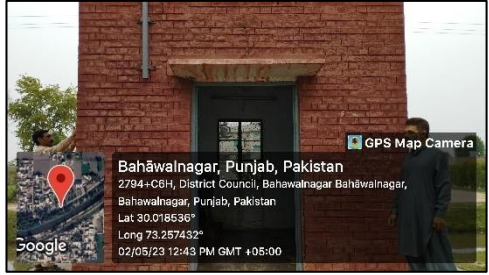
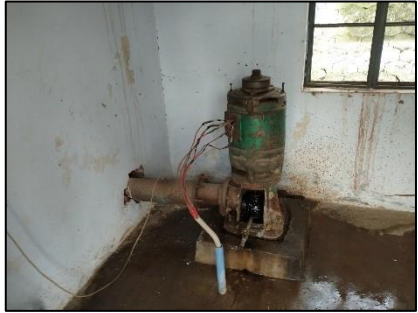
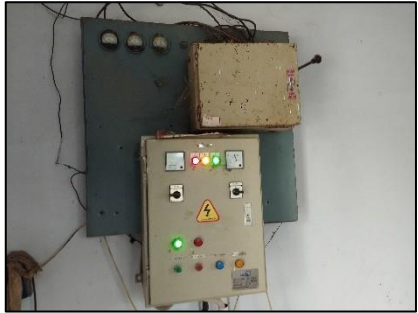
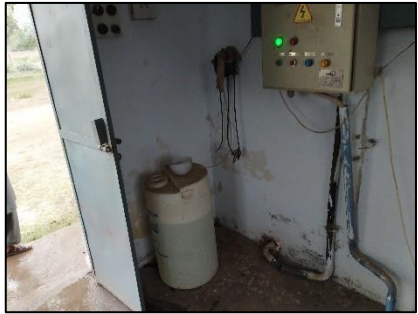
Integrated Development and Asset Management Plan (IDAMP)				
Municipal Committee Bahawalnagar				
Form: IDAMP-A1	Tube Well Asset Condition Assessment			Asset Code: _____ Date: 02-05-2023
Asset Detail			Pictures	
Name		Ford Wah Old # 10		
Location	Latitude	30.018536		
	Longitude	73.257432		
Address		Arifwala Road, Ford wah Canal, Bahawalnagar		
Area (Marla)		1		
Working Status		Functional	Non-Functional	
Installation Year of Tube Well		1984		
Installation Year of Pump		1984		
Capital Cost of Machinery				
Operational Hours		6		
Delivery Pipe	Dia	6"		
	Material	MS		
Chlorinator		Yes	No	
Chlorination Schedule		Once in a Year	After 6 Months	No Schedule
Apron Around Pump House		Yes	No	
Hoisting Girder		Yes	No	
Civil Structure Condition		Good	Fair	Poor
Approach to Pump House		Good	Fair	Poor
Pump Details				
Pump Type		Turbine		
Pump Make		PECO		
Discharge Capacity (Cusec)		0.5		
Rotational Speed (RPM)		1460		
Housing Dia (inches)		12

Bore Depth (ft.)		180		
Head (ft.)		200		
Impeller Installation Depth (ft.)		60		
Paint of Pumping Unit		Good	Fair	Poor
Number of Valves	Gate Valve	0		
	Non-Returning Valve	1		
Base Plate		Yes	No	
Electro-Mechanical Equipment Details				
Transformer Capacity (kVA)		25		
Sanctioned Load (Kwh)		14.92		
Motor Power (HP)		20		
Motor Make		PECO		
MCU		Yes	No	
Earthing of Motor		Yes	No	
Power Wiring		Yes	No	
Service Cable		Yes	No	
Earthing of MCU		Yes	No

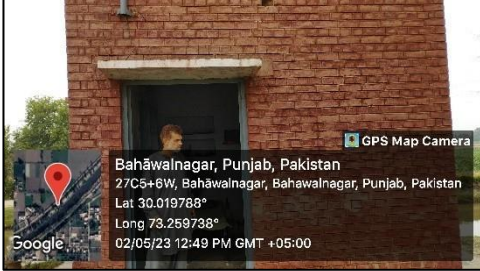
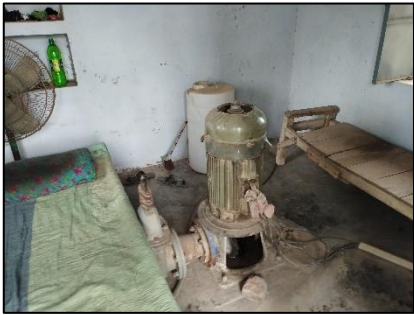
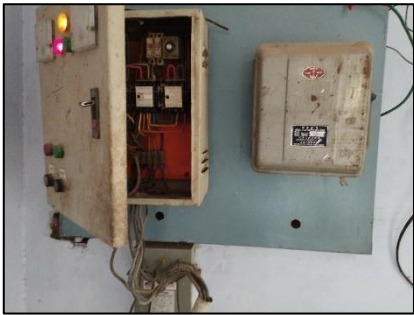
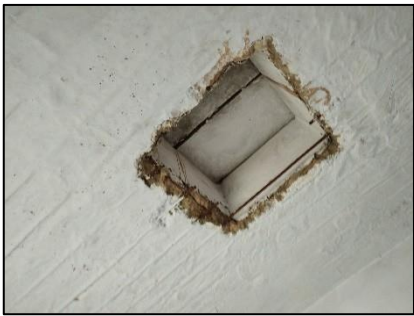
Integrated Development and Asset Management Plan (IDAMP)				
Municipal Committee Bahawalnagar				
Form: IDAMP-A1	Tube Well Asset Condition Assessment			Asset Code: _____ Date: 02-05-2023
Asset Detail			Pictures	
Name		Ford Wah New # 01		
Location	Latitude	30.019788		
	Longitude	73.259738		
Address		Arifwala Road, Ford wah Canal, Bahawalnagar		
Area (Marla)		1		
Working Status		Functional	Non-Functional	
Installation Year of Tube Well		2005		
Installation Year of Pump		2005		
Capital Cost of Machinery				
Operational Hours		6		
Delivery Pipe	Dia	6"		
	Material	MS		
Chlorinator		Yes	No	
Chlorination Schedule		Once in a Year	After 6 Months	No Schedule
Apron Around Pump House		Yes	No	
Hoisting Girder		Yes	No	
Civil Structure Condition		Good	Fair	Poor
Approach to Pump House		Good	Fair	Poor
Pump Details				
Pump Type		Turbine		
Pump Make		KSB		
Discharge Capacity (Cusec)		0.5		
Rotational Speed (RPM)		1460		
Housing Dia (inches)		12

Bore Depth (ft.)		180		
Head (ft.)		200		
Impeller Installation Depth (ft.)		60		
Paint of Pumping Unit		Good	Fair	Poor
Number of Valves	Gate Valve	1		
	Non-Returning Valve	1		
Base Plate		Yes	No	
Electro-Mechanical Equipment Details				
Transformer Capacity (kVA)		25		
Sanctioned Load (Kwh)		14.92		
Motor Power (HP)		20		
Motor Make		Siemens		
MCU		Yes	No	
Earthing of Motor		Yes	No	
Power Wiring		Yes	No	
Service Cable		Yes	No	
Earthing of MCU		Yes	No

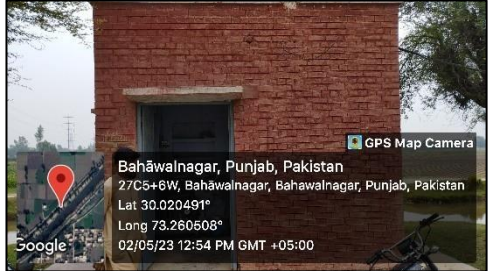
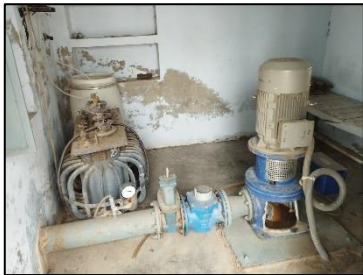
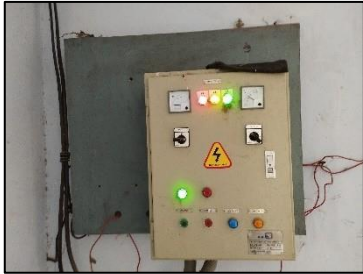
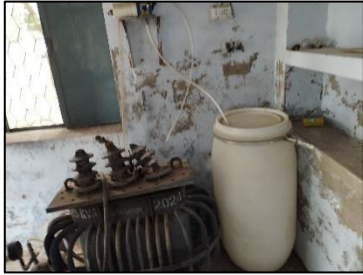
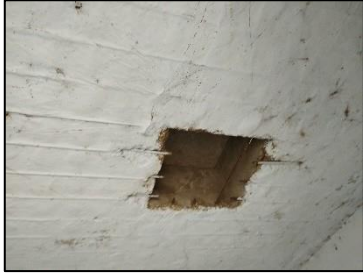
Integrated Development and Asset Management Plan (IDAMP)				
Municipal Committee Bahawalnagar				
Form: IDAMP-A1	Tube Well Asset Condition Assessment			Asset Code: _____ Date: 02-05-2023
Asset Detail			Pictures	
Name		Ford Wah New # 02		
Location	Latitude	30.020491		
	Longitude	73.260508		
Address		Arifwala Road, Ford wah Canal, Bahawalnagar		
Area (Marla)		1		
Working Status		Functional	Non-Functional	
Installation Year of Tube Well		2005		
Installation Year of Pump		2005		
Capital Cost of Machinery				
Operational Hours		6		
Delivery Pipe	Dia	6"		
	Material	MS		
Chlorinator		Yes	No	
Chlorination Schedule		Once in a Year	After 6 Months	No Schedule
Apron Around Pump House		Yes	No	
Hoisting Girder		Yes	No	
Civil Structure Condition		Good	Fair	Poor
Approach to Pump House		Good	Fair	Poor
Pump Details				
Pump Type		Turbine		
Pump Make		KSB		
Discharge Capacity (Cusec)		0.5		
Rotational Speed (RPM)		1460		
Housing Dia (inches)		12

Bore Depth (ft.)		180		
Head (ft.)		200		
Impeller Installation Depth (ft.)		60		
Paint of Pumping Unit		Good	Fair	Poor
Number of Valves	Gate Valve	1		
	Non-Returning Valve	1		
Base Plate		Yes	No	
Electro-Mechanical Equipment Details				
Transformer Capacity (kVA)		25		
Sanctioned Load (Kwh)		14.92		
Motor Power (HP)		20		
Motor Make		Siemens		
MCU		Yes	No	
Earthing of Motor		Yes	No	
Power Wiring		Yes	No	
Service Cable		Yes	No	
Earthing of MCU		Yes	No

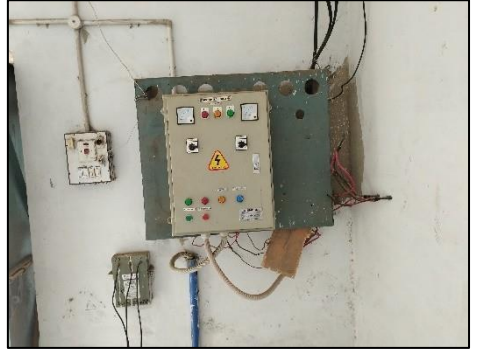
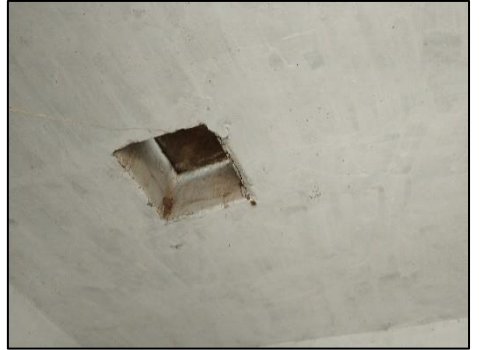
Integrated Development and Asset Management Plan (IDAMP)					
Municipal Committee Bahawalnagar					
Form: IDAMP-A1	Tube Well Asset Condition Assessment			Asset Code: _____ Date: 02-05-2023	
Asset Detail				Pictures	
Name		Ford Wah New # 21			
Location	Latitude	30.021300			
	Longitude	73.261497			
Address		Arifwala Road, Ford wah Canal, Bahawalnagar			
Area (Marla)		1			
Working Status		Functional	Non-Functional		
Installation Year of Tube Well		2005			
Installation Year of Pump		2005			
Capital Cost of Machinery					
Operational Hours		0			
Delivery Pipe	Dia	6"			
	Material	MS			
Chlorinator		Yes	No		
Chlorination Schedule		Once in a Year	After 6 Months	No Schedule	
Apron Around Pump House		Yes	No		
Hoisting Girder		Yes	No		
Civil Structure Condition		Good	Fair	Poor	
Approach to Pump House		Good	Fair	Poor	
Pump Details					
Pump Type		Turbine			
Pump Make		KSB			
Discharge Capacity (Cusec)		0.5			
Rotational Speed (RPM)

Housing Dia (inches)		12			
Bore Depth (ft.)		180			
Head (ft.)		200			
Impeller Installation Depth (ft.)		60			
Paint of Pumping Unit		Good	Fair	Poor	
Number of Valves	Gate Valve	1			
	Non-Returning Valve	1			
Base Plate		Yes	No		
Electro-Mechanical Equipment Details					
Transformer Capacity (kVA)		No Motor			
Sanctioned Load (Kwh)					
Motor Power (HP)					
Motor Make					
MCU		Yes	No		
Earthing of Motor		Yes	No		
Power Wiring		Yes	No		
Service Cable		Yes	No		
Earthing of MCU		Yes	No

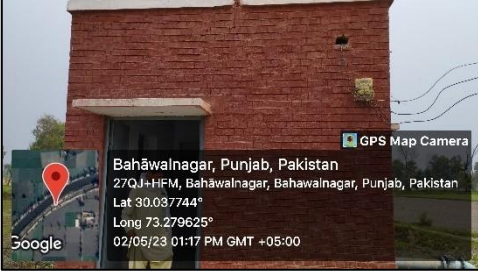
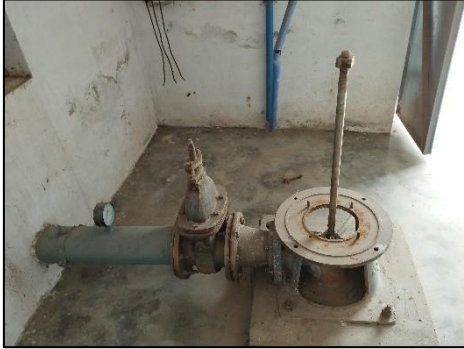
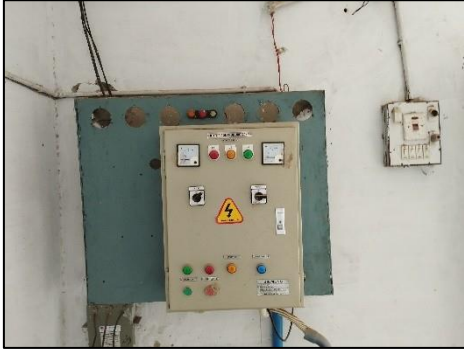
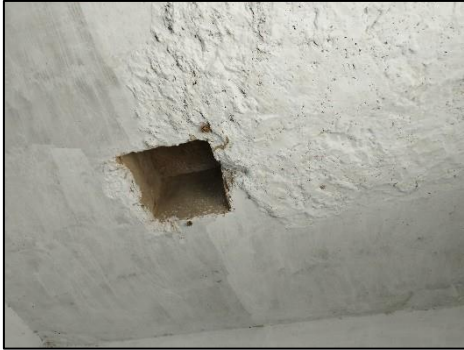
Integrated Development and Asset Management Plan (IDAMP)					
Municipal Committee Bahawalnagar					
Form: IDAMP-A1	Tube Well Asset Condition Assessment			Asset Code: _____ Date: 02-05-2023	
Asset Detail				Pictures	
Name		Ford Wah New # 20			
Location	Latitude	30.037744			
	Longitude	73.279625			
Address		Arifwala Road, Ford wah Canal, Bahawalnagar			
Area (Marla)		1			
Working Status		Functional	Non-Functional		
Installation Year of Tube Well		2005			
Installation Year of Pump		2005			
Capital Cost of Machinery					
Operational Hours		0			
Delivery Pipe	Dia	6"			
	Material	MS			
Chlorinator		Yes	No		
Chlorination Schedule		Once in a Year	After 6 Months	No Schedule	
Apron Around Pump House		Yes	No		
Hoisting Girder		Yes	No		
Civil Structure Condition		Good	Fair	Poor	
Approach to Pump House		Good	Fair	Poor	
Pump Details					
Pump Type		Turbine			
Pump Make		KSB			
Discharge Capacity (Cusec)		0.5			
Rotational Speed (RPM)		-

Housing Dia (inches)		12			
Bore Depth (ft.)		180			
Head (ft.)		200			
Impeller Installation Depth (ft.)		60			
Paint of Pumping Unit		Good	Fair	Poor	
Number of Valves	Gate Valve	1			
	Non-Returning Valve	1			
Base Plate		Yes	No		
Electro-Mechanical Equipment Details					
Transformer Capacity (kVA)		No Motor			
Sanctioned Load (Kwh)					
Motor Power (HP)					
Motor Make					
MCU		Yes	No		
Earthing of Motor		Yes	No		
Power Wiring		Yes	No		
Service Cable		Yes	No		
Earthing of MCU		Yes	No

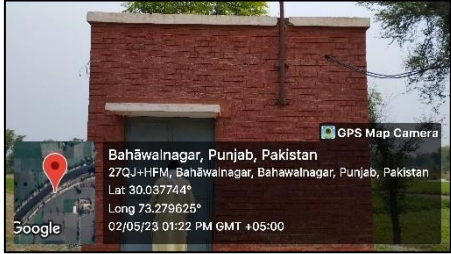
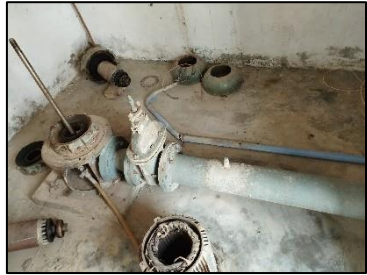
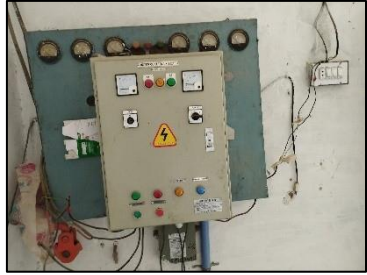
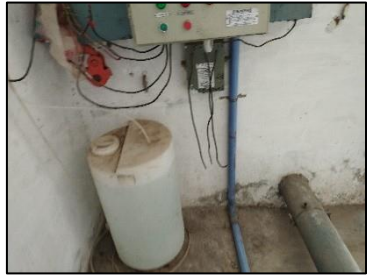
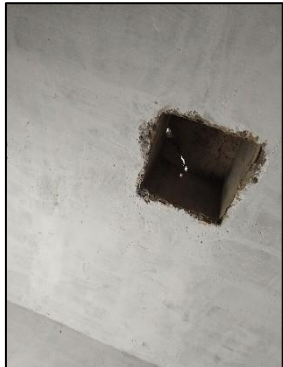
Integrated Development and Asset Management Plan (IDAMP)				
Municipal Committee Bahawalnagar				
Form: IDAMP-A1	Tube Well Asset Condition Assessment	Asset Code: _____ Date: 02-05-2023		
Asset Detail			Pictures	
Name		Ford Wah New # 19		
Location	Latitude	30.037744		
	Longitude	73.279625		
Address		Arifwala Road, Ford wah Canal, Bahawalnagar		
Area (Marla)		1		
Working Status		Functional	Non-Functional	
Installation Year of Tube Well		2005		
Installation Year of Pump		2005		
Capital Cost of Machinery				
Operational Hours		0		
Delivery Pipe	Dia	6"		
	Material	MS		
Chlorinator		Yes	No	
Chlorination Schedule		Once in a Year	After 6 Months	No Schedule
Apron Around Pump House		Yes	No	
Hoisting Girder		Yes	No	
Civil Structure Condition		Good	Fair	Poor
Approach to Pump House		Good	Fair	Poor
Pump Details				
Pump Type		Turbine		
Pump Make		KSB		
Discharge Capacity (Cusec)		0.5		
Rotational Speed (RPM)		-		
Housing Dia (inches)		12

Bore Depth (ft.)		180		
Head (ft.)		200		
Impeller Installation Depth (ft.)		60		
Paint of Pumping Unit		Good	Fair	Poor
Number of Valves	Gate Valve	1		
	Non-Returning Valve	1		
Base Plate		Yes	No	
Electro-Mechanical Equipment Details				
Transformer Capacity (kVA)		No Motor		
Sanctioned Load (Kwh)				
Motor Power (HP)				
Motor Make				
MCU		Yes	No	
Earthing of Motor		Yes	No	
Power Wiring		Yes	No	
Service Cable		Yes	No	
Earthing of MCU		Yes	No

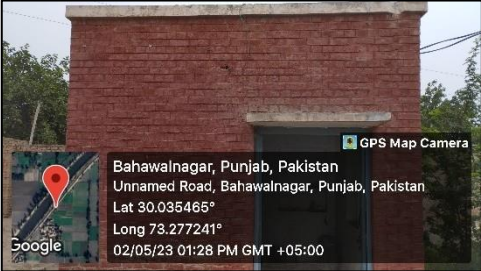
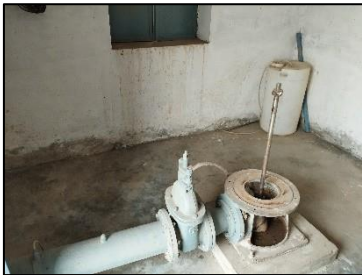
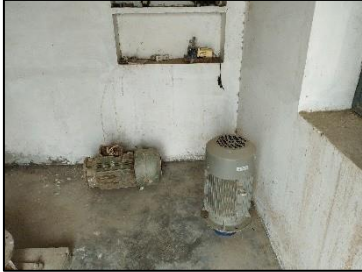
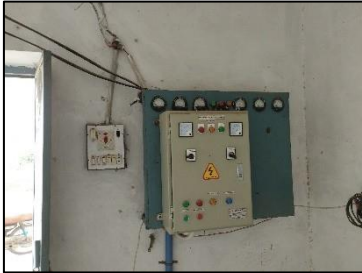
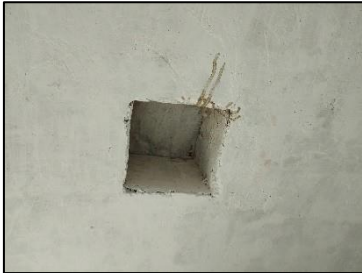
Integrated Development and Asset Management Plan (IDAMP)					
Municipal Committee Bahawalnagar					
Form: IDAMP-A1	Tube Well Asset Condition Assessment			Asset Code: _____ Date: 02-05-2023	
Asset Detail				Pictures	
Name		Ford Wah New # 18			
Location	Latitude	30.035465			
	Longitude	73.277241			
Address		Arifwala Road, Ford wah Canal, Bahawalnagar			
Area (Marla)		1			
Working Status		Functional	Non-Functional		
Installation Year of Tube Well		2005			
Installation Year of Pump		2005			
Capital Cost of Machinery					
Operational Hours		0			
Delivery Pipe	Dia	6"			
	Material	MS			
Chlorinator		Yes	No		
Chlorination Schedule		Once in a Year	After 6 Months	No Schedule	
Apron Around Pump House		Yes	No		
Hoisting Girder		Yes	No		
Civil Structure Condition		Good	Fair	Poor	
Approach to Pump House		Good	Fair	Poor	
Pump Details					
Pump Type		Turbine			
Pump Make		KSB			
Discharge Capacity (Cusec)		0.5			
Rotational Speed (RPM)		-

Housing Dia (inches)		12			
Bore Depth (ft.)		180			
Head (ft.)		200			
Impeller Installation Depth (ft.)		60			
Paint of Pumping Unit		Good	Fair	Poor	
Number of Valves	Gate Valve	1			
	Non-Returning Valve	1			
Base Plate		Yes	No		
Electro-Mechanical Equipment Details					
Transformer Capacity (kVA)		No Motor			
Sanctioned Load (Kwh)					
Motor Power (HP)					
Motor Make					
MCU		Yes	No		
Earthing of Motor		Yes	No		
Power Wiring		Yes	No		
Service Cable		Yes	No		
Earthing of MCU		Yes	No

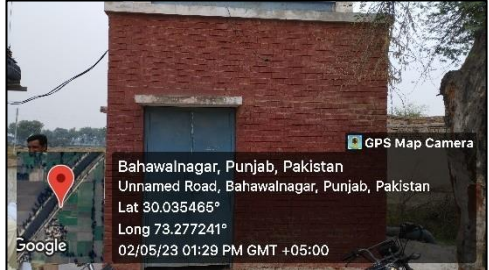
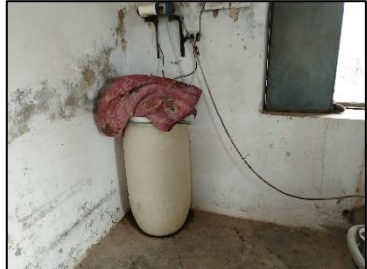
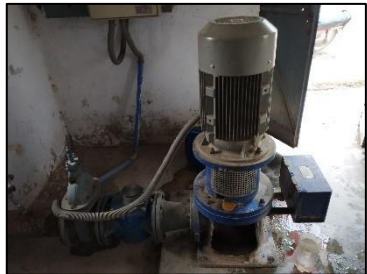
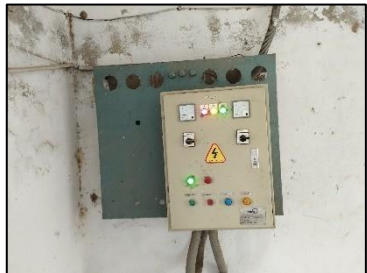
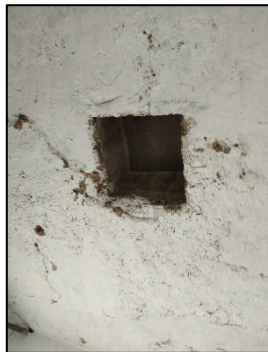
Integrated Development and Asset Management Plan (IDAMP)				
Municipal Committee Bahawalnagar				
Form: IDAMP-A1	Tube Well Asset Condition Assessment			Asset Code: _____ Date: 02-05-2023
Asset Detail			Pictures	
Name		Ford Wah New # 17		
Location	Latitude	30.035465		
	Longitude	73.277241		
Address		Arifwala Road, Ford wah Canal, Bahawalnagar		
Area (Marla)		1		
Working Status		Functional	Non-Functional	
Installation Year of Tube Well		2005		
Installation Year of Pump		2005		
Capital Cost of Machinery				
Operational Hours		6		
Delivery Pipe	Dia	6"		
	Material	MS		
Chlorinator		Yes	No	
Chlorination Schedule		Once in a Year	After 6 Months	No Schedule
Apron Around Pump House		Yes	No	
Hoisting Girder		Yes	No	
Civil Structure Condition		Good	Fair	Poor
Approach to Pump House		Good	Fair	Poor
Pump Details				
Pump Type		Turbine		
Pump Make		KSB		
Discharge Capacity (Cusec)		0.5		
Rotational Speed (RPM)		1460		
Housing Dia (inches)		12

Bore Depth (ft.)		180		
Head (ft.)		200		
Impeller Installation Depth (ft.)		60		
Paint of Pumping Unit		Good	Fair	Poor
Number of Valves	Gate Valve	1		
	Non-Returning Valve	1		
Base Plate		Yes	No	
Electro-Mechanical Equipment Details				
Transformer Capacity (kVA)		25		
Sanctioned Load (Kwh)		14.92		
Motor Power (HP)		20		
Motor Make		Siemens		
MCU		Yes	No	
Earthing of Motor		Yes	No	
Power Wiring		Yes	No	
Service Cable		Yes	No	
Earthing of MCU		Yes	No

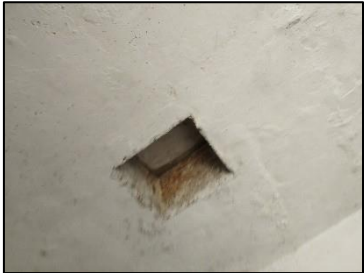
Integrated Development and Asset Management Plan (IDAMP)				
Municipal Committee Bahawalnagar				
Form: IDAMP-A1	Tube Well Asset Condition Assessment			Asset Code: _____ Date: 02-05-2023
Asset Detail			Pictures	
Name		Ford Wah New # 16		
Location	Latitude	30.035465		
	Longitude	73.277241		
Address		Arifwala Road, Ford wah Canal, Bahawalnagar		
Area (Marla)		1		
Working Status		Functional	Non-Functional	
Installation Year of Tube Well		2005		
Installation Year of Pump		2005		
Capital Cost of Machinery				
Operational Hours		0		
Delivery Pipe	Dia	6"		
	Material	MS		
Chlorinator		Yes	No	
Chlorination Schedule		Once in a Year	After 6 Months	No Schedule
Apron Around Pump House		Yes	No	
Hoisting Girder		Yes	No	
Civil Structure Condition		Good	Fair	Poor
Approach to Pump House		Good	Fair	Poor
Pump Details				
Pump Type		Turbine		
Pump Make		KSB		
Discharge Capacity (Cusec)		0.5		
Rotational Speed (RPM)		-		
Housing Dia (inches)		12

Bore Depth (ft.)		180		
Head (ft.)		200		
Impeller Installation Depth (ft.)		60		
Paint of Pumping Unit		Good	Fair	Poor
Number of Valves	Gate Valve	1		
	Non-Returning Valve	1		
Base Plate		Yes	No	
Electro-Mechanical Equipment Details				
Transformer Capacity (kVA)		Motor Repair		
Sanctioned Load (Kwh)				
Motor Power (HP)				
Motor Make				
MCU		Yes	No	
Earthing of Motor		Yes	No	
Power Wiring		Yes	No	
Service Cable		Yes	No	
Earthing of MCU		Yes	No

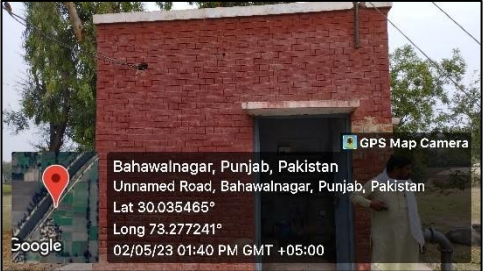
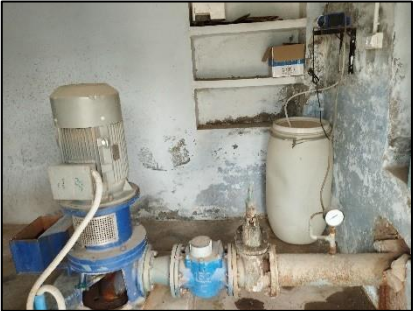
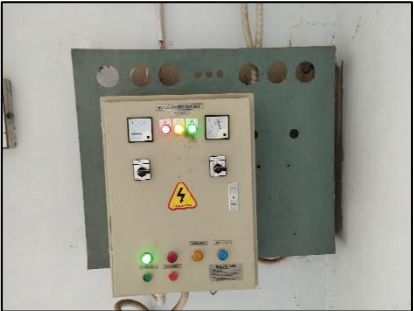
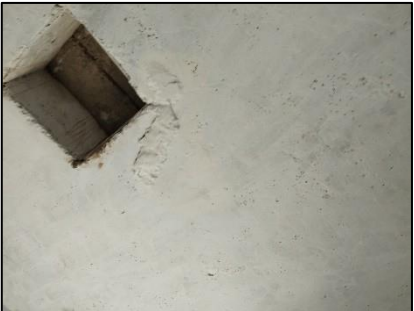
Integrated Development and Asset Management Plan (IDAMP)				
Municipal Committee Bahawalnagar				
Form: IDAMP-A1	Tube Well Asset Condition Assessment			Asset Code: _____ Date: 02-05-2023
Asset Detail			Pictures	
Name		Ford Wah New # 14		
Location	Latitude	30.035465		
	Longitude	73.277241		
Address		Arifwala Road, Ford wah Canal, Bahawalnagar		
Area (Marla)		1		
Working Status		Functional	Non-Functional	
Installation Year of Tube Well		2005		
Installation Year of Pump		2005		
Capital Cost of Machinery				
Operational Hours		6		
Delivery Pipe	Dia	6"		
	Material	MS		
Chlorinator		Yes	No	
Chlorination Schedule		Once in a Year	After 6 Months	No Schedule
Apron Around Pump House		Yes	No	
Hoisting Girder		Yes	No	
Civil Structure Condition		Good	Fair	Poor
Approach to Pump House		Good	Fair	Poor
Pump Details				
Pump Type		Turbine		
Pump Make		KSB		
Discharge Capacity (Cusec)		0.5		
Rotational Speed (RPM)		1460		
Housing Dia (inches)		12

Bore Depth (ft.)		180		
Head (ft.)		200		
Impeller Installation Depth (ft.)		60		
Paint of Pumping Unit		Good	Fair	Poor
Number of Valves	Gate Valve	1		
	Non-Returning Valve	1		
Base Plate		Yes	No	
Electro-Mechanical Equipment Details				
Transformer Capacity (kVA)		25		
Sanctioned Load (Kwh)		14.92		
Motor Power (HP)		20		
Motor Make		Siemens		
MCU		Yes	No	
Earthing of Motor		Yes	No	
Power Wiring		Yes	No	
Service Cable		Yes	No	
Earthing of MCU		Yes	No

Integrated Development and Asset Management Plan (IDAMP)					
Municipal Committee Bahawalnagar					
Form: IDAMP-A1	Tube Well Asset Condition Assessment			Asset Code: _____ Date: 02-05-2023	
Energy Meter	Yes	No			
Water Meter	Yes	No			
PFI Equipment	Yes	No			
Generator	Yes	No			
Change Over	Yes	No			
Overall Rating					
Average Score	1	2	3	4	5
Asset Condition	Excellent	Good	Fair	Poor	Failing
Category	A	B	C	D	E
Remarks / Requirements					
<ul style="list-style-type: none"> No remarks 					
<i>Data Collected By: Mr. Abdullah</i>		<i>Designation: Team Member</i>

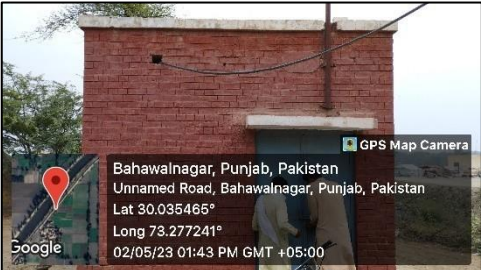
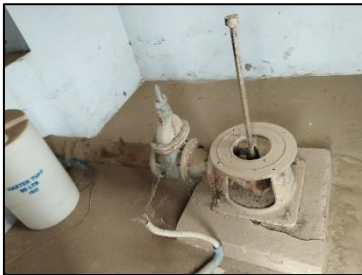
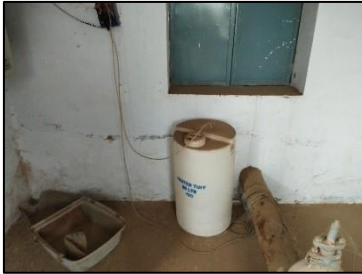
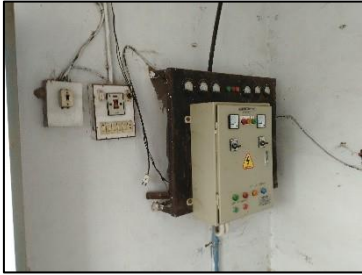
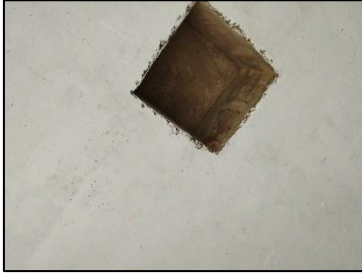
Integrated Development and Asset Management Plan (IDAMP)				
Municipal Committee Bahawalnagar				
Form: IDAMP-A1	Tube Well Asset Condition Assessment			Asset Code: _____ Date: 02-05-2023
Asset Detail			Pictures	
Name		Ford Wah New # 13		
Location	Latitude	30.035465		
	Longitude	73.277241		
Address		Arifwala Road, Ford wah Canal, Bahawalnagar		
Area (Marla)		1		
Working Status		Functional	Non-Functional	
Installation Year of Tube Well		2005		
Installation Year of Pump		2005		
Capital Cost of Machinery				
Operational Hours		6		
Delivery Pipe	Dia	6"		
	Material	MS		
Chlorinator		Yes	No	
Chlorination Schedule		Once in a Year	After 6 Months	No Schedule
Apron Around Pump House		Yes	No	
Hoisting Girder		Yes	No	
Civil Structure Condition		Good	Fair	Poor
Approach to Pump House		Good	Fair	Poor
Pump Details				
Pump Type		Turbine		
Pump Make		KSB		
Discharge Capacity (Cusec)		0.5		
Rotational Speed (RPM)				
Housing Dia (inches)		12

Bore Depth (ft.)		180		
Head (ft.)		200		
Impeller Installation Depth (ft.)		60		
Paint of Pumping Unit		Good	Fair	Poor
Number of Valves	Gate Valve	1		
	Non-Returning Valve	1		
Base Plate		Yes	No	
Electro-Mechanical Equipment Details				
Transformer Capacity (kVA)		No Motor		
Sanctioned Load (Kwh)				
Motor Power (HP)				
Motor Make				
MCU		Yes	No	
Earthing of Motor		Yes	No	
Power Wiring		Yes	No	
Service Cable		Yes	No	
Earthing of MCU		Yes	No

Integrated Development and Asset Management Plan (IDAMP)					
Municipal Committee Bahawalnagar					
Form: IDAMP-A1	Tube Well Asset Condition Assessment			Asset Code: _____ Date: 02-05-2023	
Energy Meter	Yes	No			
Water Meter	Yes	No			
PFI Equipment	Yes	No			
Generator	Yes	No			
Change Over	Yes	No			
Overall Rating					
Average Score	1	2	3	4	5
Asset Condition	Excellent	Good	Fair	Poor	Failing
Category	A	B	C	D	E
Remarks / Requirements					
<ul style="list-style-type: none"> The temporary non-functionality of the tube well, due to the motor unit undergoing repair 					
Data Collected By: Mr. Abdullah		Designation: Team Member

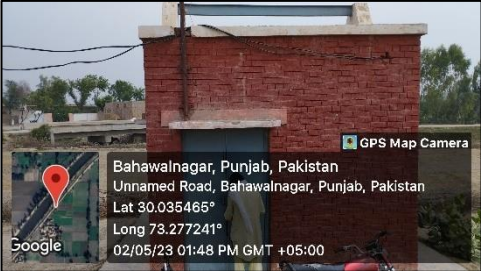
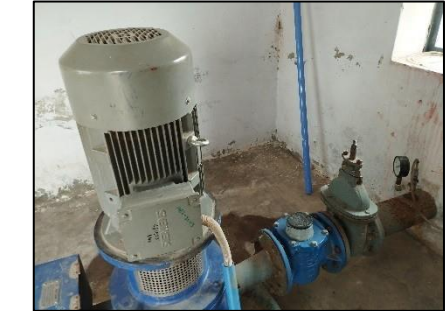
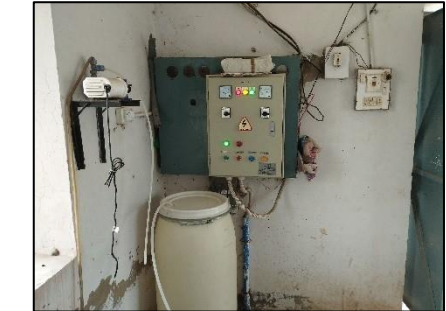
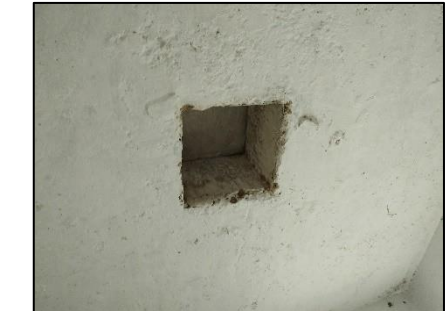
Integrated Development and Asset Management Plan (IDAMP)				
Municipal Committee Bahawalnagar				
Form: IDAMP-A1	Tube Well Asset Condition Assessment			Asset Code: _____ Date: 02-05-2023
Asset Detail			Pictures	
Name		Ford Wah New # 12		
Location	Latitude	30.035465		
	Longitude	73.277241		
Address		Arifwala Road, Ford wah Canal, Bahawalnagar		
Area (Marla)		1		
Working Status		Functional	Non-Functional	
Installation Year of Tube Well		2005		
Installation Year of Pump		2005		
Capital Cost of Machinery				
Operational Hours		6		
Delivery Pipe	Dia	6"		
	Material	MS		
Chlorinator		Yes	No	
Chlorination Schedule		Once in a Year	After 6 Months	No Schedule
Apron Around Pump House		Yes	No	
Hoisting Girder		Yes	No	
Civil Structure Condition		Good	Fair	Poor
Approach to Pump House		Good	Fair	Poor
Pump Details				
Pump Type		Turbine		
Pump Make		KSB		
Discharge Capacity (Cusec)		0.5		
Rotational Speed (RPM)		1460		
Housing Dia (inches)		12

Bore Depth (ft.)		180		
Head (ft.)		200		
Impeller Installation Depth (ft.)		60		
Paint of Pumping Unit		Good	Fair	Poor
Number of Valves	Gate Valve	1		
	Non-Returning Valve	1		
Base Plate		Yes	No	
Electro-Mechanical Equipment Details				
Transformer Capacity (kVA)		25		
Sanctioned Load (Kwh)		14.92		
Motor Power (HP)		20		
Motor Make		Siemens		
MCU		Yes	No	
Earthing of Motor		Yes	No	
Power Wiring		Yes	No	
Service Cable		Yes	No	
Earthing of MCU		Yes	No

Integrated Development and Asset Management Plan (IDAMP)					
Municipal Committee Bahawalnagar					
Form: IDAMP-A1	Tube Well Asset Condition Assessment			Asset Code: _____ Date: 02-05-2023	
Energy Meter	Yes	No			
Water Meter	Yes	No			
PFI Equipment	Yes	No			
Generator	Yes	No			
Change Over	Yes	No			
Overall Rating					
Average Score	1	2	3	4	5
Asset Condition	Excellent	Good	Fair	Poor	Failing
Category	A	B	C	D	E
Remarks / Requirements					
<ul style="list-style-type: none"> No remarks 					
<i>Data Collected By: Mr. Abdullah</i>		<i>Designation: Team Member</i>

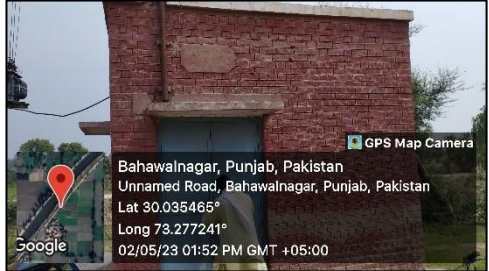
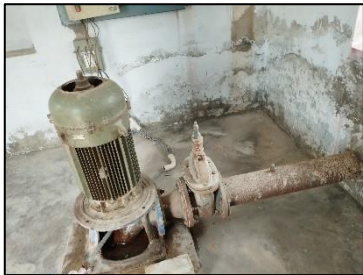
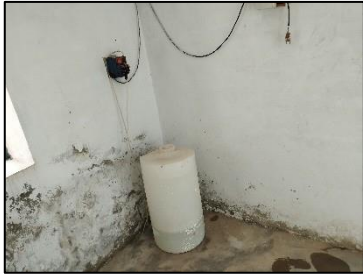
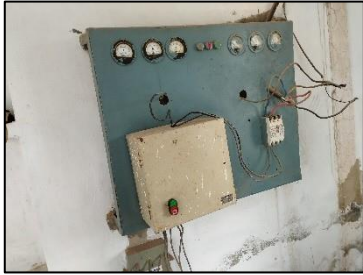
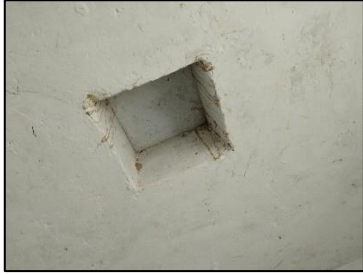
Integrated Development and Asset Management Plan (IDAMP)				
Municipal Committee Bahawalnagar				
Form: IDAMP-A1	Tube Well Asset Condition Assessment			Asset Code: _____ Date: 02-05-2023
Asset Detail			Pictures	
Name		Ford Wah New # 11		
Location	Latitude	30.035465		
	Longitude	73.277241		
Address		Arifwala Road, Ford wah Canal, Bahawalnagar		
Area (Marla)		1		
Working Status		Functional	Non-Functional	
Installation Year of Tube Well		2005		
Installation Year of Pump		2005		
Capital Cost of Machinery				
Operational Hours		6		
Delivery Pipe	Dia	6"		
	Material	MS		
Chlorinator		Yes	No	
Chlorination Schedule		Once in a Year	After 6 Months	No Schedule
Apron Around Pump House		Yes	No	
Hoisting Girder		Yes	No	
Civil Structure Condition		Good	Fair	Poor
Approach to Pump House		Good	Fair	Poor
Pump Details				
Pump Type		Turbine		
Pump Make		KSB		
Discharge Capacity (Cusec)		0.5		
Rotational Speed (RPM)		1460		
Housing Dia (inches)		12

Bore Depth (ft.)		180		
Head (ft.)		200		
Impeller Installation Depth (ft.)		60		
Paint of Pumping Unit		Good	Fair	Poor
Number of Valves	Gate Valve	1		
	Non-Returning Valve	1		
Base Plate		Yes	No	
Electro-Mechanical Equipment Details				
Transformer Capacity (kVA)		25		
Sanctioned Load (Kwh)		14.92		
Motor Power (HP)		20		
Motor Make		Siemens		
MCU		Yes	No	
Earthing of Motor		Yes	No	
Power Wiring		Yes	No	
Service Cable		Yes	No	
Earthing of MCU		Yes	No

Integrated Development and Asset Management Plan (IDAMP)					
Municipal Committee Bahawalnagar					
Form: IDAMP-A1	Tube Well Asset Condition Assessment			Asset Code: _____ Date: 02-05-2023	
Energy Meter	Yes	No			
Water Meter	Yes	No			
PFI Equipment	Yes	No			
Generator	Yes	No			
Change Over	Yes	No			
Overall Rating					
Average Score	1	2	3	4	5
Asset Condition	Excellent	Good	Fair	Poor	Failing
Category	A	B	C	D	E
Remarks / Requirements					
<ul style="list-style-type: none"> No remarks 					
<i>Data Collected By: Mr. Abdullah</i>		<i>Designation: Team Member</i>

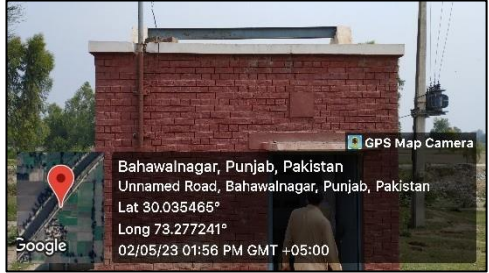
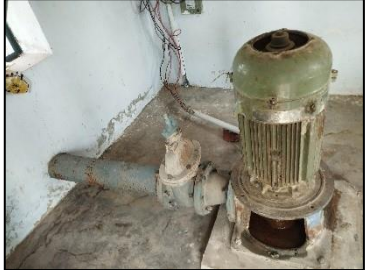
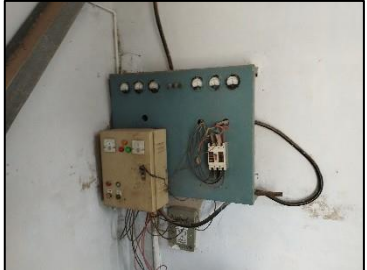
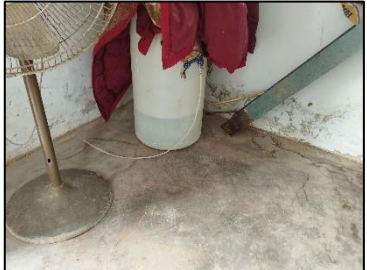
Integrated Development and Asset Management Plan (IDAMP)				
Municipal Committee Bahawalnagar				
Form: IDAMP-A1	Tube Well Asset Condition Assessment			Asset Code: _____ Date: 02-05-2023
Asset Detail			Pictures	
Name		Ford Wah New # 10		
Location	Latitude	30.035465		
	Longitude	73.277241		
Address		Arifwala Road, Ford wah Canal, Bahawalnagar		
Area (Marla)		1		
Working Status		Functional	Non-Functional	
Installation Year of Tube Well		2005		
Installation Year of Pump		2005		
Capital Cost of Machinery				
Operational Hours		6		
Delivery Pipe	Dia	6"		
	Material	MS		
Chlorinator		Yes	No	
Chlorination Schedule		Once in a Year	After 6 Months	No Schedule
Apron Around Pump House		Yes	No	
Hoisting Girder		Yes	No	
Civil Structure Condition		Good	Fair	Poor
Approach to Pump House		Good	Fair	Poor
Pump Details				
Pump Type		Turbine		
Pump Make		KSB		
Discharge Capacity (Cusec)		0.5		
Rotational Speed (RPM)		1460		
Housing Dia (inches)		12

Bore Depth (ft.)		180		
Head (ft.)		200		
Impeller Installation Depth (ft.)		60		
Paint of Pumping Unit		Good	Fair	Poor
Number of Valves	Gate Valve	1		
	Non-Returning Valve	1		
Base Plate		Yes	No	
Electro-Mechanical Equipment Details				
Transformer Capacity (kVA)		25		
Sanctioned Load (Kwh)		14.92		
Motor Power (HP)		20		
Motor Make		Siemens		
MCU		Yes	No	
Earthing of Motor		Yes	No	
Power Wiring		Yes	No	
Service Cable		Yes	No	
Earthing of MCU		Yes	No

Integrated Development and Asset Management Plan (IDAMP)					
Municipal Committee Bahawalnagar					
Form: IDAMP-A1	Tube Well Asset Condition Assessment			Asset Code: _____ Date: 02-05-2023	
Energy Meter	Yes	No			
Water Meter	Yes	No			
PFI Equipment	Yes	No			
Generator	Yes	No			
Change Over	Yes	No			
Overall Rating					
Average Score	1	2	3	4	5
Asset Condition	Excellent	Good	Fair	Poor	Failing
Category	A	B	C	D	E
Remarks / Requirements					
<ul style="list-style-type: none"> No remarks 					
<i>Data Collected By: Mr. Abdullah</i>		<i>Designation: Team Member</i>

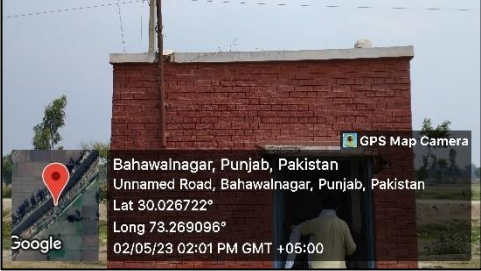
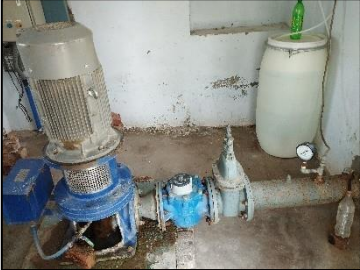
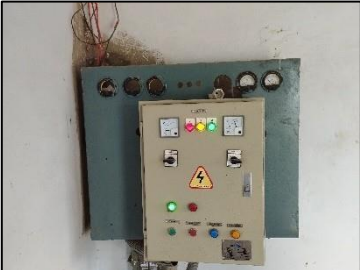
Integrated Development and Asset Management Plan (IDAMP)				
Municipal Committee Bahawalnagar				
Form: IDAMP-A1	Tube Well Asset Condition Assessment			Asset Code: _____ Date: 02-05-2023
Asset Detail			Pictures	
Name		Ford Wah New # 09		
Location	Latitude	30.026722		
	Longitude	73.269096		
Address		Arifwala Road, Ford wah Canal, Bahawalnagar		
Area (Marla)		1		
Working Status		Functional	Non-Functional	
Installation Year of Tube Well		2005		
Installation Year of Pump		2005		
Capital Cost of Machinery				
Operational Hours		24		
Delivery Pipe	Dia	6"		
	Material	MS		
Chlorinator		Yes	No	
Chlorination Schedule		Once in a Year	After 6 Months	No Schedule
Apron Around Pump House		Yes	No	
Hoisting Girder		Yes	No	
Civil Structure Condition		Good	Fair	Poor
Approach to Pump House		Good	Fair	Poor
Pump Details				
Pump Type		Turbine		
Pump Make		KSB		
Discharge Capacity (Cusec)		0.5		
Rotational Speed (RPM)		1460		
Housing Dia (inches)		12

Bore Depth (ft.)		180		
Head (ft.)		200		
Impeller Installation Depth (ft.)		60		
Paint of Pumping Unit		Good	Fair	Poor
Number of Valves	Gate Valve	1		
	Non-Returning Valve	1		
Base Plate		Yes	No	
Electro-Mechanical Equipment Details				
Transformer Capacity (kVA)		25		
Sanctioned Load (Kwh)		14.92		
Motor Power (HP)		20		
Motor Make		Siemens		
MCU		Yes	No	
Earthing of Motor		Yes	No	
Power Wiring		Yes	No	
Service Cable		Yes	No	
Earthing of MCU		Yes	No

Integrated Development and Asset Management Plan (IDAMP)					
Municipal Committee Bahawalnagar					
Form: IDAMP-A1	Tube Well Asset Condition Assessment			Asset Code: _____ Date: 02-05-2023	
Energy Meter	Yes	No			
Water Meter	Yes	No			
PFI Equipment	Yes	No			
Generator	Yes	No			
Change Over	Yes	No			
Overall Rating					
Average Score	1	2	3	4	5
Asset Condition	Excellent	Good	Fair	Poor	Failing
Category	A	B	C	D	E
Remarks / Requirements					
<ul style="list-style-type: none"> No remarks 					
<i>Data Collected By: Mr. Abdullah</i>		<i>Designation: Team Member</i>

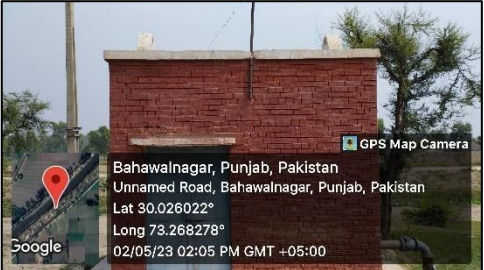
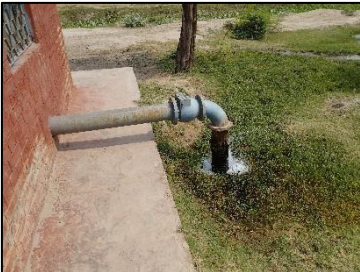
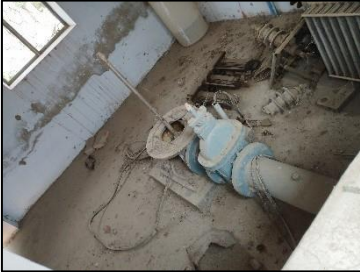
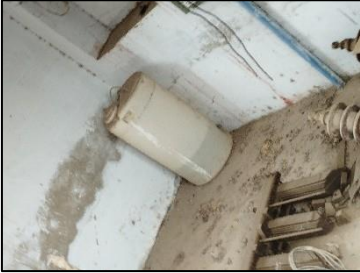
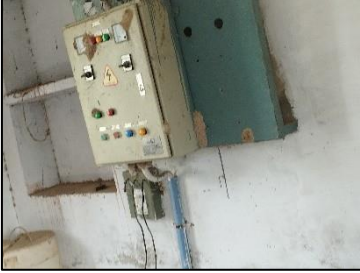
Integrated Development and Asset Management Plan (IDAMP)					
Municipal Committee Bahawalnagar					
Form: IDAMP-A1	Tube Well Asset Condition Assessment			Asset Code: _____ Date: 02-05-2023	
Asset Detail				Pictures	
Name		Ford Wah New # 08			
Location	Latitude	30.026022			
	Longitude	73.268278			
Address		Arifwala Road, Ford wah Canal, Bahawalnagar			
Area (Marla)		1			
Working Status		Functional	Non-Functional		
Installation Year of Tube Well		2005			
Installation Year of Pump		2005			
Capital Cost of Machinery					
Operational Hours		0			
Delivery Pipe	Dia	6"			
	Material	MS			
Chlorinator		Yes	No		
Chlorination Schedule		Once in a Year	After 6 Months	No Schedule	
Apron Around Pump House		Yes	No		
Hoisting Girder		Yes	No		
Civil Structure Condition		Good	Fair	Poor	
Approach to Pump House		Good	Fair	Poor	
Pump Details					
Pump Type		Turbine			
Pump Make		KSB			
Discharge Capacity (Cusec)		0.5			
Rotational Speed (RPM)		-

Housing Dia (inches)		12			
Bore Depth (ft.)		180			
Head (ft.)		200			
Impeller Installation Depth (ft.)		60			
Paint of Pumping Unit		Good	Fair	Poor	
Number of Valves	Gate Valve	1			
	Non-Returning Valve	1			
Base Plate		Yes	No		
Electro-Mechanical Equipment Details					
Transformer Capacity (kVA)		No Motor			
Sanctioned Load (Kwh)					
Motor Power (HP)					
Motor Make					
MCU		Yes	No		
Earthing of Motor		Yes	No		
Power Wiring		Yes	No		
Service Cable		Yes	No		
Earthing of MCU		Yes	No

Integrated Development and Asset Management Plan (IDAMP)					
Municipal Committee Bahawalnagar					
Form: IDAMP-A1	Tube Well Asset Condition Assessment			Asset Code: _____ Date: 02-05-2023	
Energy Meter	Yes	No			
Water Meter	Yes	No			
PFI Equipment	Yes	No			
Generator	Yes	No			
Change Over	Yes	No			
Overall Rating					
Average Score	1	2	3	4	5
Asset Condition	Excellent	Good	Fair	Poor	Failing
Category	A	B	C	D	E
Remarks / Requirements					
<ul style="list-style-type: none"> The temporary non-functionality of the tube well, due to the motor unit undergoing repair 					
<i>Data Collected By: Mr. Abdullah</i>		<i>Designation: Team Member</i>

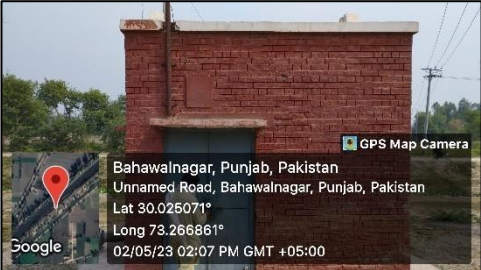
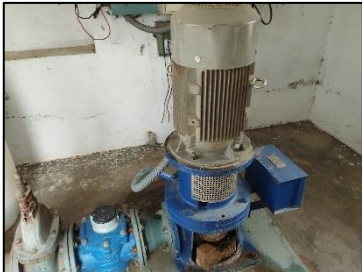
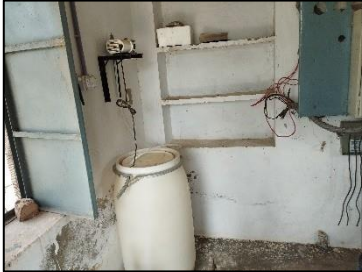
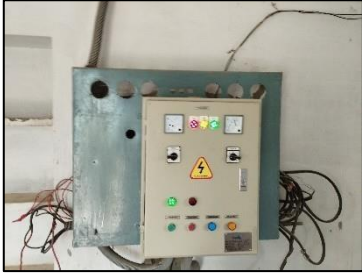
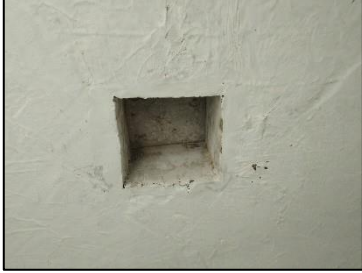
Integrated Development and Asset Management Plan (IDAMP)				
Municipal Committee Bahawalnagar				
Form: IDAMP-A1	Tube Well Asset Condition Assessment			Asset Code: _____ Date: 02-05-2023
Asset Detail			Pictures	
Name		Ford Wah New # 07		
Location	Latitude	30.025071		
	Longitude	73.266861		
Address		Arifwala Road, Ford wah Canal, Bahawalnagar		
Area (Marla)		1		
Working Status		Functional	Non-Functional	
Installation Year of Tube Well		2005		
Installation Year of Pump		2005		
Capital Cost of Machinery				
Operational Hours		6		
Delivery Pipe	Dia	6"		
	Material	MS		
Chlorinator		Yes	No	
Chlorination Schedule		Once in a Year	After 6 Months	No Schedule
Apron Around Pump House		Yes	No	
Hoisting Girder		Yes	No	
Civil Structure Condition		Good	Fair	Poor
Approach to Pump House		Good	Fair	Poor
Pump Details				
Pump Type		Turbine		
Pump Make		KSB		
Discharge Capacity (Cusec)		0.5		
Rotational Speed (RPM)		1460		
Housing Dia (inches)		12

Bore Depth (ft.)		180		
Head (ft.)		200		
Impeller Installation Depth (ft.)		60		
Paint of Pumping Unit		Good	Fair	Poor
Number of Valves	Gate Valve	1		
	Non-Returning Valve	1		
Base Plate		Yes	No	
Electro-Mechanical Equipment Details				
Transformer Capacity (kVA)		25		
Sanctioned Load (Kwh)		14.92		
Motor Power (HP)		20		
Motor Make		Siemens		
MCU		Yes	No	
Earthing of Motor		Yes	No	
Power Wiring		Yes	No	
Service Cable		Yes	No	
Earthing of MCU		Yes	No

Integrated Development and Asset Management Plan (IDAMP)					
Municipal Committee Bahawalnagar					
Form: IDAMP-A1	Tube Well Asset Condition Assessment			Asset Code: _____ Date: 02-05-2023	
Energy Meter	Yes	No			
Water Meter	Yes	No			
PFI Equipment	Yes	No			
Generator	Yes	No			
Change Over	Yes	No			
Overall Rating					
Average Score	1	2	3	4	5
Asset Condition	Excellent	Good	Fair	Poor	Failing
Category	A	B	C	D	E
Remarks / Requirements					
<ul style="list-style-type: none"> No remarks 					
<i>Data Collected By: Mr. Abdullah</i>		<i>Designation: Team Member</i>

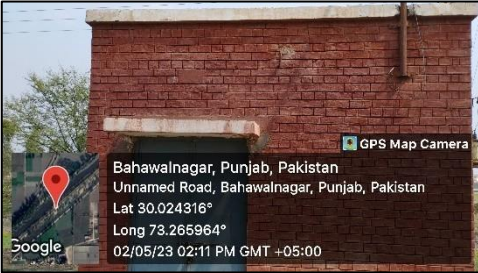
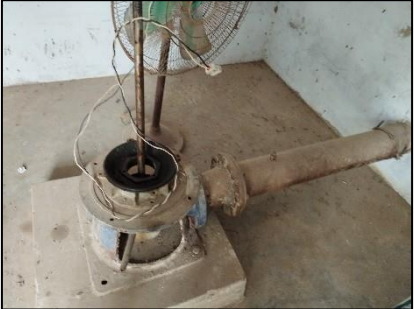
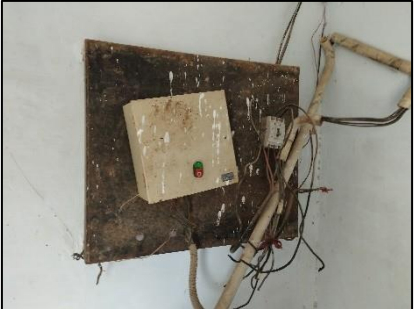
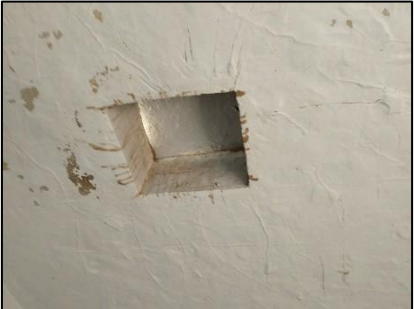
Integrated Development and Asset Management Plan (IDAMP)				
Municipal Committee Bahawalnagar				
Form: IDAMP-A1	Tube Well Asset Condition Assessment			Asset Code: _____ Date: 02-05-2023
Asset Detail			Pictures	
Name		Ford Wah New # 06		
Location	Latitude	30.024316		
	Longitude	73.265964		
Address		Arifwala Road, Ford wah Canal, Bahawalnagar		
Area (Marla)		1		
Working Status		Functional	Non-Functional	
Installation Year of Tube Well		2005		
Installation Year of Pump		2005		
Capital Cost of Machinery				
Operational Hours		0		
Delivery Pipe	Dia	6"		
	Material	MS		
Chlorinator		Yes	No	
Chlorination Schedule		Once in a Year	After 6 Months	No Schedule
Apron Around Pump House		Yes	No	
Hoisting Girder		Yes	No	
Civil Structure Condition		Good	Fair	Poor
Approach to Pump House		Good	Fair	Poor
Pump Details				
Pump Type		Turbine		
Pump Make		KSB		
Discharge Capacity (Cusec)		0.5		
Rotational Speed (RPM)		1460		
Housing Dia (inches)		12

Bore Depth (ft.)		180		
Head (ft.)		200		
Impeller Installation Depth (ft.)		60		
Paint of Pumping Unit		Good	Fair	Poor
Number of Valves	Gate Valve	1		
	Non-Returning Valve	1		
Base Plate		Yes	No	
Electro-Mechanical Equipment Details				
Transformer Capacity (kVA)		No Motor		
Sanctioned Load (Kwh)				
Motor Power (HP)				
Motor Make				
MCU		Yes	No	
Earthing of Motor		Yes	No	
Power Wiring		Yes	No	
Service Cable		Yes	No	
Earthing of MCU		Yes	No

Integrated Development and Asset Management Plan (IDAMP)					
Municipal Committee Bahawalnagar					
Form: IDAMP-A1	Tube Well Asset Condition Assessment			Asset Code: _____ Date: 02-05-2023	
Energy Meter	Yes	No			
Water Meter	Yes	No			
PFI Equipment	Yes	No			
Generator	Yes	No			
Change Over	Yes	No			
Overall Rating					
Average Score	1	2	3	4	5
Asset Condition	Excellent	Good	Fair	Poor	Failing
Category	A	B	C	D	E
Remarks / Requirements					
<ul style="list-style-type: none"> The temporary non-functionality of the tube well, due to the motor unit undergoing repair 					
<i>Data Collected By: Mr. Abdullah</i>		<i>Designation: Team Member</i>

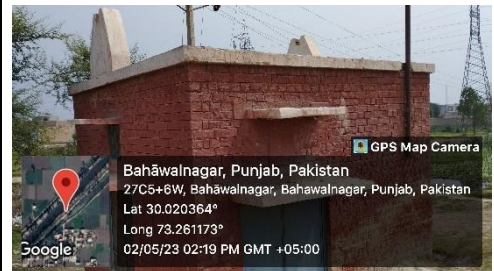
Integrated Development and Asset Management Plan (IDAMP)				
Municipal Committee Bahawalnagar				
Form: IDAMP-A1	Tube Well Asset Condition Assessment			Asset Code: _____ Date: 02-05-2023
Asset Detail			Pictures	
Name		Ford Wah New # 05		
Location	Latitude	30.020364		
	Longitude	73.261173		
Address		Arifwala Road, Ford wah Canal, Bahawalnagar		
Area (Marla)		1		
Working Status		Functional	Non-Functional	
Installation Year of Tube Well		2005		
Installation Year of Pump		2005		
Capital Cost of Machinery				
Operational Hours		0		
Delivery Pipe	Dia	6"		
	Material	MS		
Chlorinator		Yes	No	
Chlorination Schedule		Once in a Year	After 6 Months	No Schedule
Apron Around Pump House		Yes	No	
Hoisting Girder		Yes	No	
Civil Structure Condition		Good	Fair	Poor
Approach to Pump House		Good	Fair	Poor
Pump Details				
Pump Type		Turbine		
Pump Make		KSB		
Discharge Capacity (Cusec)		0.5		
Rotational Speed (RPM)		-		
Housing Dia (inches)		12

Bore Depth (ft.)		180		
Head (ft.)		200		
Impeller Installation Depth (ft.)		60		
Paint of Pumping Unit		Good	Fair	Poor
Number of Valves	Gate Valve	1		
	Non-Returning Valve	1		
Base Plate		Yes	No	
Electro-Mechanical Equipment Details				
Transformer Capacity (kVA)		No Motor		
Sanctioned Load (Kwh)				
Motor Power (HP)				
Motor Make				
MCU		Yes	No	
Earthing of Motor		Yes	No	
Power Wiring		Yes	No	
Service Cable		Yes	No	
Earthing of MCU		Yes	No

Integrated Development and Asset Management Plan (IDAMP)					
Municipal Committee Bahawalnagar					
Form: IDAMP-A1	Tube Well Asset Condition Assessment			Asset Code: _____ Date: 02-05-2023	
Energy Meter	Yes	No			
Water Meter	Yes	No			
PFI Equipment	Yes	No			
Generator	Yes	No			
Change Over	Yes	No			
Overall Rating					
Average Score	1	2	3	4	5
Asset Condition	Excellent	Good	Fair	Poor	Failing
Category	A	B	C	D	E
Remarks / Requirements					
<ul style="list-style-type: none"> The temporary non-functionality of the tube well, due to the motor unit undergoing repair 					
<i>Data Collected By: Mr. Abdullah</i>		<i>Designation: Team Member</i>
