Punjab Municipal Development Fund Company

Hiring of Consulting Services for Preparation of Integrated Development and Asset Management Plan (IDAMP) for 16 selected MCs In Punjab under Punjab Cities Program (PCP)

**IDAMP – Municipal Committee Bahawalnagar
May 2024**

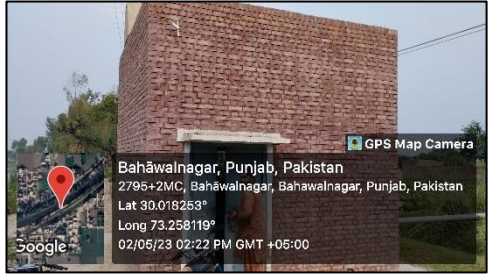
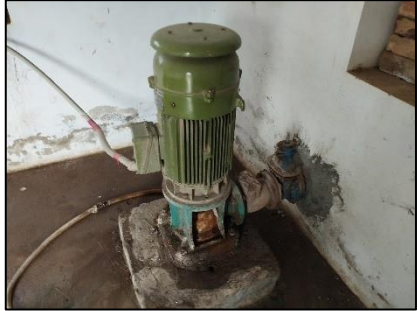
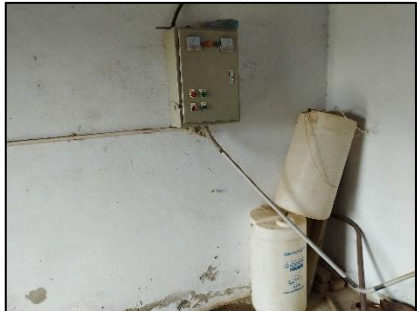
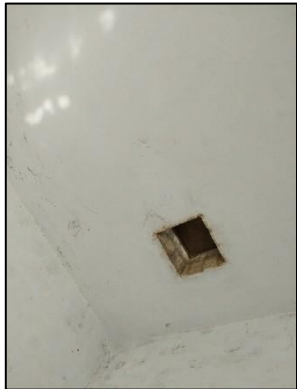
Integrated Development and Asset Management Plan (IDAMP)				
Municipal Committee Bahawalnagar				
Form: IDAMP-A1	Tube Well Asset Condition Assessment			Asset Code: _____ Date: 02-05-2023
Asset Detail			Pictures	
Name		Ford Wah New # 04		
Location	Latitude	30.018253		
	Longitude	73.258119		
Address		Arifwala Road, Ford wah Canal, Bahawalnagar		
Area (Marla)		1		
Working Status		Functional	Non-Functional	
Installation Year of Tube Well		2005		
Installation Year of Pump		2005		
Capital Cost of Machinery				
Operational Hours		6		
Delivery Pipe	Dia	6"		
	Material	MS		
Chlorinator		Yes	No	
Chlorination Schedule		Once in a Year	After 6 Months	No Schedule
Apron Around Pump House		Yes	No	
Hoisting Girder		Yes	No	
Civil Structure Condition		Good	Fair	Poor
Approach to Pump House		Good	Fair	Poor
Pump Details				
Pump Type		Turbine		
Pump Make		KSB		
Discharge Capacity (Cusec)		0.5		
Rotational Speed (RPM)		1460		
Housing Dia (inches)		12

Bore Depth (ft.)		180		
Head (ft.)		200		
Impeller Installation Depth (ft.)		60		
Paint of Pumping Unit		Good	Fair	Poor
Number of Valves	Gate Valve	1		
	Non-Returning Valve	1		
Base Plate		Yes	No	
Electro-Mechanical Equipment Details				
Transformer Capacity (kVA)		25		
Sanctioned Load (Kwh)		19		
Motor Power (HP)		20		
Motor Make		Siemens		
MCU		Yes	No	
Earthing of Motor		Yes	No	
Power Wiring		Yes	No	
Service Cable		Yes	No	
Earthing of MCU		Yes	No

Integrated Development and Asset Management Plan (IDAMP)					
Municipal Committee Bahawalnagar					
Form: IDAMP-A1	Tube Well Asset Condition Assessment			Asset Code: _____ Date: 02-05-2023	
Energy Meter	Yes	No			
Water Meter	Yes	No			
PFI Equipment	Yes	No			
Generator	Yes	No			
Change Over	Yes	No			
Overall Rating					
Average Score	1	2	3	4	5
Asset Condition	Excellent	Good	Fair	Poor	Failing
Category	A	B	C	D	E
Remarks / Requirements					
<ul style="list-style-type: none"> No remarks 					
<i>Data Collected By: Mr. Abdullah</i>		<i>Designation: Team Member</i>

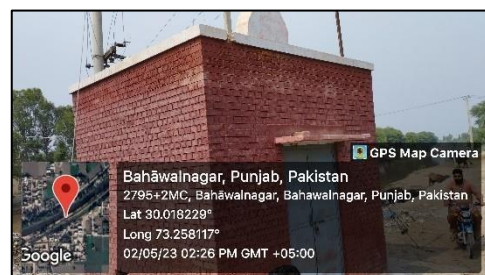
Integrated Development and Asset Management Plan (IDAMP)					
Municipal Committee Bahawalnagar					
Form: IDAMP-A1		Tube Well Asset Condition Assessment			Asset Code: _____
					Date: 02-05-2023
Asset Detail				Pictures	
Name		Ford Wah Old # 15			
Location	Latitude	30.018229			
	Longitude	73.258117			
Address		Arifwala Road, Ford wah Canal, Bahawalnagar			
Area (Marla)		1			
Working Status		Functional	Non-Functional		
Installation Year of Tube Well		1984			
Installation Year of Pump		1984			
Capital Cost of Machinery					
Operational Hours		0			
Delivery Pipe	Dia	6"			
	Material	MS			
Chlorinator		Yes	No		
Chlorination Schedule		Once in a Year	After 6 Months	No Schedule	
Apron Around Pump House		Yes	No		
Hoisting Girder		Yes	No		
Civil Structure Condition		Good	Fair	Poor	
Approach to Pump House		Good	Fair	Poor	
Pump Details					
Pump Type		Turbine			
Pump Make		PECO			
Discharge Capacity (Cusec)		0.5			
Rotational Speed (RPM)		-

Housing Dia (inches)		12			
Bore Depth (ft.)		180			
Head (ft.)		200			
Impeller Installation Depth (ft.)		60			
Paint of Pumping Unit		Good	Fair	Poor	
Number of Valves	Gate Valve	1			
	Non-Returning Valve	1			
Base Plate		Yes	No		
Electro-Mechanical Equipment Details					
Transformer Capacity (kVA)		No Motor & Transformer			
Sanctioned Load (Kwh)					
Motor Power (HP)					
Motor Make					
MCU		Yes	No		
Earthing of Motor		Yes	No		
Power Wiring		Yes	No		
Service Cable		Yes	No		
Earthing of MCU		Yes	No

Integrated Development and Asset Management Plan (IDAMP)					
Municipal Committee Bahawalnagar					
Form: IDAMP-A1	Tube Well Asset Condition Assessment			Asset Code: _____ Date: 02-05-2023	
Energy Meter	Yes	No			
Water Meter	Yes	No			
PFI Equipment	Yes	No			
Generator	Yes	No			
Change Over	Yes	No			
Overall Rating					
Average Score	1	2	3	4	5
Asset Condition	Excellent	Good	Fair	Poor	Failing
Category	A	B	C	D	E
Remarks / Requirements					
<ul style="list-style-type: none"> The temporary non-functionality of the tube well, due to the motor unit undergoing repair 					
Data Collected By: Mr. Abdullah		Designation: Team Member

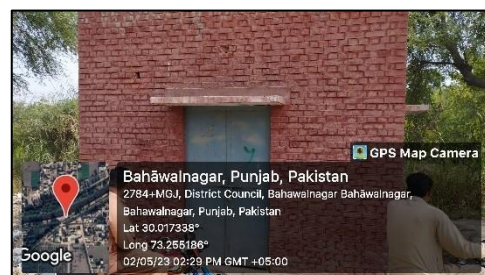
Integrated Development and Asset Management Plan (IDAMP)					
Municipal Committee Bahawalnagar					
Form: IDAMP-A1	Tube Well Asset Condition Assessment			Asset Code: _____ Date: 02-05-2023	
Asset Detail				Pictures	
Name		Ford Wah Old # 14			
Location	Latitude	30.017338			
	Longitude	73.255186			
Address		Arifwala Road, Ford wah Canal, Bahawalnagar			
Area (Marla)		1			
Working Status		Functional	Non-Functional		
Installation Year of Tube Well		1984			
Installation Year of Pump		1984			
Capital Cost of Machinery					
Operational Hours		0			
Delivery Pipe	Dia	6"			
	Material	MS			
Chlorinator		Yes	No		
Chlorination Schedule		Once in a Year	After 6 Months	No Schedule	
Apron Around Pump House		Yes	No		
Hoisting Girder		Yes	No		
Civil Structure Condition		Good	Fair	Poor	
Approach to Pump House		Good	Fair	Poor	
Pump Details					
Pump Type		Turbine			
Pump Make		PECO			
Discharge Capacity (Cusec)		0.5			
Rotational Speed (RPM)		-

Housing Dia (inches)		12			
Bore Depth (ft.)		180			
Head (ft.)		200			
Impeller Installation Depth (ft.)		60			
Paint of Pumping Unit		Good	Fair	Poor	
Number of Valves	Gate Valve	1			
	Non-Returning Valve	1			
Base Plate		Yes	No		
Electro-Mechanical Equipment Details					
Transformer Capacity (kVA)		No Motor & Transformer			
Sanctioned Load (Kwh)					
Motor Power (HP)					
Motor Make					
MCU		Yes	No		
Earthing of Motor		Yes	No		
Power Wiring		Yes	No		
Service Cable		Yes	No		
Earthing of MCU		Yes	No

Integrated Development and Asset Management Plan (IDAMP)					
Municipal Committee Bahawalnagar					
Form: IDAMP-A1	Tube Well Asset Condition Assessment			Asset Code: _____ Date: 02-05-2023	
Energy Meter	Yes	No			
Water Meter	Yes	No			
PFI Equipment	Yes	No			
Generator	Yes	No			
Change Over	Yes	No			
Overall Rating					
Average Score	1	2	3	4	5
Asset Condition	Excellent	Good	Fair	Poor	Failing
Category	A	B	C	D	E
Remarks / Requirements					
<ul style="list-style-type: none"> The temporary non-functionality of the tube well, due to the motor unit undergoing repair 					
Data Collected By: Mr. Abdullah		Designation: Team Member

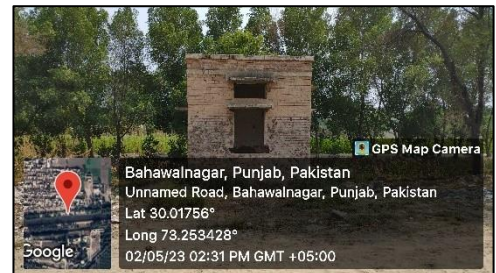
Integrated Development and Asset Management Plan (IDAMP)					
Municipal Committee Bahawalnagar					
Form: IDAMP-A1	Tube Well Asset Condition Assessment			Asset Code: _____ Date: 02-05-2023	
Asset Detail				Pictures	
Name		Ford Wah Old # 13			
Location	Latitude	30.017560			
	Longitude	73.253428			
Address		Arifwala Road, Ford wah Canal, Bahawalnagar			
Area (Marla)		1			
Working Status		Abandoned			
Installation Year of Tube Well					
Installation Year of Pump					
Capital Cost of Machinery					
Operational Hours					
Delivery Pipe	Dia				
	Material				
Chlorinator		Yes	No		
Chlorination Schedule		Once in a Year	After 6 Months	No Schedule	
Apron Around Pump House		Yes	No		
Hoisting Girder		Yes	No		
Civil Structure Condition		Good	Fair	Poor	
Approach to Pump House		Good	Fair	Poor	
Pump Details					
Pump Type					
Pump Make					
Discharge Capacity (Cusec)					
Rotational Speed (RPM)					
Housing Dia (inches)					
Bore Depth (ft.)

Head (ft.)					
Impeller Installation Depth (ft.)					
Paint of Pumping Unit		Good	Fair	Poor	
Number of Valves	Gate Valve				
	Non-Returning Valve				
Base Plate		Yes	No		
Electro-Mechanical Equipment Details					
Transformer Capacity (kVA)					
Sanctioned Load (Kwh)					
Motor Power (HP)					
Motor Make					
MCU		Yes	No		
Earthing of Motor		Yes	No		
Power Wiring		Yes	No		
Service Cable		Yes	No		
Earthing of MCU		Yes	No		
Energy Meter		Yes	No

Integrated Development and Asset Management Plan (IDAMP)					
Municipal Committee Bahawalnagar					
Form: IDAMP-A1	Tube Well Asset Condition Assessment			Asset Code: _____ Date: 02-05-2023	
Water Meter	Yes	No			
PFI Equipment	Yes	No			
Generator	Yes	No			
Change Over	Yes	No			
Overall Rating					
Average Score	1	2	3	4	5
Asset Condition	Excellent	Good	Fair	Poor	Failing
Category	A	B	C	D	E
Remarks / Requirements					
<ul style="list-style-type: none"> No remarks 					
Data Collected By: Mr. Abdullah		Designation: Team Member

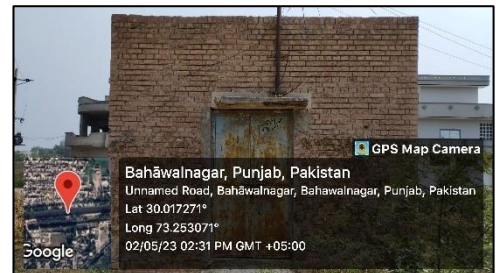
Integrated Development and Asset Management Plan (IDAMP)					
Municipal Committee Bahawalnagar					
Form: IDAMP-A1		Tube Well Asset Condition Assessment			Asset Code: _____
					Date: 02-05-2023
Asset Detail				Pictures	
Name		Ford Wah Old # 12			
Location	Latitude	30.017271			
	Longitude	73.253071			
Address		Arifwala Road, Ford wah Canal, Bahawalnagar			
Area (Marla)		1			
Working Status		Abandoned			
Installation Year of Tube Well					
Installation Year of Pump					
Capital Cost of Machinery					
Operational Hours					
Delivery Pipe	Dia				
	Material				
Chlorinator		Yes	No		
Chlorination Schedule		Once in a Year	After 6 Months	No Schedule	
Apron Around Pump House		Yes	No		
Hoisting Girder		Yes	No		
Civil Structure Condition		Good	Fair	Poor	
Approach to Pump House		Good	Fair	Poor	
Pump Details					
Pump Type					
Pump Make					
Discharge Capacity (Cusec)					
Rotational Speed (RPM)					
Housing Dia (inches)					
Bore Depth (ft.)

Head (ft.)					
Impeller Installation Depth (ft.)					
Paint of Pumping Unit		Good	Fair	Poor	
Number of Valves	Gate Valve				
	Non-Returning Valve				
Base Plate		Yes	No		
Electro-Mechanical Equipment Details					
Transformer Capacity (kVA)					
Sanctioned Load (Kwh)					
Motor Power (HP)					
Motor Make					
MCU		Yes	No		
Earthing of Motor		Yes	No		
Power Wiring		Yes	No		
Service Cable		Yes	No		
Earthing of MCU		Yes	No		
Energy Meter		Yes	No

Integrated Development and Asset Management Plan (IDAMP)					
Municipal Committee Bahawalnagar					
Form: IDAMP-A1	Tube Well Asset Condition Assessment			Asset Code: _____ Date: 02-05-2023	
Water Meter	Yes	No			
PFI Equipment	Yes	No			
Generator	Yes	No			
Change Over	Yes	No			
Overall Rating					
Average Score	1	2	3	4	5
Asset Condition	Excellent	Good	Fair	Poor	Failing
Category	A	B	C	D	E
Remarks / Requirements					
<ul style="list-style-type: none"> No remarks 					
Data Collected By: Mr. Abdullah		Designation: Team Member

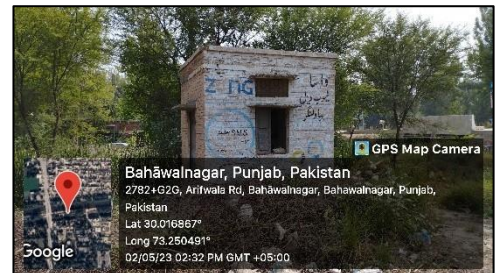
Integrated Development and Asset Management Plan (IDAMP)					
Municipal Committee Bahawalnagar					
Form: IDAMP-A1	Tube Well Asset Condition Assessment			Asset Code: _____ Date: 02-05-2023	
Asset Detail				Pictures	
Name		Ford Wah Old # 11			
Location	Latitude	30.016867			
	Longitude	73.250491			
Address		Arifwala Road, Ford wah Canal, Bahawalnagar			
Area (Marla)		1			
Working Status		Abandoned			
Installation Year of Tube Well					
Installation Year of Pump					
Capital Cost of Machinery					
Operational Hours					
Delivery Pipe	Dia				
	Material				
Chlorinator		Yes	No		
Chlorination Schedule		Once in a Year	After 6 Months	No Schedule	
Apron Around Pump House		Yes	No		
Hoisting Girder		Yes	No		
Civil Structure Condition		Good	Fair	Poor	
Approach to Pump House		Good	Fair	Poor	
Pump Details					
Pump Type					
Pump Make					
Discharge Capacity (Cusec)					
Rotational Speed (RPM)					
Housing Dia (inches)					
Bore Depth (ft.)

Head (ft.)					
Impeller Installation Depth (ft.)					
Paint of Pumping Unit		Good	Fair	Poor	
Number of Valves	Gate Valve				
	Non-Returning Valve				
Base Plate		Yes	No		
Electro-Mechanical Equipment Details					
Transformer Capacity (kVA)					
Sanctioned Load (Kwh)					
Motor Power (HP)					
Motor Make					
MCU		Yes	No		
Earthing of Motor		Yes	No		
Power Wiring		Yes	No		
Service Cable		Yes	No		
Earthing of MCU		Yes	No		
Energy Meter		Yes	No

Integrated Development and Asset Management Plan (IDAMP)					
Municipal Committee Bahawalnagar					
Form: IDAMP-A1	Tube Well Asset Condition Assessment			Asset Code: _____ Date: 02-05-2023	
Water Meter	Yes	No			
PFI Equipment	Yes	No			
Generator	Yes	No			
Change Over	Yes	No			
Overall Rating					
Average Score	1	2	3	4	5
Asset Condition	Excellent	Good	Fair	Poor	Failing
Category	A	B	C	D	E
Remarks / Requirements					
<ul style="list-style-type: none"> No remarks 					
Data Collected By: Mr. Abdullah		Designation: Team Member

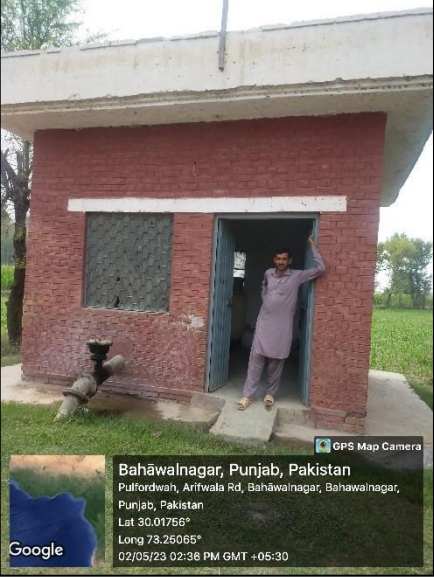
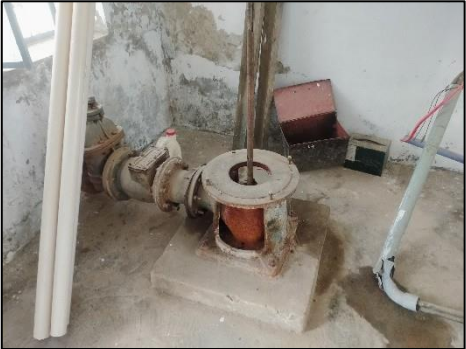
Integrated Development and Asset Management Plan (IDAMP)					
Municipal Committee Bahawalnagar					
Form: IDAMP-A1		Tube Well Asset Condition Assessment			Asset Code: _____
					Date: 02-05-2023
Asset Detail				Pictures	
Name		Sadiqia Canal # 01			
Location	Latitude	29.948697			
	Longitude	73.398153			
Address		Sadiqia Canal, Bahawalnagar			
Area (Marla)		1			
Working Status		Abandoned			
Installation Year of Tube Well					
Installation Year of Pump					
Capital Cost of Machinery					
Operational Hours					
Delivery Pipe	Dia				
	Material				
Chlorinator		Yes	No		
Chlorination Schedule		Once in a Year	After 6 Months	No Schedule	
Apron Around Pump House		Yes	No		
Hoisting Girder		Yes	No		
Civil Structure Condition		Good	Fair	Poor	
Approach to Pump House		Good	Fair	Poor	
Pump Details					
Pump Type					
Pump Make					
Discharge Capacity (Cusec)					
Rotational Speed (RPM)					
Housing Dia (inches)					
Bore Depth (ft.)

Head (ft.)					
Impeller Installation Depth (ft.)					
Paint of Pumping Unit		Good	Fair	Poor	
Number of Valves	Gate Valve				
	Non-Returning Valve				
Base Plate		Yes	No		
Electro-Mechanical Equipment Details					
Transformer Capacity (kVA)					
Sanctioned Load (Kwh)					
Motor Power (HP)					
Motor Make					
MCU		Yes	No		
Earthing of Motor		Yes	No		
Power Wiring		Yes	No		
Service Cable		Yes	No		
Earthing of MCU		Yes	No		
Energy Meter		Yes	No		
Water Meter		Yes	No

Integrated Development and Asset Management Plan (IDAMP)					
Municipal Committee Bahawalnagar					
Form: IDAMP-A1	Tube Well Asset Condition Assessment			Asset Code: _____ Date: 02-05-2023	
PFI Equipment	Yes	No			
Generator	Yes	No			
Change Over	Yes	No			
Overall Rating					
Average Score	1	2	3	4	5
Asset Condition	Excellent	Good	Fair	Poor	Failing
Category	A	B	C	D	E
Remarks / Requirements					
<ul style="list-style-type: none"> No remarks 					
<i>Data Collected By: Mr. Abdullah</i>		<i>Designation: Team Member</i>

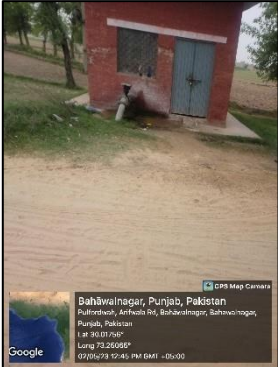
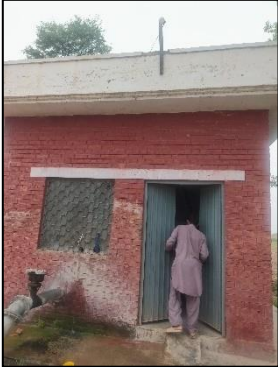
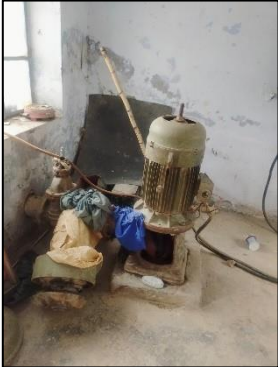
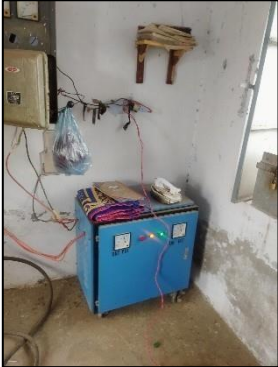
Integrated Development and Asset Management Plan (IDAMP)				
Municipal Committee Bahawalnagar				
Form: IDAMP-A1	Tube Well Asset Condition Assessment			Asset Code: _____ Date: 02-05-2023
Asset Detail			Pictures	
Name		Sadiqia Canal # 02		
Location	Latitude	29.948697		
	Longitude	73.398153		
Address		Sadiqia Canal, Bahawalnagar		
Area (Marla)		1		
Working Status		Functional	Non-Functional	
Installation Year of Tube Well		2010		
Installation Year of Pump		2010		
Capital Cost of Machinery				
Operational Hours		6		
Delivery Pipe	Dia	6"		
	Material	MS		
Chlorinator		Yes	No	
Chlorination Schedule		Once in a Year	After 6 Months	No Schedule
Apron Around Pump House		Yes	No	
Hoisting Girder		Yes	No	
Civil Structure Condition		Good	Fair	Poor
Approach to Pump House		Good	Fair	Poor
Pump Details				
Pump Type		Turbine		
Pump Make		Flowpak		
Discharge Capacity (Cusec)		0.5		
Rotational Speed (RPM)		1460		
Housing Dia (inches)		12

Bore Depth (ft.)		130		
Head (ft.)		200		
Impeller Installation Depth (ft.)		60		
Paint of Pumping Unit		Good	Fair	Poor
Number of Valves	Gate Valve	1		
	Non-Returning Valve	1		
Base Plate		Yes	No	
Electro-Mechanical Equipment Details				
Transformer Capacity (kVA)		25		
Sanctioned Load (Kwh)		18.65		
Motor Power (HP)		25		
Motor Make		Siemens		
MCU		Yes	No	
Earthing of Motor		Yes	No	
Power Wiring		Yes	No	
Service Cable		Yes	No	
Earthing of MCU		Yes	No	
Energy Meter		Yes	No

Integrated Development and Asset Management Plan (IDAMP)					
Municipal Committee Bahawalnagar					
Form: IDAMP-A1	Tube Well Asset Condition Assessment			Asset Code: _____ Date: 02-05-2023	
Water Meter	Yes	No			
PFI Equipment	Yes	No			
Generator	Yes	No			
Change Over	Yes	No			
Overall Rating					
Average Score	1	2	3	4	5
Asset Condition	Excellent	Good	Fair	Poor	Failing
Category	A	B	C	D	E
Remarks / Requirements					
<ul style="list-style-type: none"> No remarks 					
Data Collected By: Mr. Abdullah		Designation: Team Member

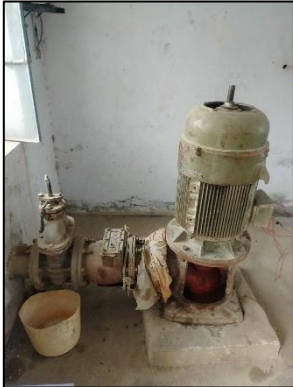
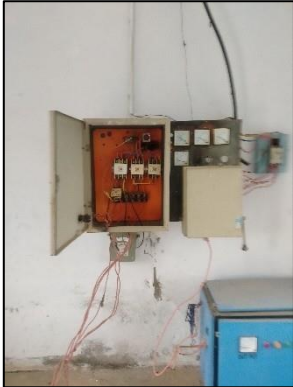
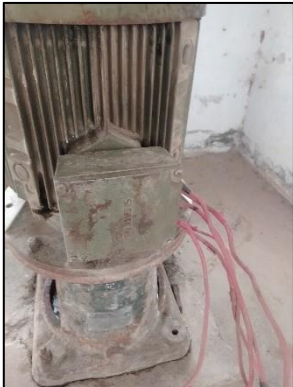
Integrated Development and Asset Management Plan (IDAMP)					
Municipal Committee Bahawalnagar					
Form: IDAMP-A1		Tube Well Asset Condition Assessment			Asset Code: _____ Date: 02-05-2023
Asset Detail				Pictures	
Name		Sadiqia Canal # 03			
Location	Latitude	29.948697			
	Longitude	73.398153			
Address		Sadiqia Canal, Bahawalnagar			
Area (Marla)		1			
Working Status		Functional	Non-Functional		
Installation Year of Tube Well		2010			
Installation Year of Pump		2010			
Capital Cost of Machinery					
Operational Hours		6			
Delivery Pipe	Dia	6"			
	Material	MS			
Chlorinator		Yes	No		
Chlorination Schedule		Once in a Year	After 6 Months	No Schedule	
Apron Around Pump House		Yes	No		
Hoisting Girder		Yes	No		
Civil Structure Condition		Good	Fair	Poor	
Approach to Pump House		Good	Fair	Poor	
Pump Details					
Pump Type		Turbine			
Pump Make		Flowpak			
Discharge Capacity (Cusec)		0.5			
Rotational Speed (RPM)		1460

Housing Dia (inches)		12			
Bore Depth (ft.)		130			
Head (ft.)		200			
Impeller Installation Depth (ft.)		60			
Paint of Pumping Unit		Good	Fair	Poor	
Number of Valves	Gate Valve	1			
	Non-Returning Valve	1			
Base Plate		Yes	No		
Electro-Mechanical Equipment Details					
Transformer Capacity (kVA)		25			
Sanctioned Load (Kwh)		18.65			
Motor Power (HP)		25			
Motor Make		Siemens			
MCU		Yes	No		
Earthing of Motor		Yes	No		
Power Wiring		Yes	No		
Service Cable		Yes	No		
Earthing of MCU		Yes	No		
Energy Meter		Yes	No

Integrated Development and Asset Management Plan (IDAMP)					
Municipal Committee Bahawalnagar					
Form: IDAMP-A1	Tube Well Asset Condition Assessment			Asset Code: _____ Date: 02-05-2023	
Water Meter	Yes	No			
PFI Equipment	Yes	No			
Generator	Yes	No			
Change Over	Yes	No			
Overall Rating					
Average Score	1	2	3	4	5
Asset Condition	Excellent	Good	Fair	Poor	Failing
Category	A	B	C	D	E
Remarks / Requirements					
<ul style="list-style-type: none"> No remarks 					
<i>Data Collected By: Mr. Abdullah</i>		<i>Designation: Team Member</i>

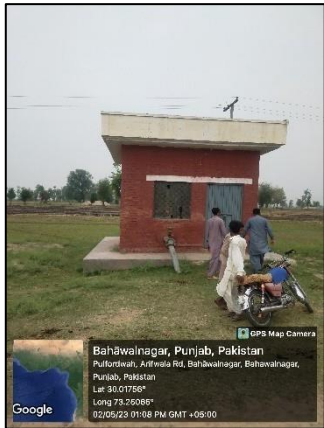
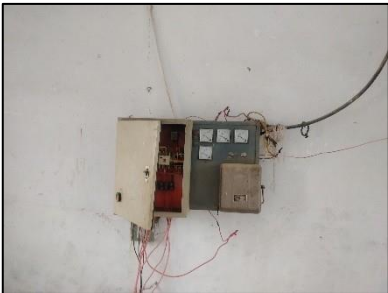
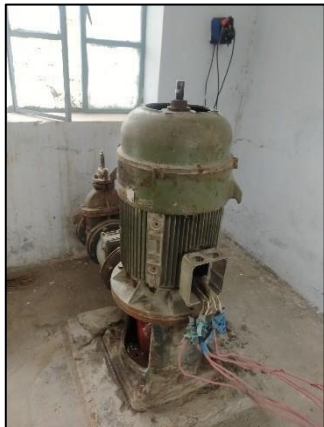
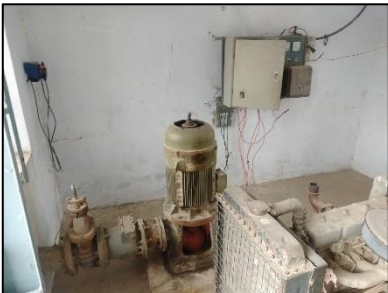
Integrated Development and Asset Management Plan (IDAMP)				
Municipal Committee Bahawalnagar				
Form: IDAMP-A1	Tube Well Asset Condition Assessment			Asset Code: _____ Date: 02-05-2023
Asset Detail			Pictures	
Name		Sadiqia Canal # 04		
Location	Latitude	29.948697		
	Longitude	73.398153		
Address		Sadiqia Canal, Bahawalnagar		
Area (Marla)		1		
Working Status		Functional	Non-Functional	
Installation Year of Tube Well		2010		
Installation Year of Pump		2010		
Capital Cost of Machinery				
Operational Hours		6		
Delivery Pipe	Dia	6"		
	Material	MS		
Chlorinator		Yes	No	
Chlorination Schedule		Once in a Year	After 6 Months	No Schedule
Apron Around Pump House		Yes	No	
Hoisting Girder		Yes	No	
Civil Structure Condition		Good	Fair	Poor
Approach to Pump House		Good	Fair	Poor
Pump Details				
Pump Type		Turbine		
Pump Make		Flowpak		
Discharge Capacity (Cusec)		0.5		
Rotational Speed (RPM)		1460		
Housing Dia (inches)		12

Bore Depth (ft.)		130		
Head (ft.)		200		
Impeller Installation Depth (ft.)		60		
Paint of Pumping Unit		Good	Fair	Poor
Number of Valves	Gate Valve	1		
	Non-Returning Valve	1		
Base Plate		Yes	No	
Electro-Mechanical Equipment Details				
Transformer Capacity (kVA)		25		
Sanctioned Load (Kwh)		18.65		
Motor Power (HP)		25		
Motor Make		Siemens		
MCU		Yes	No	
Earthing of Motor		Yes	No	
Power Wiring		Yes	No	
Service Cable		Yes	No	
Earthing of MCU		Yes	No	
Energy Meter		Yes	No

Integrated Development and Asset Management Plan (IDAMP)					
Municipal Committee Bahawalnagar					
Form: IDAMP-A1	Tube Well Asset Condition Assessment			Asset Code: _____ Date: 02-05-2023	
Water Meter	Yes	No			
PFI Equipment	Yes	No			
Generator	Yes	No			
Change Over	Yes	No			
Overall Rating					
Average Score	1	2	3	4	5
Asset Condition	Excellent	Good	Fair	Poor	Failing
Category	A	B	C	D	E
Remarks / Requirements					
<ul style="list-style-type: none"> No remarks 					
Data Collected By: Mr. Abdullah		Designation: Team Member

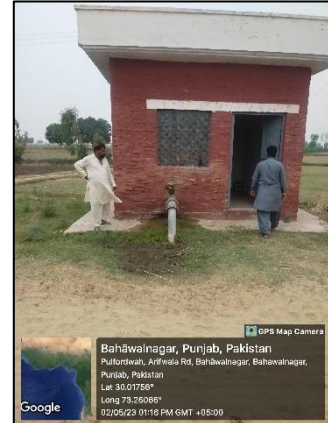
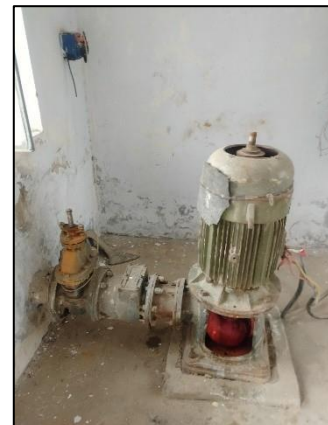
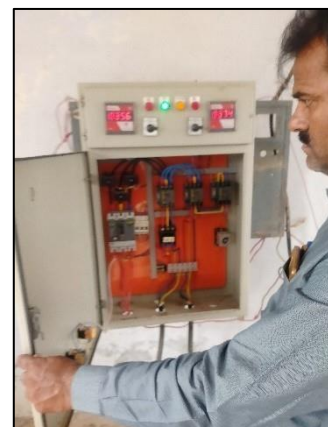
Integrated Development and Asset Management Plan (IDAMP)					
Municipal Committee Bahawalnagar					
Form: IDAMP-A1	Tube Well Asset Condition Assessment			Asset Code: _____ Date: 02-05-2023	
Asset Detail				Pictures	
Name		Sadiqia Canal # 05			
Location	Latitude	29.948697			
	Longitude	73.398153			
Address		Sadiqia Canal, Bahawalnagar			
Area (Marla)		1			
Working Status		Functional	Non-Functional		
Installation Year of Tube Well		2010			
Installation Year of Pump		2010			
Capital Cost of Machinery					
Operational Hours		6			
Delivery Pipe	Dia	6"			
	Material	MS			
Chlorinator		Yes	No		
Chlorination Schedule		Once in a Year	After 6 Months	No Schedule	
Apron Around Pump House		Yes	No		
Hoisting Girder		Yes	No		
Civil Structure Condition		Good	Fair	Poor	
Approach to Pump House		Good	Fair	Poor	
Pump Details					
Pump Type		Turbine			
Pump Make		Flowpak			
Discharge Capacity (Cusec)		0.5			
Rotational Speed (RPM)		1460

Housing Dia (inches)		12			
Bore Depth (ft.)		130			
Head (ft.)		200			
Impeller Installation Depth (ft.)		60			
Paint of Pumping Unit		Good	Fair	Poor	
Number of Valves	Gate Valve	1			
	Non-Returning Valve	1			
Base Plate		Yes	No		
Electro-Mechanical Equipment Details					
Transformer Capacity (kVA)		25			
Sanctioned Load (Kwh)		18.65			
Motor Power (HP)		25			
Motor Make		Siemens			
MCU		Yes	No		
Earthing of Motor		Yes	No		
Power Wiring		Yes	No		
Service Cable		Yes	No		
Earthing of MCU		Yes	No		
Energy Meter		Yes	No

Integrated Development and Asset Management Plan (IDAMP)					
Municipal Committee Bahawalnagar					
Form: IDAMP-A1	Tube Well Asset Condition Assessment			Asset Code: _____ Date: 02-05-2023	
Water Meter	Yes	No			
PFI Equipment	Yes	No			
Generator	Yes	No			
Change Over	Yes	No			
Overall Rating					
Average Score	1	2	3	4	5
Asset Condition	Excellent	Good	Fair	Poor	Failing
Category	A	B	C	D	E
Remarks / Requirements					
<ul style="list-style-type: none"> No remarks 					
Data Collected By: Mr. Abdullah		Designation: Team Member

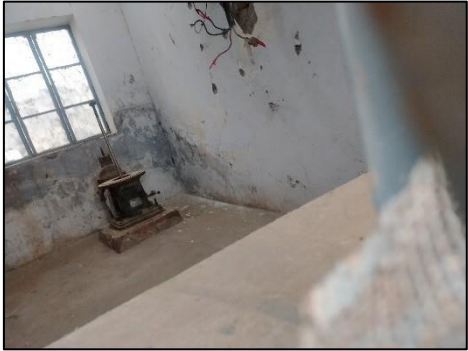
Integrated Development and Asset Management Plan (IDAMP)					
Municipal Committee Bahawalnagar					
Form: IDAMP-A1	Tube Well Asset Condition Assessment			Asset Code: _____ Date: 02-05-2023	
Asset Detail				Pictures	
Name		Sadiqia Canal # 06			
Location	Latitude	29.948697			
	Longitude	73.398153			
Address		Sadiqia Canal, Bahawalnagar			
Area (Marla)		1			
Working Status		Functional	Non-Functional		
Installation Year of Tube Well		2010			
Installation Year of Pump		2010			
Capital Cost of Machinery					
Operational Hours		0			
Delivery Pipe	Dia	6"			
	Material	MS			
Chlorinator		Yes	No		
Chlorination Schedule		Once in a Year	After 6 Months	No Schedule	
Apron Around Pump House		Yes	No		
Hoisting Girder		Yes	No		
Civil Structure Condition		Good	Fair	Poor	
Approach to Pump House		Good	Fair	Poor	
Pump Details					
Pump Type		Turbine			
Pump Make		Flowpak			
Discharge Capacity (Cusec)		0.5			
Rotational Speed (RPM)		-

Housing Dia (inches)		12			
Bore Depth (ft.)		130			
Head (ft.)		200			
Impeller Installation Depth (ft.)		60			
Paint of Pumping Unit		Good	Fair	Poor	
Number of Valves	Gate Valve	1			
	Non-Returning Valve	1			
Base Plate		Yes	No		
Electro-Mechanical Equipment Details					
Transformer Capacity (kVA)		No Motor			
Sanctioned Load (Kwh)					
Motor Power (HP)					
Motor Make					
MCU		Yes	No		
Earthing of Motor		Yes	No		
Power Wiring		Yes	No		
Service Cable		Yes	No		
Earthing of MCU		Yes	No		
Energy Meter		Yes	No

Bahawalnagar, Punjab, Pakistan
Puffordwah, Arifwala Rd, Bahawalnagar, Bahawalnagar,
Punjab, Pakistan
Lat 30.01756°
Long 73.26065°
02/05/23 01:21 PM GMT +05:00

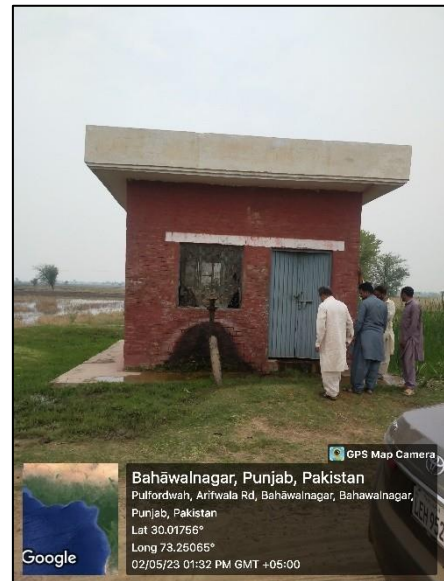
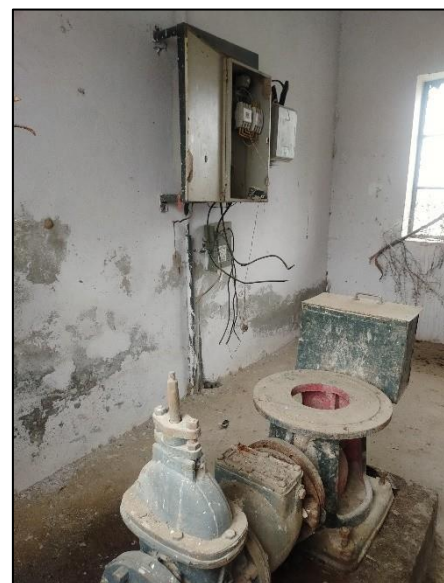
Integrated Development and Asset Management Plan (IDAMP)					
Municipal Committee Bahawalnagar					
Form:	Tube Well			Asset Code: _____	
IDAMP-A1	Asset Condition Assessment			Date: 02-05-2023	
Asset Detail				Pictures	
Name		Sadiqia Canal # 08			
Location	Latitude	29.948697			
	Longitude	73.398153			
Address		Sadiqia Canal, Bahawalnagar			
Area (Marla)		1			
Working Status		Functional	Non-Functional		
Installation Year of Tube Well		2010			
Installation Year of Pump		2010			
Capital Cost of Machinery					
Operational Hours		6			
Delivery Pipe	Dia	6"			
	Material	MS			
Chlorinator		Yes	No		
Chlorination Schedule		Once in a Year	After 6 Months	No Schedule	
Apron Around Pump House		Yes	No		
Hoisting Girder		Yes	No		
Civil Structure Condition		Good	Fair	Poor	
Approach to Pump House		Good	Fair	Poor	
Pump Details					
Pump Type		Turbine			
Pump Make		Flowpak			
Discharge Capacity (Cusec)		0.5			
Rotational Speed (RPM)		-

Housing Dia (inches)		12			
Bore Depth (ft.)		130			
Head (ft.)		200			
Impeller Installation Depth (ft.)		60			
Paint of Pumping Unit		Good	Fair	Poor	
Number of Valves	Gate Valve	1			
	Non-Returning Valve	1			
Base Plate		Yes	No		
Electro-Mechanical Equipment Details					
Transformer Capacity (kVA)		No Motor & Transformer			
Sanctioned Load (Kwh)					
Motor Power (HP)					
Motor Make					
MCU		Yes	No		
Earthing of Motor		Yes	No		
Power Wiring		Yes	No		
Service Cable		Yes	No		
Earthing of MCU		Yes	No		
Energy Meter		Yes	No

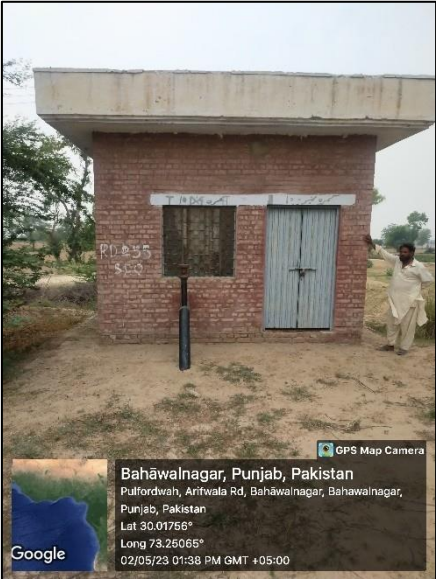
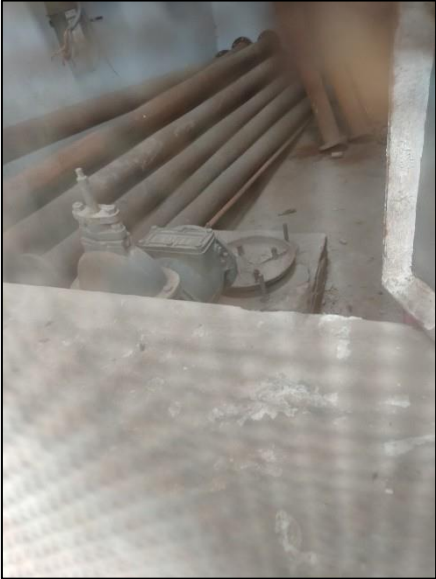
Integrated Development and Asset Management Plan (IDAMP)					
Municipal Committee Bahawalnagar					
Form: IDAMP-A1		Tube Well Asset Condition Assessment			Asset Code: _____
					Date: 02-05-2023
Asset Detail				Pictures	
Name		Sadiqia Canal # 10			
Location	Latitude	29.948697			
	Longitude	73.398153			
Address		Sadiqia Canal, Bahawalnagar			
Area (Marla)		1			
Working Status		Functional		Non-Functional	
Installation Year of Tube Well		2010			
Installation Year of Pump		2010			
Capital Cost of Machinery					
Operational Hours		0			
Delivery Pipe	Dia	6"			
	Material	MS			
Chlorinator		Yes		No	
Chlorination Schedule		Once in a Year	After 6 Months	No Schedule	
Apron Around Pump House		Yes		No	
Hoisting Girder		Yes		No	
Civil Structure Condition		Good	Fair	Poor	
Approach to Pump House		Good	Fair	Poor	
Pump Details					
Pump Type		Turbine			
Pump Make		Flowpak			
Discharge Capacity (Cusec)		0.5			
Rotational Speed (RPM)		-

Housing Dia (inches)		12			
Bore Depth (ft.)		130			
Head (ft.)		200			
Impeller Installation Depth (ft.)		60			
Paint of Pumping Unit		Good	Fair	Poor	
Number of Valves	Gate Valve				
	Non-Returning Valve				
Base Plate		Yes		No	
Electro-Mechanical Equipment Details					
Transformer Capacity (kVA)		No Motor, MCU & Transformer			
Sanctioned Load (Kwh)					
Motor Power (HP)					
Motor Make					
MCU		Yes		No	
Earthing of Motor		Yes		No	
Power Wiring		Yes		No	
Service Cable		Yes		No	
Earthing of MCU		Yes		No	
Energy Meter		Yes		No

Bahawalnagar, Punjab, Pakistan
Pulfordwah, Arifwala Rd, Bahawalnagar, Bahawalnagar, Punjab, Pakistan
Lat 30.01756°
Long 73.26065°
02/05/23 01:38 PM GMT +05:00

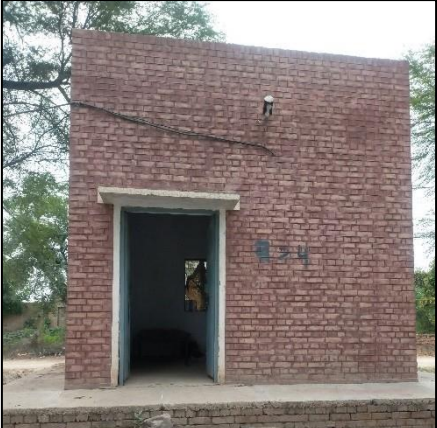
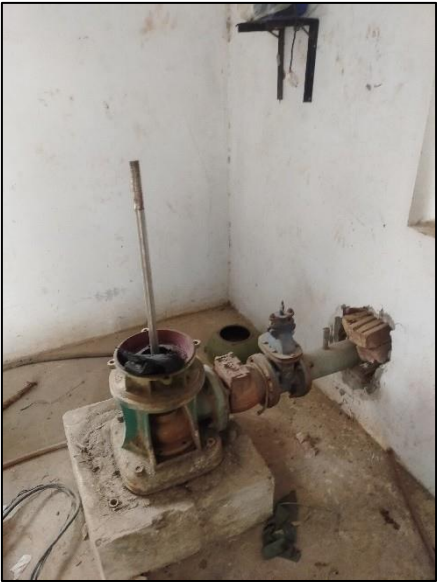
Integrated Development and Asset Management Plan (IDAMP)					
Municipal Committee Bahawalnagar					
Form: IDAMP-A1		Tube Well Asset Condition Assessment			Asset Code: _____
					Date: 02-05-2023
Asset Detail				Pictures	
Name		Ford Wah Old # 29			
Location	Latitude	30.014698			
	Longitude	73.241552			
Address		Arifwala Road, Ford wah Canal, Bahawalnagar			
Area (Marla)		1			
Working Status		Functional	Non-Functional		
Installation Year of Tube Well		2018			
Installation Year of Pump		2018			
Capital Cost of Machinery					
Operational Hours		0			
Delivery Pipe	Dia	4"			
	Material	MS			
Chlorinator		Yes		No	
Chlorination Schedule		Once in a Year	After 6 Months	No Schedule	
Apron Around Pump House		Yes		No	
Hoisting Girder		Yes		No	
Civil Structure Condition		Good	Fair	Poor	
Approach to Pump House		Good	Fair	Poor	
Pump Details					
Pump Type		Turbine			
Pump Make		PECO			
Discharge Capacity (Cusec)		0.5			
Rotational Speed (RPM)		1460

Housing Dia (inches)		10			
Bore Depth (ft.)		160			
Head (ft.)		200			
Impeller Installation Depth (ft.)		72			
Paint of Pumping Unit		Good	Fair	Poor	
Number of Valves	Gate Valve	1			
	Non-Returning Valve	1			
Base Plate		Yes		No	
Electro-Mechanical Equipment Details					
Transformer Capacity (kVA)		No Motor			
Sanctioned Load (Kwh)					
Motor Power (HP)					
Motor Make					
MCU		Yes		No	
Earthing of Motor		Yes		No	
Power Wiring		Yes		No	
Service Cable		Yes		No	
Earthing of MCU		Yes		No

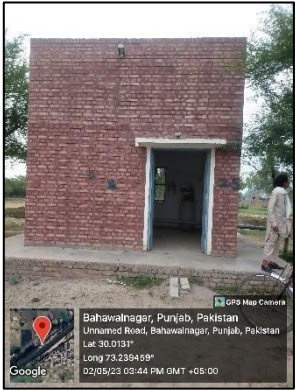
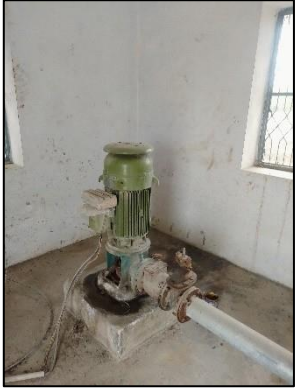
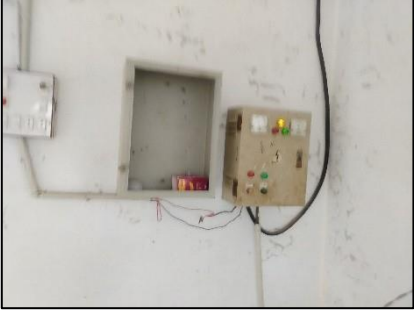
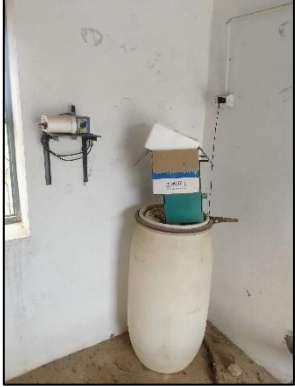
Integrated Development and Asset Management Plan (IDAMP)				
Municipal Committee Bahawalnagar				
Form: IDAMP-A1	Tube Well Asset Condition Assessment			Asset Code: _____ Date: 02-05-2023
Asset Detail			Pictures	
Name		Ford Wah Old # 28		
Location	Latitude	30.013100		
	Longitude	73.239459		
Address		Arifwala Road, Ford wah Canal, Bahawalnagar		
Area (Marla)		1		
Working Status		Functional	Non-Functional	
Installation Year of Tube Well		2018		
Installation Year of Pump		2018		
Capital Cost of Machinery				
Operational Hours		6		
Delivery Pipe	Dia	4"		
	Material	MS		
Chlorinator		Yes	No	
Chlorination Schedule		Once in a Year	After 6 Months	No Schedule
Apron Around Pump House		Yes	No	
Hoisting Girder		Yes	No	
Civil Structure Condition		Good	Fair	Poor
Approach to Pump House		Good	Fair	Poor
Pump Details				
Pump Type		Turbine		
Pump Make		PECO		
Discharge Capacity (Cusec)		0.5		
Rotational Speed (RPM)		1460		
Housing Dia (inches)		10

Bore Depth (ft.)		160		
Head (ft.)		200		
Impeller Installation Depth (ft.)		72		
Paint of Pumping Unit		Good	Fair	Poor
Number of Valves	Gate Valve	1		
	Non-Returning Valve	1		
Base Plate		Yes	No	
Electro-Mechanical Equipment Details				
Transformer Capacity (kVA)		25		
Sanctioned Load (Kwh)		19		
Motor Power (HP)		20		
Motor Make		Siemens		
MCU		Yes	No	
Earthing of Motor		Yes	No	
Power Wiring		Yes	No	
Service Cable		Yes	No	
Earthing of MCU		Yes	No

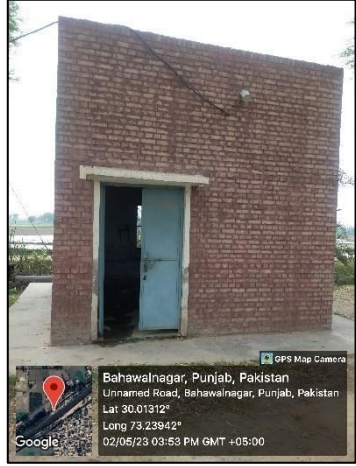
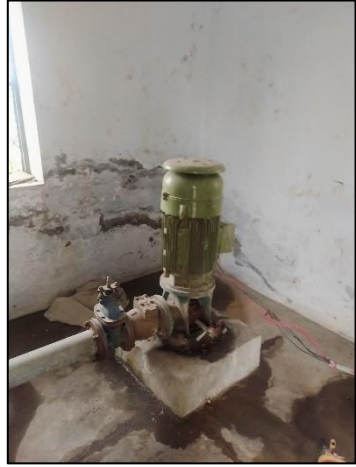
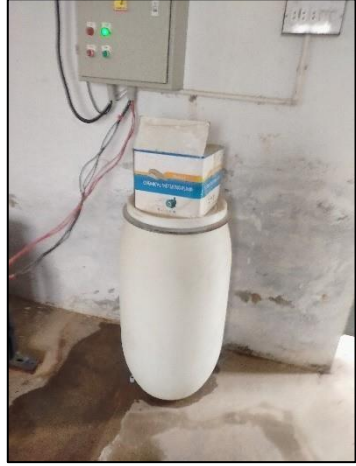
Integrated Development and Asset Management Plan (IDAMP)				
Municipal Committee Bahawalnagar				
Form: IDAMP-A1	Tube Well Asset Condition Assessment			Asset Code: _____ Date: 02-05-2023
Asset Detail			Pictures	
Name		Ford Wah Old # 27		
Location	Latitude	30.013120		
	Longitude	73.239420		
Address		Arifwala Road, Ford wah Canal, Bahawalnagar		
Area (Marla)		1		
Working Status		Functional	Non-Functional	
Installation Year of Tube Well		2018		
Installation Year of Pump		2018		
Capital Cost of Machinery				
Operational Hours		6		
Delivery Pipe	Dia	4"		
	Material	MS		
Chlorinator		Yes	No	
Chlorination Schedule		Once in a Year	After 6 Months	No Schedule
Apron Around Pump House		Yes	No	
Hoisting Girder		Yes	No	
Civil Structure Condition		Good	Fair	Poor
Approach to Pump House		Good	Fair	Poor
Pump Details				
Pump Type		Turbine		
Pump Make		PECO		
Discharge Capacity (Cusec)		0.5		
Rotational Speed (RPM)		1460		
Housing Dia (inches)		10

Bore Depth (ft.)		160		
Head (ft.)		200		
Impeller Installation Depth (ft.)		72		
Paint of Pumping Unit		Good	Fair	Poor
Number of Valves	Gate Valve	1		
	Non-Returning Valve	1		
Base Plate		Yes	No	
Electro-Mechanical Equipment Details				
Transformer Capacity (kVA)		25		
Sanctioned Load (Kwh)		19		
Motor Power (HP)		20		
Motor Make		Siemens		
MCU		Yes	No	
Earthing of Motor		Yes	No	
Power Wiring		Yes	No	
Service Cable		Yes	No	
Earthing of MCU		Yes	No

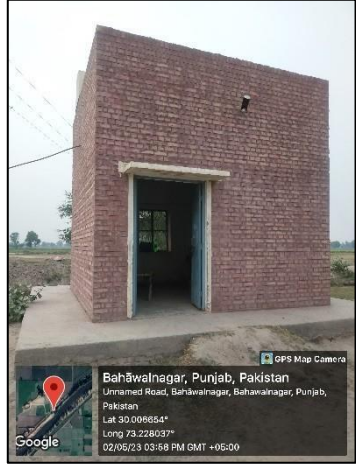
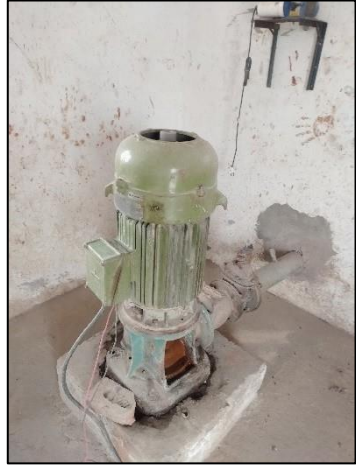
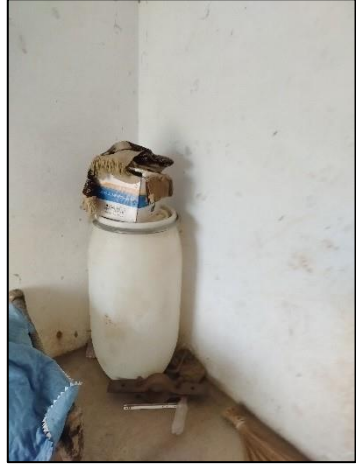
Integrated Development and Asset Management Plan (IDAMP)				
Municipal Committee Bahawalnagar				
Form: IDAMP-A1	Tube Well Asset Condition Assessment			Asset Code: _____ Date: 02-05-2023
Asset Detail			Pictures	
Name		Ford Wah Old # 26		
Location	Latitude	30.006654		
	Longitude	73.228037		
Address		Arifwala Road, Ford wah Canal, Bahawalnagar		
Area (Marla)		1		
Working Status		Functional	Non-Functional	
Installation Year of Tube Well		2018		
Installation Year of Pump		2018		
Capital Cost of Machinery				
Operational Hours		6		
Delivery Pipe	Dia	4"		
	Material	MS		
Chlorinator		Yes	No	
Chlorination Schedule		Once in a Year	After 6 Months	No Schedule
Apron Around Pump House		Yes	No	
Hoisting Girder		Yes	No	
Civil Structure Condition		Good	Fair	Poor
Approach to Pump House		Good	Fair	Poor
Pump Details				
Pump Type		Turbine		
Pump Make		PECO		
Discharge Capacity (Cusec)		0.5		
Rotational Speed (RPM)		1460		
Housing Dia (inches)		10

Bore Depth (ft.)		160		
Head (ft.)		200		
Impeller Installation Depth (ft.)		72		
Paint of Pumping Unit		Good	Fair	Poor
Number of Valves	Gate Valve	1		
	Non-Returning Valve	1		
Base Plate		Yes	No	
Electro-Mechanical Equipment Details				
Transformer Capacity (kVA)		25		
Sanctioned Load (Kwh)		19		
Motor Power (HP)		20		
Motor Make		Siemens		
MCU		Yes	No	
Earthing of Motor		Yes	No	
Power Wiring		Yes	No	
Service Cable		Yes	No	
Earthing of MCU		Yes	No

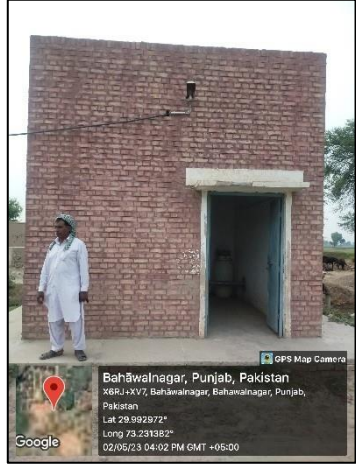
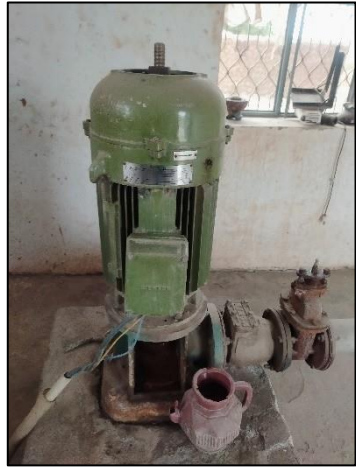
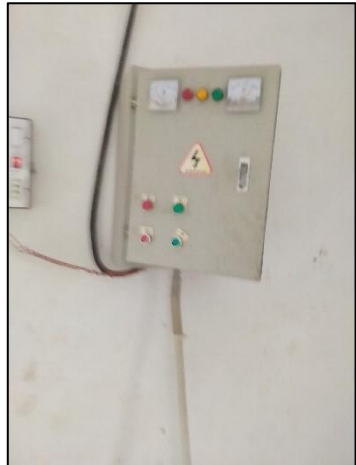
Integrated Development and Asset Management Plan (IDAMP)				
Municipal Committee Bahawalnagar				
Form: IDAMP-A1	Tube Well Asset Condition Assessment			Asset Code: _____ Date: 02-05-2023
Asset Detail			Pictures	
Name		Ford Wah Old # 25		
Location	Latitude	29.992972		
	Longitude	73.231382		
Address		Arifwala Road, Ford wah Canal, Bahawalnagar		
Area (Marla)		1		
Working Status		Functional	Non-Functional	
Installation Year of Tube Well		2018		
Installation Year of Pump		2018		
Capital Cost of Machinery				
Operational Hours		6		
Delivery Pipe	Dia	4"		
	Material	MS		
Chlorinator		Yes	No	
Chlorination Schedule		Once in a Year	After 6 Months	No Schedule
Apron Around Pump House		Yes	No	
Hoisting Girder		Yes	No	
Civil Structure Condition		Good	Fair	Poor
Approach to Pump House		Good	Fair	Poor
Pump Details				
Pump Type		Turbine		
Pump Make		PECO		
Discharge Capacity (Cusec)		0.5		
Rotational Speed (RPM)		1460		
Housing Dia (inches)		10

Bore Depth (ft.)		160		
Head (ft.)		200		
Impeller Installation Depth (ft.)		72		
Paint of Pumping Unit		Good	Fair	Poor
Number of Valves	Gate Valve	1		
	Non-Returning Valve	1		
Base Plate		Yes	No	
Electro-Mechanical Equipment Details				
Transformer Capacity (kVA)		25		
Sanctioned Load (Kwh)		19		
Motor Power (HP)		20		
Motor Make		Siemens		
MCU		Yes	No	
Earthing of Motor		Yes	No	
Power Wiring		Yes	No	
Service Cable		Yes	No	
Earthing of MCU		Yes	No

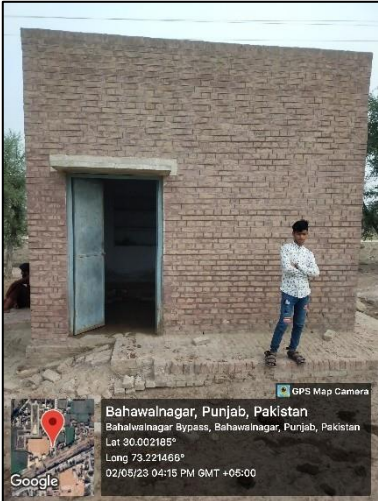
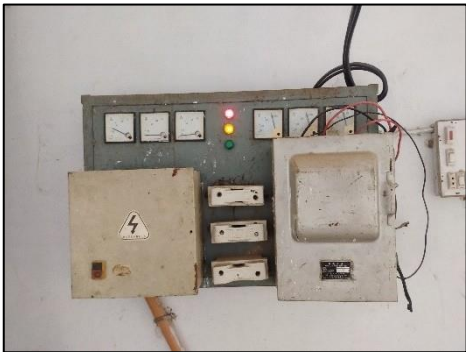
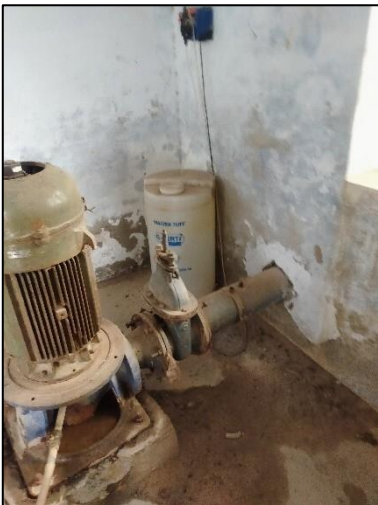
Integrated Development and Asset Management Plan (IDAMP)				
Municipal Committee Bahawalnagar				
Form: IDAMP-A1	Tube Well Asset Condition Assessment			Asset Code: _____ Date: 02-05-2023
Asset Detail			Pictures	
Name		Ford Wah Old # 24		
Location	Latitude	30.002185		
	Longitude	73.221466		
Address		Arifwala Road, Ford wah Canal, Bahawalnagar		
Area (Marla)		1		
Working Status		Functional	Non-Functional	
Installation Year of Tube Well		2009		
Installation Year of Pump		2009		
Capital Cost of Machinery				
Operational Hours		6		
Delivery Pipe	Dia	6"		
	Material	MS		
Chlorinator		Yes	No	
Chlorination Schedule		Once in a Year	After 6 Months	No Schedule
Apron Around Pump House		Yes	No	
Hoisting Girder		Yes	No	
Civil Structure Condition		Good	Fair	Poor
Approach to Pump House		Good	Fair	Poor
Pump Details				
Pump Type		Turbine		
Pump Make		KSB		
Discharge Capacity (Cusec)		0.5		
Rotational Speed (RPM)		1460		
Housing Dia (inches)		12

Bore Depth (ft.)		160		
Head (ft.)		200		
Impeller Installation Depth (ft.)		72		
Paint of Pumping Unit		Good	Fair	Poor
Number of Valves	Gate Valve	1		
	Non-Returning Valve	1		
Base Plate		Yes	No	
Electro-Mechanical Equipment Details				
Transformer Capacity (kVA)		25		
Sanctioned Load (Kwh)		14.92		
Motor Power (HP)		20		
Motor Make		Siemens		
MCU		Yes	No	
Earthing of Motor		Yes	No	
Power Wiring		Yes	No	
Service Cable		Yes	No	
Earthing of MCU		Yes	No

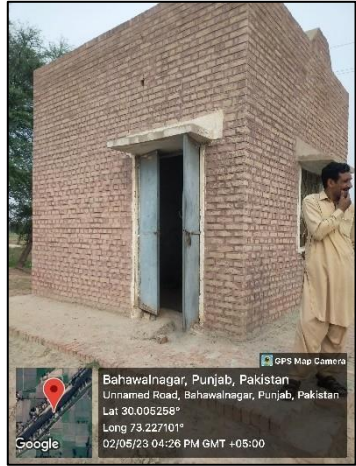
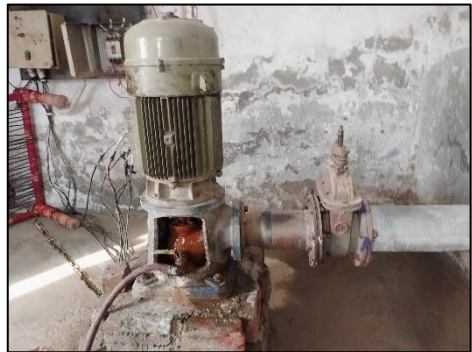
Integrated Development and Asset Management Plan (IDAMP)					
Municipal Committee Bahawalnagar					
Form: IDAMP-A1	Tube Well Asset Condition Assessment			Asset Code: _____ Date: 02-05-2023	
Asset Detail				Pictures	
Name		Ford Wah Old # 23			
Location	Latitude	30.005258			
	Longitude	73.227101			
Address		Arifwala Road, Ford wah Canal, Bahawalnagar			
Area (Marla)		1			
Working Status		Functional	Non-Functional		
Installation Year of Tube Well		2005			
Installation Year of Pump		2006			
Capital Cost of Machinery					
Operational Hours		6			
Delivery Pipe	Dia	6"			
	Material	MS			
Chlorinator		Yes	No		
Chlorination Schedule		Once in a Year	After 6 Months	No Schedule	
Apron Around Pump House		Yes	No		
Hoisting Girder		Yes	No		
Civil Structure Condition		Good	Fair	Poor	
Approach to Pump House		Good	Fair	Poor	
Pump Details					
Pump Type		Turbine			
Pump Make		PECO			
Discharge Capacity (Cusec)		0.5			
Rotational Speed (RPM)		1460

Housing Dia (inches)		12			
Bore Depth (ft.)		160			
Head (ft.)		200			
Impeller Installation Depth (ft.)		72			
Paint of Pumping Unit		Good	Fair	Poor	
Number of Valves	Gate Valve	1			
	Non-Returning Valve	1			
Base Plate		Yes	No		
Electro-Mechanical Equipment Details					
Transformer Capacity (kVA)		25			
Sanctioned Load (Kwh)		22			
Motor Power (HP)		20			
Motor Make		Siemens			
MCU		Yes	No		
Earthing of Motor		Yes	No		
Power Wiring		Yes	No		
Service Cable		Yes	No		
Earthing of MCU		Yes	No

Bahawalnagar, Punjab, Pakistan
Unnamed Road, Bahawalnagar, Punjab, Pakistan
Lat 30.005258°
Long 73.227101°
02/05/23 04:26 PM GMT +05:00

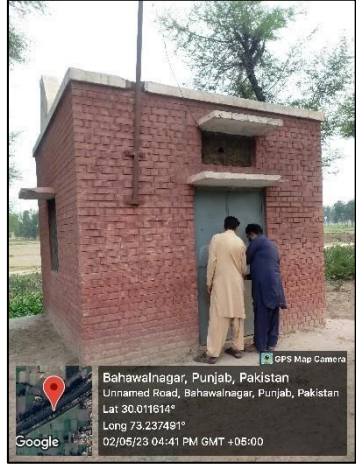
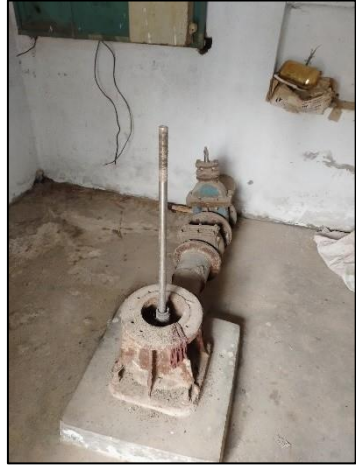
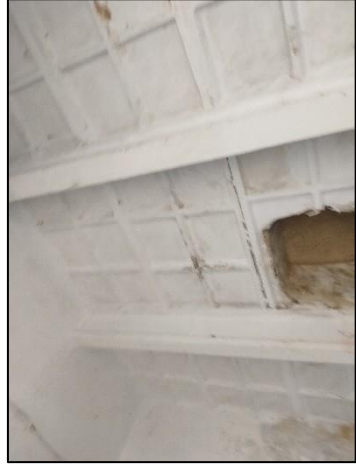
Integrated Development and Asset Management Plan (IDAMP)					
Municipal Committee Bahawalnagar					
Form: IDAMP-A1		Tube Well Asset Condition Assessment			Asset Code: _____
					Date: 02-05-2023
Asset Detail				Pictures	
Name		Ford Wah Old # 22			
Location	Latitude	30.011614			
	Longitude	73.237491			
Address		Arifwala Road, Ford wah Canal, Bahawalnagar			
Area (Marla)		1			
Working Status		Functional		Non-Functional	
Installation Year of Tube Well		2000			
Installation Year of Pump		2002			
Capital Cost of Machinery					
Operational Hours		0			
Delivery Pipe	Dia	6"			
	Material	MS			
Chlorinator		Yes		No	
Chlorination Schedule		Once in a Year	After 6 Months	No Schedule	
Apron Around Pump House		Yes		No	
Hoisting Girder		Yes		No	
Civil Structure Condition		Good	Fair	Poor	
Approach to Pump House		Good	Fair	Poor	
Pump Details					
Pump Type		Turbine			
Pump Make		PECO			
Discharge Capacity (Cusec)		0.5			
Rotational Speed (RPM)		-

Housing Dia (inches)		12			
Bore Depth (ft.)		170			
Head (ft.)		200			
Impeller Installation Depth (ft.)		72			
Paint of Pumping Unit		Good	Fair	Poor	
Number of Valves	Gate Valve	1			
	Non-Returning Valve	1			
Base Plate		Yes		No	
Electro-Mechanical Equipment Details					
Transformer Capacity (kVA)		No Motor & Transformer			
Sanctioned Load (Kwh)					
Motor Power (HP)					
Motor Make					
MCU		Yes		No	
Earthing of Motor		Yes		No	
Power Wiring		Yes		No	
Service Cable		Yes		No	
Earthing of MCU		Yes		No

Integrated Development and Asset Management Plan (IDAMP)					
Municipal Committee Bahawalnagar					
Form: IDAMP-A1	Tube Well Asset Condition Assessment			Asset Code: _____ Date: 02-05-2023	
Energy Meter	Yes	No			
Water Meter	Yes	No			
PFI Equipment	Yes	No			
Generator	Yes	No			
Change Over	Yes	No			
Overall Rating					
Average Score	1	2	3	4	5
Asset Condition	Excellent	Good	Fair	Poor	Failing
Category	A	B	C	D	E
Remarks / Requirements					
<ul style="list-style-type: none"> The temporary non-functionality of the tube well, due to the motor unit undergoing repair 					
<i>Data Collected By: Mr. Abdullah</i>		<i>Designation: Team Member</i>

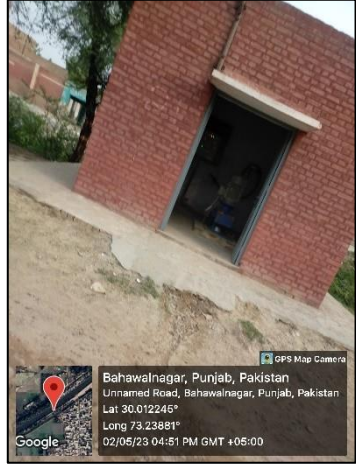
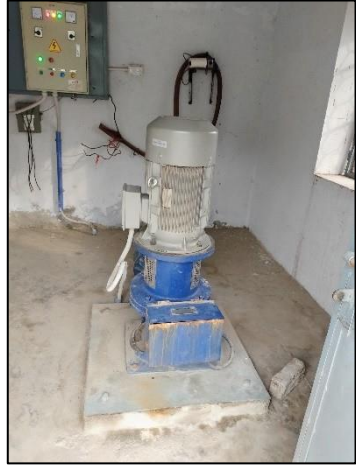
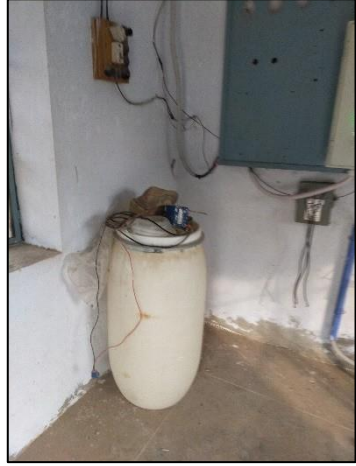
Integrated Development and Asset Management Plan (IDAMP)				
Municipal Committee Bahawalnagar				
Form: IDAMP-A1	Tube Well Asset Condition Assessment			Asset Code: _____ Date: 02-05-2023
Asset Detail			Pictures	
Name		Ford Wah Old # 21		
Location	Latitude	30.012245		
	Longitude	73.238810		
Address		Arifwala Road, Ford wah Canal, Bahawalnagar		
Area (Marla)		1		
Working Status		Functional	Non-Functional	
Installation Year of Tube Well		2000		
Installation Year of Pump		2021		
Capital Cost of Machinery				
Operational Hours		6		
Delivery Pipe	Dia	6"		
	Material	MS		
Chlorinator		Yes	No	
Chlorination Schedule		Once in a Year	After 6 Months	No Schedule
Apron Around Pump House		Yes	No	
Hoisting Girder		Yes	No	
Civil Structure Condition		Good	Fair	Poor
Approach to Pump House		Good	Fair	Poor
Pump Details				
Pump Type		Turbine		
Pump Make		KSB		
Discharge Capacity (Cusec)		0.5		
Rotational Speed (RPM)		1460		
Housing Dia (inches)		12

Bore Depth (ft.)		170		
Head (ft.)		200		
Impeller Installation Depth (ft.)		72		
Paint of Pumping Unit		Good	Fair	Poor
Number of Valves	Gate Valve	1		
	Non-Returning Valve	1		
Base Plate		Yes	No	
Electro-Mechanical Equipment Details				
Transformer Capacity (kVA)		100 (Combined)		
Sanctioned Load (Kwh)		19		
Motor Power (HP)		20		
Motor Make		Siemens		
MCU		Yes	No	
Earthing of Motor		Yes	No	
Power Wiring		Yes	No	
Service Cable		Yes	No	
Earthing of MCU		Yes	No

Integrated Development and Asset Management Plan (IDAMP)					
Municipal Committee Bahawalnagar					
Form: IDAMP-A1	Tube Well Asset Condition Assessment			Asset Code: _____ Date: 02-05-2023	
Energy Meter	Yes	No			
Water Meter	Yes	No			
PFI Equipment	Yes	No			
Generator	Yes	No			
Change Over	Yes	No			
Overall Rating					
Average Score	1	2	3	4	5
Asset Condition	Excellent	Good	Fair	Poor	Failing
Category	A	B	C	D	E
Remarks / Requirements					
<ul style="list-style-type: none"> No remarks 					
<i>Data Collected By: Mr. Abdullah</i>		<i>Designation: Team Member</i>

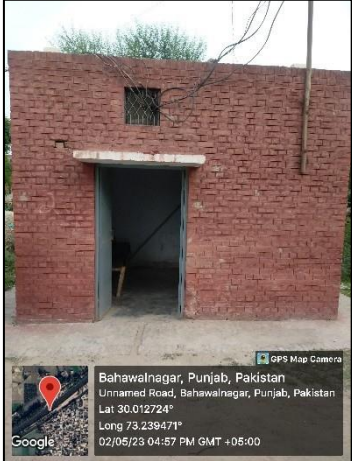
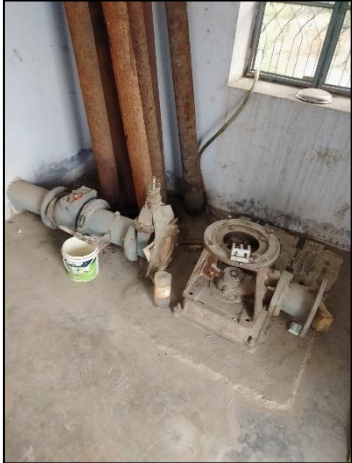
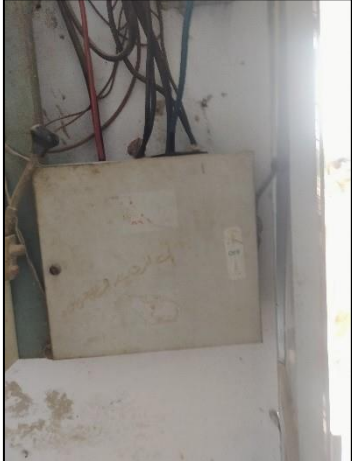
Integrated Development and Asset Management Plan (IDAMP)					
Municipal Committee Bahawalnagar					
Form: IDAMP-A1		Tube Well Asset Condition Assessment			Asset Code: _____
					Date: 02-05-2023
Asset Detail				Pictures	
Name		Ford Wah Old # 20			
Location	Latitude	30.012724			
	Longitude	73.239471			
Address		Arifwala Road, Ford wah Canal, Bahawalnagar			
Area (Marla)		1			
Working Status		Functional	Non-Functional		
Installation Year of Tube Well		2000			
Installation Year of Pump		2004			
Capital Cost of Machinery					
Operational Hours		0			
Delivery Pipe	Dia	6"			
	Material	MS			
Chlorinator		Yes	No		
Chlorination Schedule		Once in a Year	After 6 Months	No Schedule	
Apron Around Pump House		Yes		No	
Hoisting Girder		Yes		No	
Civil Structure Condition		Good	Fair	Poor	
Approach to Pump House		Good	Fair	Poor	
Pump Details					
Pump Type		Turbine			
Pump Make		PECO			
Discharge Capacity (Cusec)		0.5			
Rotational Speed (RPM)		-

Housing Dia (inches)		12			
Bore Depth (ft.)		170			
Head (ft.)		200			
Impeller Installation Depth (ft.)		72			
Paint of Pumping Unit		Good	Fair	Poor	
Number of Valves	Gate Valve	1			
	Non-Returning Valve	1			
Base Plate		Yes		No	
Electro-Mechanical Equipment Details					
Transformer Capacity (kVA)		No Motor			
Sanctioned Load (Kwh)					
Motor Power (HP)					
Motor Make					
MCU		Yes		No	
Earthing of Motor		Yes		No	
Power Wiring		Yes		No	
Service Cable		Yes		No	
Earthing of MCU		Yes		No

Integrated Development and Asset Management Plan (IDAMP)					
Municipal Committee Bahawalnagar					
Form: IDAMP-A1	Tube Well Asset Condition Assessment			Asset Code: _____ Date: 02-05-2023	
Energy Meter	Yes	No			
Water Meter	Yes	No			
PFI Equipment	Yes	No			
Generator	Yes	No			
Change Over	Yes	No			
Overall Rating					
Average Score	1	2	3	4	5
Asset Condition	Excellent	Good	Fair	Poor	Failing
Category	A	B	C	D	E
Remarks / Requirements					
<ul style="list-style-type: none"> The temporary non-functionality of the tube well, due to the motor unit undergoing repair 					
Data Collected By: Mr. Abdullah		Designation: Team Member
