Punjab Municipal Development Fund Company

Hiring of Consulting Services for Preparation of Integrated Development and Asset Management Plan (IDAMP) for 16 selected MCs In Punjab under Punjab Cities Program (PCP)

**IDAMP – Municipal Committee Bahawalnagar
May 2024**

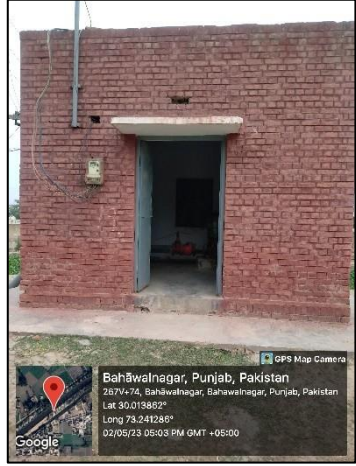
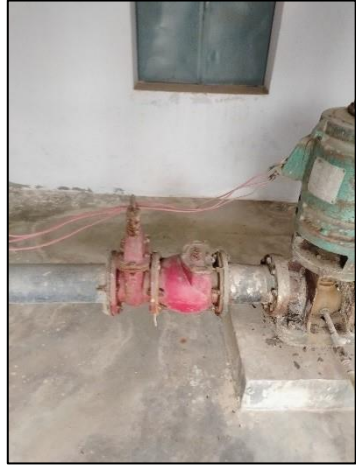
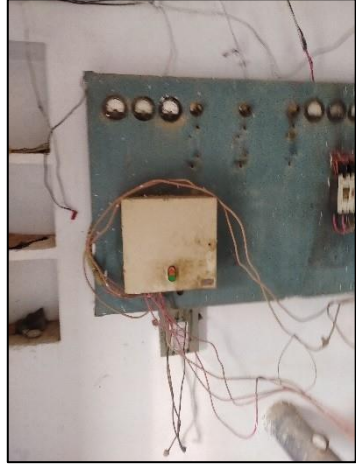
Integrated Development and Asset Management Plan (IDAMP)					
Municipal Committee Bahawalnagar					
Form: IDAMP-A1	Tube Well Asset Condition Assessment			Asset Code: _____ Date: 02-05-2023	
Asset Detail				Pictures	
Name		Ford Wah Old # 19			
Location	Latitude	30.013862			
	Longitude	73.241286			
Address		Arifwala Road, Ford wah Canal, Bahawalnagar			
Area (Marla)		1			
Working Status		Functional	Non-Functional		
Installation Year of Tube Well		2000			
Installation Year of Pump		2002			
Capital Cost of Machinery					
Operational Hours		6			
Delivery Pipe	Dia	6"			
	Material	MS			
Chlorinator		Yes	No		
Chlorination Schedule		Once in a Year	After 6 Months	No Schedule	
Apron Around Pump House		Yes	No		
Hoisting Girder		Yes	No		
Civil Structure Condition		Good	Fair	Poor	
Approach to Pump House		Good	Fair	Poor	
Pump Details					
Pump Type		Turbine			
Pump Make		PECO			
Discharge Capacity (Cusec)		0.5			
Rotational Speed (RPM)		1460

Housing Dia (inches)		12			
Bore Depth (ft.)		170			
Head (ft.)		200			
Impeller Installation Depth (ft.)		72			
Paint of Pumping Unit		Good	Fair	Poor	
Number of Valves	Gate Valve	1			
	Non-Returning Valve	1			
Base Plate		Yes	No		
Electro-Mechanical Equipment Details					
Transformer Capacity (kVA)		25			
Sanctioned Load (Kwh)		19			
Motor Power (HP)		20			
Motor Make		PECO			
MCU		Yes	No		
Earthing of Motor		Yes	No		
Power Wiring		Yes	No		
Service Cable		Yes	No		
Earthing of MCU		Yes	No

Integrated Development and Asset Management Plan (IDAMP)					
Municipal Committee Bahawalnagar					
Form: IDAMP-A1	Tube Well Asset Condition Assessment				Asset Code: _____ Date: 02-05-2023
Energy Meter	Yes	No			
Water Meter	Yes	No			
PFI Equipment	Yes	No			
Generator	Yes	No			
Change Over	Yes	No			
Overall Rating					
Average Score	1	2	3	4	5
Asset Condition	Excellent	Good	Fair	Poor	Failing
Category	A	B	C	D	E
Remarks / Requirements					
<ul style="list-style-type: none"> No remarks 					
Data Collected By: Mr. Abdullah		Designation: Team Member

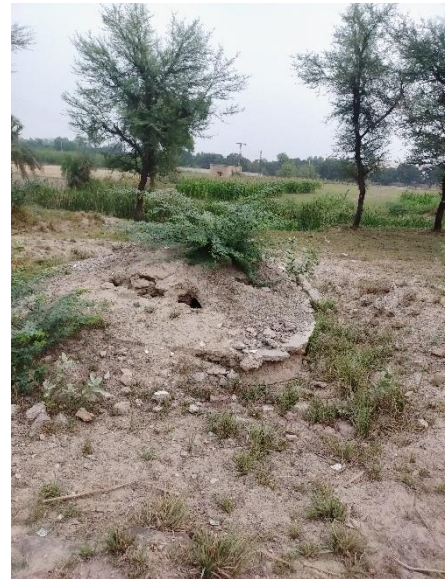
Integrated Development and Asset Management Plan (IDAMP)					
Municipal Committee Bahawalnagar					
Form: IDAMP-A1	Tube Well Asset Condition Assessment			Asset Code: _____ Date: 02-05-2023	
Asset Detail				Pictures	
Name		Ford Wah Old # 18			
Location	Latitude				
	Longitude				
Address		Arifwala Road, Ford wah Canal, Bahawalnagar			
Area (Marla)		1			
Working Status		Abandoned			
Installation Year of Tube Well					
Installation Year of Pump					
Capital Cost of Machinery					
Operational Hours					
Delivery Pipe	Dia				
	Material				
Chlorinator		Yes	No		
Chlorination Schedule		Once in a Year	After 6 Months	No Schedule	
Apron Around Pump House		Yes	No		
Hoisting Girder		Yes	No		
Civil Structure Condition		Good	Fair	Poor	
Approach to Pump House		Good	Fair	Poor	
Pump Details					
Pump Type					
Pump Make					
Discharge Capacity (Cusec)					
Rotational Speed (RPM)					
Housing Dia (inches)					
Bore Depth (ft.)					
Head (ft.)

Impeller Installation Depth (ft.)					
Paint of Pumping Unit		Good	Fair	Poor	
Number of Valves	Gate Valve				
	Non-Returning Valve				
Base Plate		Yes	No		
Electro-Mechanical Equipment Details					
Transformer Capacity (kVA)					
Sanctioned Load (Kwh)					
Motor Power (HP)					
Motor Make					
MCU		Yes	No		
Earthing of Motor		Yes	No		
Power Wiring		Yes	No		
Service Cable		Yes	No		
Earthing of MCU		Yes	No		
Energy Meter		Yes	No

Integrated Development and Asset Management Plan (IDAMP)					
Municipal Committee Bahawalnagar					
Form: IDAMP-A1	Tube Well Asset Condition Assessment			Asset Code: _____ Date: 02-05-2023	
Water Meter	Yes	No			
PFI Equipment	Yes	No			
Generator	Yes	No			
Change Over	Yes	No			
Overall Rating					
Average Score	1	2	3	4	5
Asset Condition	Excellent	Good	Fair	Poor	Failing
Category	A	B	C	D	E
Remarks / Requirements					
<ul style="list-style-type: none"> Whole Building was collapsed 					
Data Collected By: Mr. Abdullah		Designation: Team Member

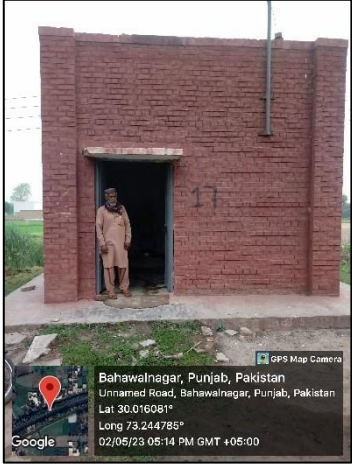
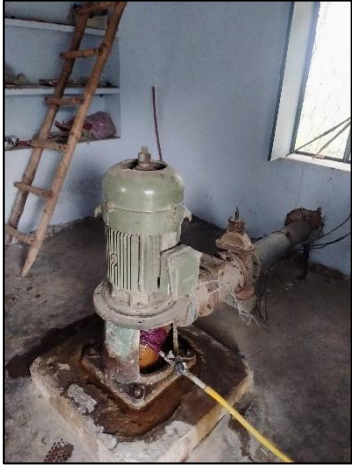
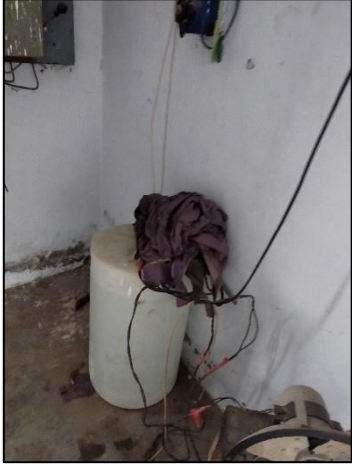
Integrated Development and Asset Management Plan (IDAMP)				
Municipal Committee Bahawalnagar				
Form: IDAMP-A1	Tube Well Asset Condition Assessment			Asset Code: _____ Date: 02-05-2023
Asset Detail			Pictures	
Name		Ford Wah Old # 17		
Location	Latitude	30.016081		
	Longitude	73.244785		
Address		Arifwala Road, Ford wah Canal, Bahawalnagar		
Area (Marla)		1		
Working Status		Functional	Non-Functional	
Installation Year of Tube Well		1985		
Installation Year of Pump		1986		
Capital Cost of Machinery				
Operational Hours		6		
Delivery Pipe	Dia	6"		
	Material	MS		
Chlorinator		Yes	No	
Chlorination Schedule		Once in a Year	After 6 Months	No Schedule
Apron Around Pump House		Yes	No	
Hoisting Girder		Yes	No	
Civil Structure Condition		Good	Fair	Poor
Approach to Pump House		Good	Fair	Poor
Pump Details				
Pump Type		Turbine		
Pump Make		KSB		
Discharge Capacity (Cusec)		0.5		
Rotational Speed (RPM)		1460		
Housing Dia (inches)		12

Bore Depth (ft.)		170		
Head (ft.)		200		
Impeller Installation Depth (ft.)		72		
Paint of Pumping Unit		Good	Fair	Poor
Number of Valves	Gate Valve	1		
	Non-Returning Valve	1		
Base Plate		Yes	No	
Electro-Mechanical Equipment Details				
Transformer Capacity (kVA)		100 (Combined)		
Sanctioned Load (Kwh)		14.92		
Motor Power (HP)		20		
Motor Make		Siemens		
MCU		Yes	No	
Earthing of Motor		Yes	No	
Power Wiring		Yes	No	
Service Cable		Yes	No	
Earthing of MCU		Yes	No

Integrated Development and Asset Management Plan (IDAMP)					
Municipal Committee Bahawalnagar					
Form: IDAMP-A1	Tube Well Asset Condition Assessment			Asset Code: _____ Date: 02-05-2023	
Energy Meter	Yes	No			
Water Meter	Yes	No			
PFI Equipment	Yes	No			
Generator	Yes	No			
Change Over	Yes	No			
Overall Rating					
Average Score	1	2	3	4	5
Asset Condition	Excellent	Good	Fair	Poor	Failing
Category	A	B	C	D	E
Remarks / Requirements					
<ul style="list-style-type: none"> No remarks 					
<i>Data Collected By: Mr. Abdullah</i>		<i>Designation: Team Member</i>

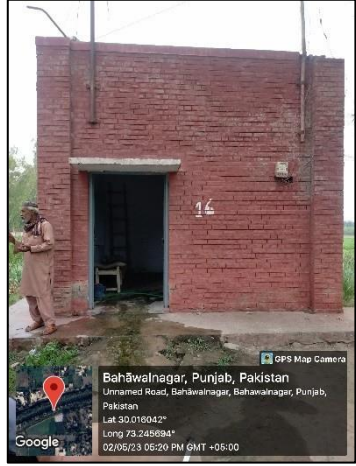
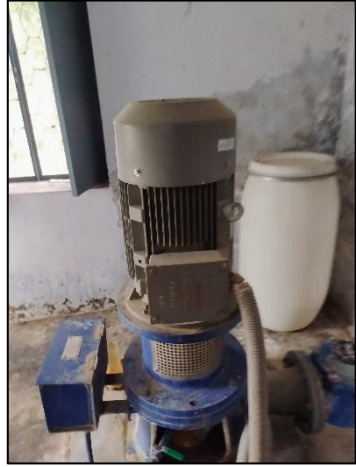
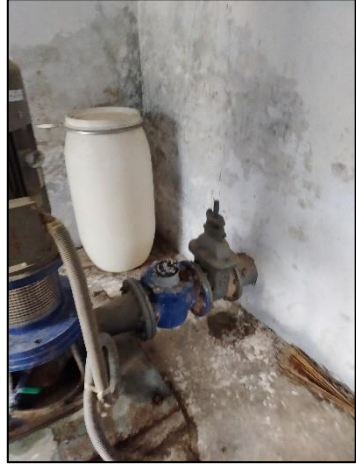
Integrated Development and Asset Management Plan (IDAMP)					
Municipal Committee Bahawalnagar					
Form: IDAMP-A1	Tube Well Asset Condition Assessment			Asset Code: _____ Date: 02-05-2023	
Asset Detail				Pictures	
Name		Ford Wah Old # 16			
Location	Latitude	30.018042			
	Longitude	73.245694			
Address		Arifwala Road, Ford wah Canal, Bahawalnagar			
Area (Marla)		1			
Working Status		Functional	Non-Functional		
Installation Year of Tube Well		2005			
Installation Year of Pump		2007			
Capital Cost of Machinery					
Operational Hours		6			
Delivery Pipe	Dia	6"			
	Material	MS			
Chlorinator		Yes	No		
Chlorination Schedule		Once in a Year	After 6 Months	No Schedule	
Apron Around Pump House		Yes	No		
Hoisting Girder		Yes	No		
Civil Structure Condition		Good	Fair	Poor	
Approach to Pump House		Good	Fair	Poor	
Pump Details					
Pump Type		Turbine			
Pump Make		FPI			
Discharge Capacity (Cusec)		0.5			
Rotational Speed (RPM)		1460

Housing Dia (inches)		12			
Bore Depth (ft.)		170			
Head (ft.)		200			
Impeller Installation Depth (ft.)		72			
Paint of Pumping Unit		Good	Fair	Poor	
Number of Valves	Gate Valve	1			
	Non-Returning Valve	1			
Base Plate		Yes	No		
Electro-Mechanical Equipment Details					
Transformer Capacity (kVA)		100 (Combined)			
Sanctioned Load (Kwh)		29.8			
Motor Power (HP)		20			
Motor Make		Siemens			
MCU		Yes	No		
Earthing of Motor		Yes	No		
Power Wiring		Yes	No		
Service Cable		Yes	No		
Earthing of MCU		Yes	No

Integrated Development and Asset Management Plan (IDAMP)					
Municipal Committee Bahawalnagar					
Form: IDAMP-A1	Tube Well Asset Condition Assessment			Asset Code: _____ Date: 02-05-2023	
Energy Meter	Yes	No			
Water Meter	Yes	No			
PFI Equipment	Yes	No			
Generator	Yes	No			
Change Over	Yes	No			
Overall Rating					
Average Score	1	2	3	4	5
Asset Condition	Excellent	Good	Fair	Poor	Failing
Category	A	B	C	D	E
Remarks / Requirements					
<ul style="list-style-type: none"> No remarks 					
<i>Data Collected By: Mr. Abdullah</i>		<i>Designation: Team Member</i>

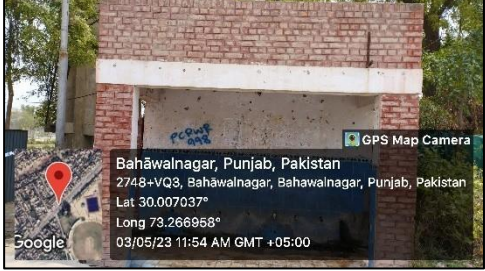
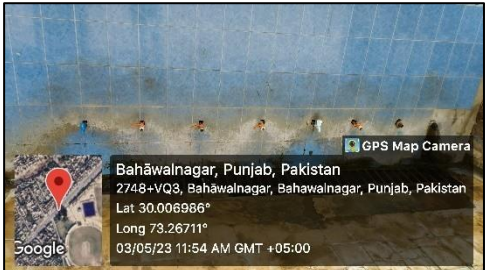
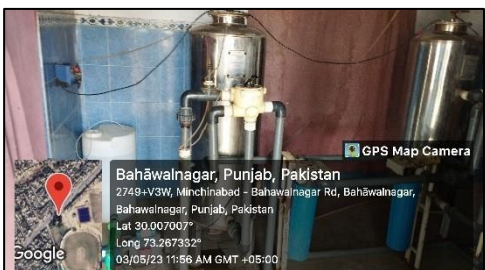
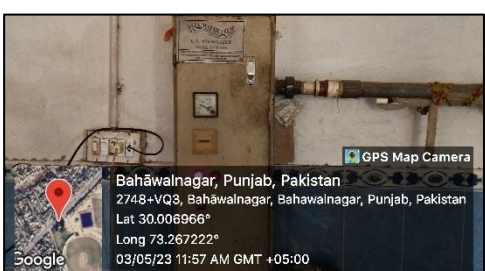
Integrated Development And Asset Management Plan (IDAMP)					
Municipal Committee Bahawalnagar					
Form: IDAMP-A4	Water Filtration Plant Asset Condition Assessment			Asset Code: _____ Date: 02-05-2023	
Name		Khadamabad		Pictures	
Location	Latitude	30.007037

Longitude	73.266958			
Address		Khadamadam, Bahawalnagar

Installation Year		2008			
Installing Agency		MC

O&M Agency		MC			
Filtration Capacity (Liter/Hour)		2000

Operational Hours		12			
No. of Taps		8			
Effluent Test (If Available)		Not Available			
Latest water quality analysis carried out?		-			
If yes, which lab and parameters?		-			
Findings of water quality analysis?		-			
In case of any parameter above the permissible limit, which steps are taken to provide safe water?		-			
Plant Type		RO	UV		
Source of Water		Local Tube Well	Public Water Supply		
Working Status		Functional	Non-Functional		
Pumping Unit		Yes	No

Control Panel		Yes	No		
Service Cable		Yes	No		
Ultraviolet Lamp/Chlorinator		Yes	No		
Takeaway Hall Condition		Good	Fair		
Building Structure Condition		Good	Fair	Poor	
Approach to Pump House		Good	Fair	Poor	
Overall Rating					
Average Score	1	2	3	4	5
Asset Condition	Excellent	Good	Fair	Poor	Failing
Category	A	B	C	D	E
Remarks / Requirements					
<ul style="list-style-type: none"> No remarks 					
<i>Data Collected By: Mr. Abdullah</i>		<i>Designation: Team Member</i>

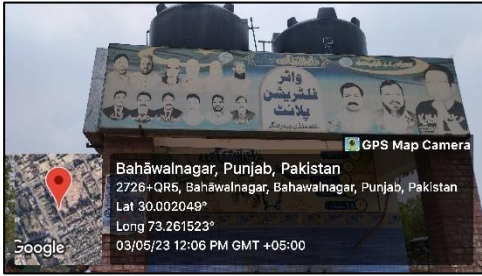
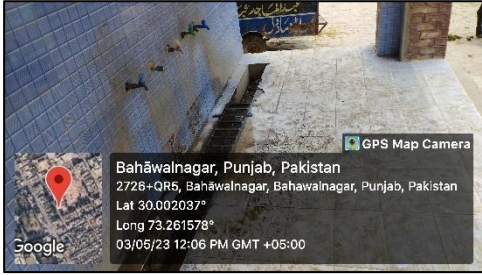
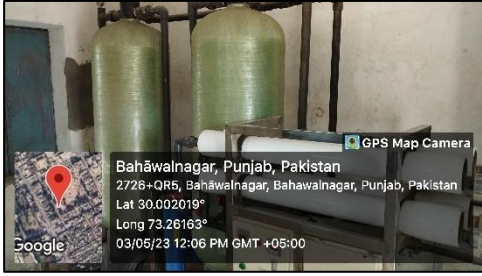
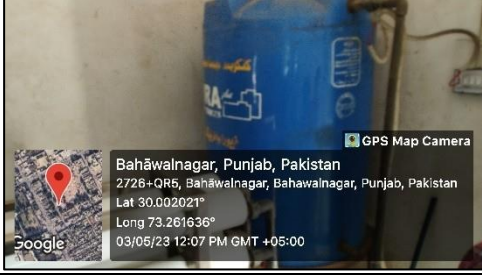
Integrated Development And Asset Management Plan (IDAMP)					
Municipal Committee Bahawalnagar					
Form: IDAMP-A4	Water Filtration Plant Asset Condition Assessment			Asset Code: _____ Date: 02-05-2023	
Name		Ghalla Mandi		Pictures	
Location	Latitude	30.002049

Longitude	73.261523			
Address		Ghalla Mandi, Bahawalnagar

Installation Year		2016			
Installing Agency		MC

O&M Agency		MC			
Filtration Capacity (Liter/Hour)		2000

Operational Hours		12			
No. of Taps		5			
Effluent Test (If Available)		Not Available			
Latest water quality analysis carried out?		-			
If yes, which lab and parameters?		-			
Findings of water quality analysis?		-			
In case of any parameter above the permissible limit, which steps are taken to provide safe water?		-			
Plant Type		RO	UV		
Source of Water		Local Tube Well	Public Water Supply		
Working Status		Functional	Non-Functional		
Pumping Unit		Yes	No

Control Panel		Yes	No		
Service Cable		Yes	No		
Ultraviolet Lamp/Chlorinator		Yes	No		
Takeaway Hall Condition		Good	Fair		
Building Structure Condition		Good	Fair	Poor	
Approach to Pump House		Good	Fair	Poor	
Overall Rating					
Average Score	1	2	3	4	5
Asset Condition	Excellent	Good	Fair	Poor	Failing
Category	A	B	C	D	E
Remarks / Requirements					
<ul style="list-style-type: none"> No remarks 					
<i>Data Collected By: Mr. Abdullah</i>		<i>Designation: Team Member</i>

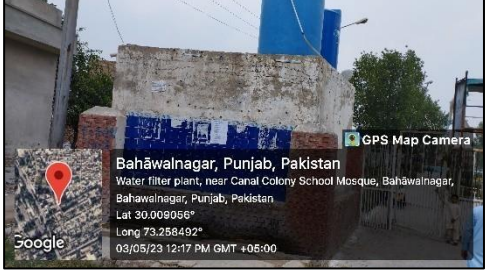
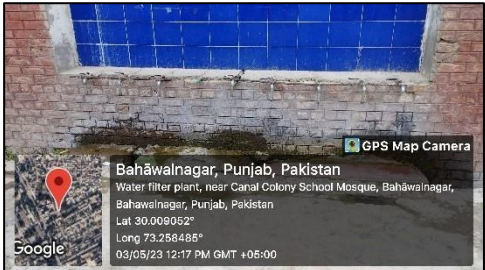
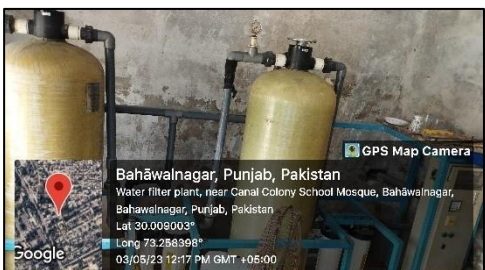
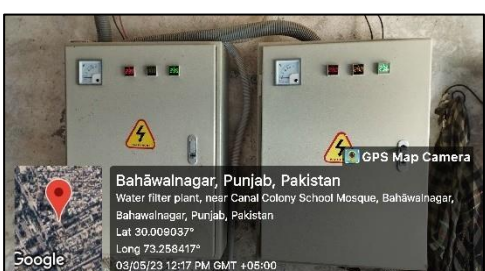
Integrated Development And Asset Management Plan (IDAMP)					
Municipal Committee Bahawalnagar					
Form: IDAMP-A4	Water Filtration Plant Asset Condition Assessment			Asset Code: _____	Date: 02-05-2023
Name		Aamir Jan Park		Pictures	
Location	Latitude	30.009056

Longitude	73.258492			
Address		Aamir Jan Park, Bahawalnagar

Operational Hours		12			
No. of Taps		9			
Effluent Test (If Available)		Not Available			
Latest water quality analysis carried out?		-			
If yes, which lab and parameters?		-			
Findings of water quality analysis?		-			
In case of any parameter above the permissible limit, which steps are taken to provide safe water?		-			
Plant Type		RO	UV		
Source of Water		Local Tube Well	Public Water Supply		
Working Status		Functional	Non-Functional		
Pumping Unit		Yes	No

Control Panel		Yes	No		
Service Cable		Yes	No		
Ultraviolet Lamp/Chlorinator		Yes	No		
Takeaway Hall Condition		Good	Fair	Poor	
Building Structure Condition		Good	Fair	Poor	
Approach to Pump House		Good	Fair	Poor	
Overall Rating					
Average Score	1	2	3	4	5
Asset Condition	Excellent	Good	Fair	Poor	Failing
Category	A	B	C	D	E
Remarks / Requirements					
<ul style="list-style-type: none"> No remarks 					
<i>Data Collected By: Mr. Abdullah</i>		<i>Designation: Team Member</i>

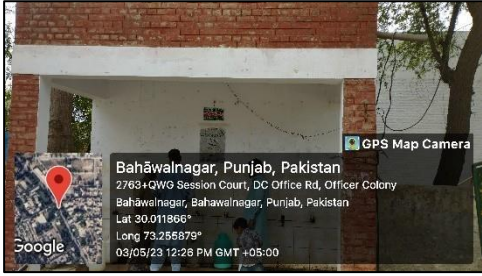
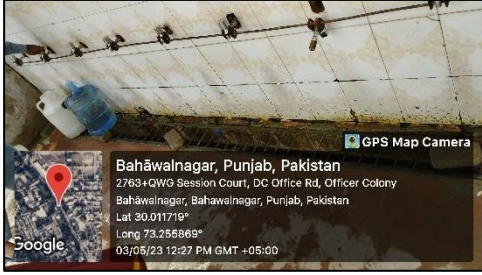
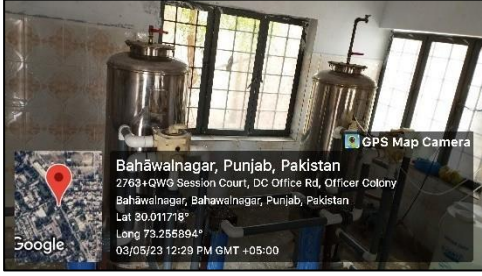
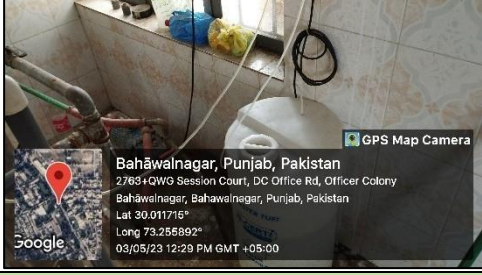
Integrated Development And Asset Management Plan (IDAMP)					
Municipal Committee Bahawalnagar					
Form: IDAMP-A4	Water Filtration Plant Asset Condition Assessment			Asset Code: _____ Date: 02-05-2023	
Name		Civil Club		Pictures	
Location	Latitude	30.011866

Longitude	73.255879			
Address		Civil Club, Bahawalnagar

Operational Hours		12			
No. of Taps		8			
Effluent Test (If Available)		Not Available			
Latest water quality analysis carried out?		-			
If yes, which lab and parameters?		-			
Findings of water quality analysis?		-			
In case of any parameter above the permissible limit, which steps are taken to provide safe water?		-			
Plant Type		RO	UV		
Source of Water		Local Tube Well	Public Water Supply		
Working Status		Functional	Non-Functional		
Pumping Unit		Yes	No

Control Panel		Yes	No		
Service Cable		Yes	No		
Ultraviolet Lamp/Chlorinator		Yes	No		
Takeaway Hall Condition		Good	Fair		
Building Structure Condition		Good	Fair	Poor	
Approach to Pump House		Good	Fair	Poor	
Overall Rating					
Average Score	1	2	3	4	5
Asset Condition	Excellent	Good	Fair	Poor	Failing
Category	A	B	C	D	E
Remarks / Requirements					
<ul style="list-style-type: none"> No remarks 					
<i>Data Collected By: Mr. Abdullah</i>		<i>Designation: Team Member</i>

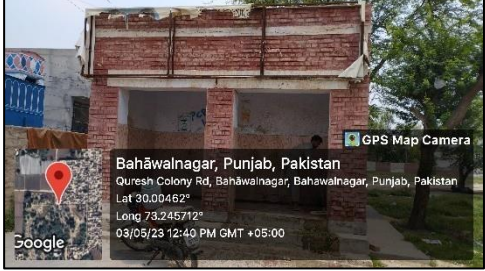
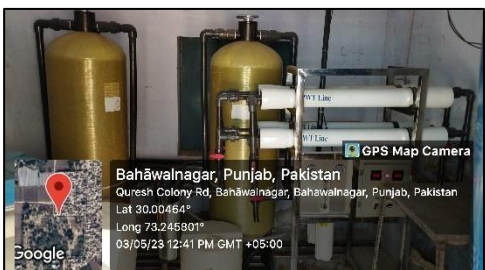
Integrated Development And Asset Management Plan (IDAMP)					
Municipal Committee Bahawalnagar					
Form: IDAMP-A4		Water Filtration Plant Asset Condition Assessment			Asset Code: _____
					Date: 02-05-2023
Name		Faisal Colony			Pictures
Location	Latitude	30.004620

Longitude	73.245712			
Address		Faisal Colony, Bahawalnagar			
Installation Year		2016			
Installing Agency		MC			
O&M Agency		MC			
Filtration Capacity (Liter/Hour)		2000			
Operational Hours		12			
No. of Taps		6			
Effluent Test (If Available)		Not Available			
Latest water quality analysis carried out?		-			
If yes, which lab and parameters?		-			
Findings of water quality analysis?		-			
In case of any parameter above the permissible limit, which steps are taken to provide safe water?		-			
Plant Type		RO	UV

Control Panel		Yes	No		
Service Cable		Yes	No		
Ultraviolet Lamp/Chlorinator		Yes	No		
Takeaway Hall Condition		Good	Fair	Poor	
Building Structure Condition		Good	Fair	Poor	
Approach to Pump House		Good	Fair	Poor	
Overall Rating					
Average Score	1	2	3	4	5
Asset Condition	Excellent	Good	Fair	Poor	Failing
Category	A	B	C	D	E
Remarks / Requirements					
<ul style="list-style-type: none"> No remarks 					
<i>Data Collected By: Mr. Abdullah</i>		<i>Designation: Team Member</i>

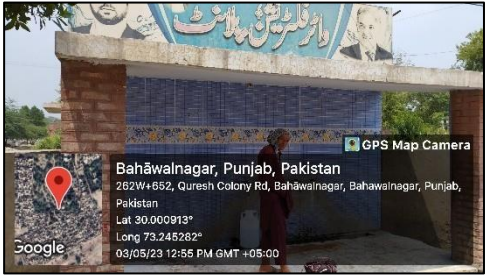
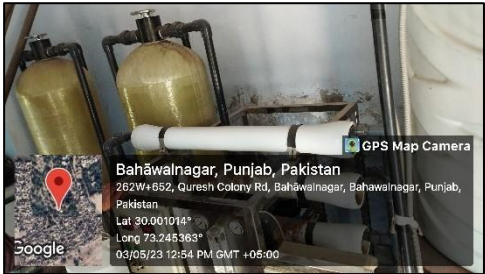
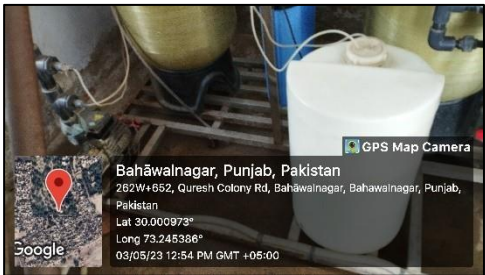
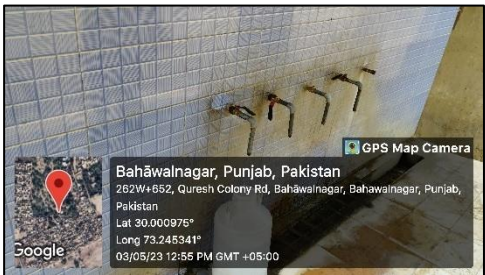
Integrated Development And Asset Management Plan (IDAMP)					
Municipal Committee Bahawalnagar					
Form: IDAMP-A4	Water Filtration Plant Asset Condition Assessment			Asset Code: _____ Date: 02-05-2023	
Name		Al-Quresh Colony		Pictures	
Location	Latitude	30.000913

Longitude	73.245282			
Address		Al-Quresh Colony, Bahawalnagar

Operational Hours		12			
No. of Taps		5			
Effluent Test (If Available)		Not Available			
Latest water quality analysis carried out?		-			
If yes, which lab and parameters?		-			
Findings of water quality analysis?		-			
In case of any parameter above the permissible limit, which steps are taken to provide safe water?		-			
Plant Type		RO	UV		
Source of Water		Local Tube Well	Public Water Supply		
Working Status		Functional	Non-Functional		
Pumping Unit		Yes	No

Control Panel		Yes	No		
Service Cable		Yes	No		
Ultraviolet Lamp/Chlorinator		Yes	No		
Takeaway Hall Condition		Good	Fair	Poor	
Building Structure Condition		Good	Fair	Poor	
Approach to Pump House		Good	Fair	Poor	
Overall Rating					
Average Score	1	2	3	4	5
Asset Condition	Excellent	Good	Fair	Poor	Failing
Category	A	B	C	D	E
Remarks / Requirements					
<ul style="list-style-type: none"> No remarks 					
<i>Data Collected By: Mr. Abdullah</i>		<i>Designation: Team Member</i>

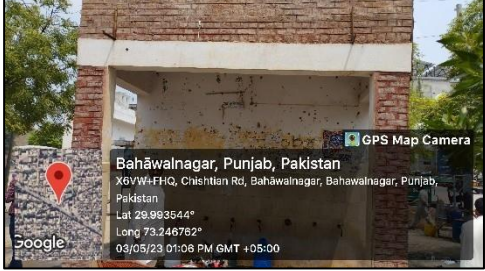
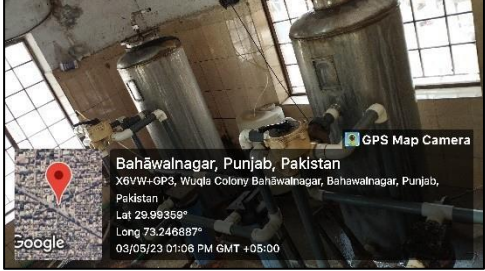
Integrated Development And Asset Management Plan (IDAMP)					
Municipal Committee Bahawalnagar					
Form: IDAMP-A4		Water Filtration Plant Asset Condition Assessment			Asset Code: _____
					Date: 02-05-2023
Name		Z.A Sayyed Filtration Plant			Pictures
Location	Latitude	29.993544

Longitude	73.246762			
Address		Z.A Sayyed Colony, Bahawalnagar			
Installation Year		2008			
Installing Agency		MC			
O&M Agency		MC			
Filtration Capacity (Liter/Hour)		2000			
Operational Hours		12			
No. of Taps		8			
Effluent Test (If Available)		Not Available			
Latest water quality analysis carried out?		-			
If yes, which lab and parameters?		-			
Findings of water quality analysis?		-			
In case of any parameter above the permissible limit, which steps are taken to provide safe water?		-			
Plant Type		RO	UV

Control Panel		Yes	No		
Service Cable		Yes	No		
Ultraviolet Lamp/Chlorinator		Yes	No		
Takeaway Hall Condition		Good	Fair	Poor	
Building Structure Condition		Good	Fair	Poor	
Approach to Pump House		Good	Fair	Poor	
Overall Rating					
Average Score	1	2	3	4	5
Asset Condition	Excellent	Good	Fair	Poor	Failing
Category	A	B	C	D	E
Remarks / Requirements					
<ul style="list-style-type: none"> No remarks 					
<i>Data Collected By: Mr. Abdullah</i>		<i>Designation: Team Member</i>

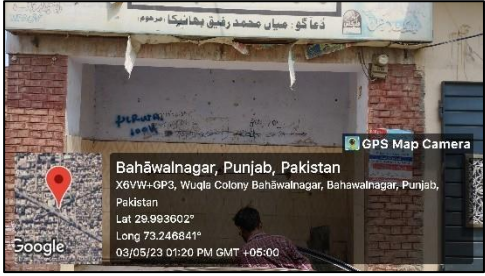
Integrated Development And Asset Management Plan (IDAMP)					
Municipal Committee Bahawalnagar					
Form: IDAMP-A4		Water Filtration Plant Asset Condition Assessment			Asset Code: _____
					Date: 02-05-2023
Name		Nizam Pura Filtration Plant			Pictures
Location	Latitude	29.993602

Longitude	73.246841			
Address		Nizam Pura, Bahawalnagar			
Installation Year		2016			
Installing Agency		MC			
O&M Agency		MC			
Filtration Capacity (Liter/Hour)		2000			
Operational Hours		12			
No. of Taps		6			
Effluent Test (If Available)		Not Available			
Latest water quality analysis carried out?		-			
If yes, which lab and parameters?		-			
Findings of water quality analysis?		-			
In case of any parameter above the permissible limit, which steps are taken to provide safe water?		-			
Plant Type		RO	UV		
Source of Water		Local Tube Well	Public Water Supply		
Working Status		Functional	Non-Functional		
Pumping Unit		Yes	No

Control Panel		Yes	No		
Service Cable		Yes	No		
Ultraviolet Lamp/Chlorinator		Yes	No		
Takeaway Hall Condition		Good	Fair	Poor	
Building Structure Condition		Good	Fair	Poor	
Approach to Pump House		Good	Fair	Poor	
Overall Rating					
Average Score	1	2	3	4	5
Asset Condition	Excellent	Good	Fair	Poor	Failing
Category	A	B	C	D	E
Remarks / Requirements					
<ul style="list-style-type: none"> No remarks 					
<i>Data Collected By: Mr. Abdullah</i>		<i>Designation: Team Member</i>

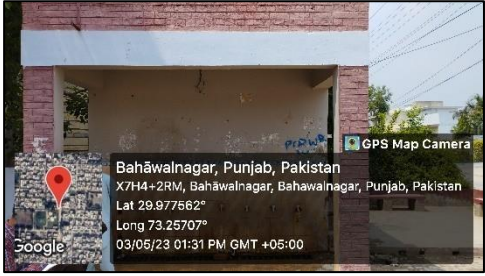
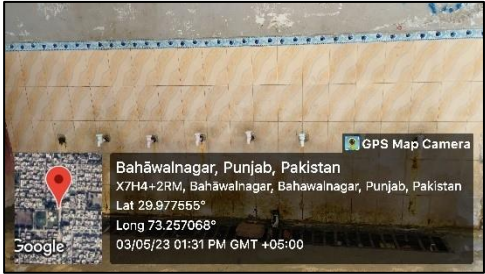
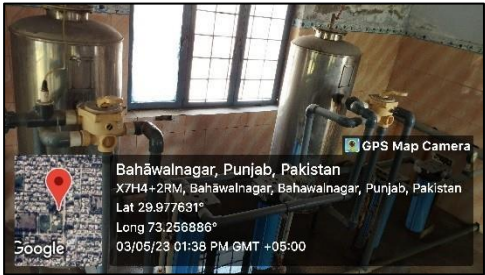
Integrated Development And Asset Management Plan (IDAMP)						
Municipal Committee Bahawalnagar						
Form: IDAMP-A4	Water Filtration Plant Asset Condition Assessment			Asset Code: _____ Date: 02-05-2023		
Name		Model Town		Pictures		
Location	Latitude	29.977562

Longitude	73.257070				
Address		Model Town, Bahawalnagar

Installation Year		2008				
Installing Agency		MC				
O&M Agency		MC				
Filtration Capacity (Liter/Hour)		2000				
Operational Hours		12				
No. of Taps		8				
Effluent Test (If Available)		Not Available				
Latest water quality analysis carried out?		-				
If yes, which lab and parameters?		-				
Findings of water quality analysis?		-				
In case of any parameter above the permissible limit, which steps are taken to provide safe water?		-

Plant Type		RO	UV			
Source of Water		Local Tube Well	Public Water Supply			
Working Status		Functional	Non-Functional			
Pumping Unit		Yes	No

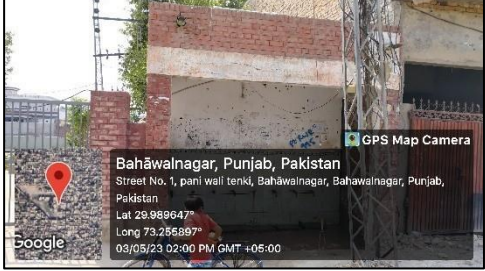
Integrated Development And Asset Management Plan (IDAMP)					
Municipal Committee Bahawalnagar					
Form: IDAMP-A4		Water Filtration Plant Asset Condition Assessment			Asset Code: _____
					Date: 02-05-2023
Name		Shahzad Nagar			Pictures
Location	Latitude	29.989647

Longitude	73.255897			
Address		Shahzad Nagar, Bahawalnagar			
Installation Year		2005			
Installing Agency		MC			
O&M Agency		MC			
Filtration Capacity (Liter/Hour)		2000			
Operational Hours		12			
No. of Taps		8			
Effluent Test (If Available)		Not Available			
Latest water quality analysis carried out?		-			
If yes, which lab and parameters?		-			
Findings of water quality analysis?		-			
In case of any parameter above the permissible limit, which steps are taken to provide safe water?		-			
Plant Type		RO	UV		
Source of Water		Local Tube Well	Public Water Supply		
Working Status		Functional	Non-Functional		
Pumping Unit		Yes	No		
Control Panel		Yes	No

Service Cable		Yes	No		
Ultraviolet Lamp/Chlorinator		Yes	No		
Takeaway Hall Condition		Good	Fair	Poor	
Building Structure Condition		Good	Fair	Poor	
Approach to Pump House		Good	Fair	Poor	
Overall Rating					
Average Score	1	2	3	4	5
Asset Condition	Excellent	Good	Fair	Poor	Failing
Category	A	B	C	D	E
Remarks / Requirements					
<ul style="list-style-type: none"> No remarks 					
<i>Data Collected By: Mr. Abdullah</i>		<i>Designation: Team Member</i>

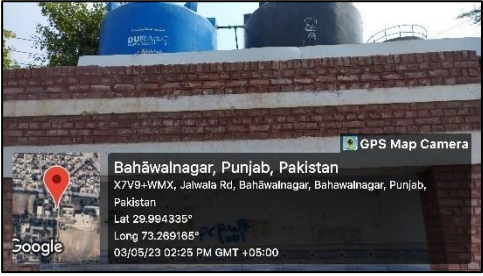
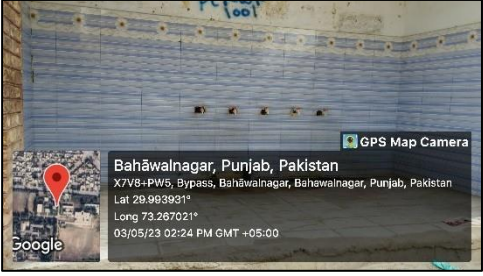
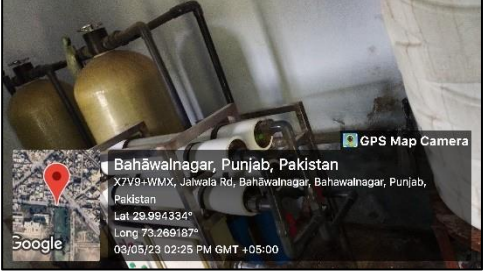
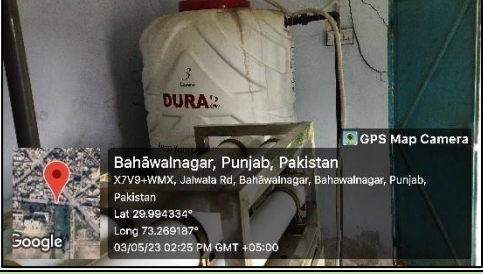
Integrated Development And Asset Management Plan (IDAMP)					
Municipal Committee Bahawalnagar					
Form: IDAMP-A4	Water Filtration Plant Asset Condition Assessment			Asset Code: _____	Date: 02-05-2023
Name		Hussainabad		Pictures	
Location	Latitude	29.994335

Longitude	73.269165			
Address		Hussainabad, Bahawalnagar

Operational Hours		12			
No. of Taps		5			
Effluent Test (If Available)		Not Available			
Latest water quality analysis carried out?		-			
If yes, which lab and parameters?		-			
Findings of water quality analysis?		-			
In case of any parameter above the permissible limit, which steps are taken to provide safe water?		-			
Plant Type		RO	UV		
Source of Water		Local Tube Well	Public Water Supply		
Working Status		Functional	Non-Functional		
Pumping Unit		Yes	No

Control Panel		Yes	No		
Service Cable		Yes	No		
Ultraviolet Lamp/Chlorinator		Yes	No		
Takeaway Hall Condition		Good	Fair	Poor	
Building Structure Condition		Good	Fair	Poor	
Approach to Pump House		Good	Fair	Poor	
Overall Rating					
Average Score	1	2	3	4	5
Asset Condition	Excellent	Good	Fair	Poor	Failing
Category	A	B	C	D	E
Remarks / Requirements					
<ul style="list-style-type: none"> Temporary Non-Functional.

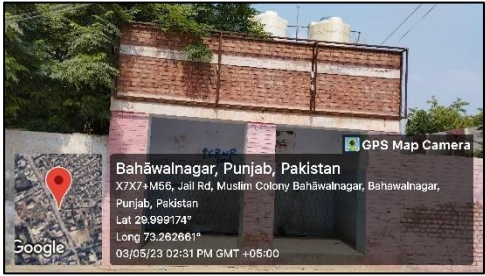
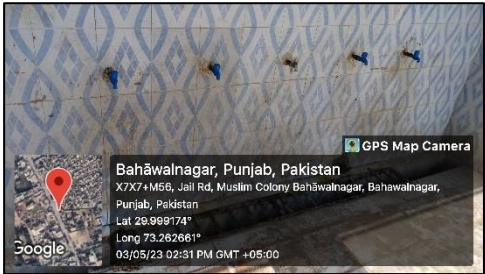
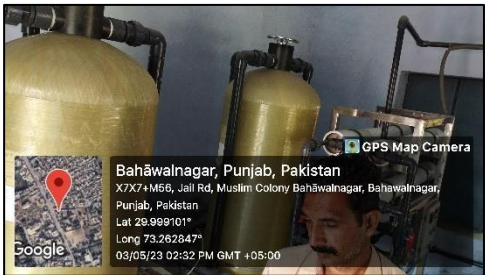
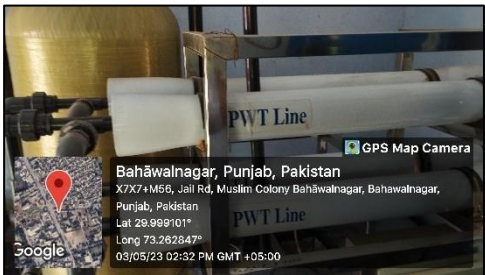
Integrated Development And Asset Management Plan (IDAMP)					
Municipal Committee Bahawalnagar					
Form: IDAMP-A4	Water Filtration Plant Asset Condition Assessment			Asset Code: _____ Date: 02-05-2023	
Name		Muslim Colony		Pictures	
Location	Latitude	29.999174

Longitude	73.262661			
Address		Muslim Colony, Bahawalnagar

Operational Hours		12			
No. of Taps		5

Effluent Test (If Available)		Not Available			
Latest water quality analysis carried out?		-

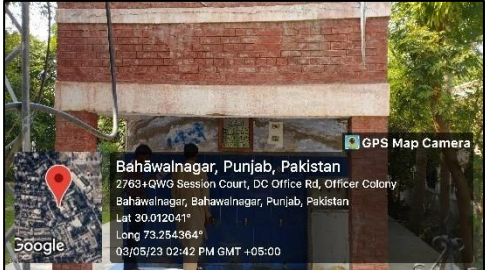
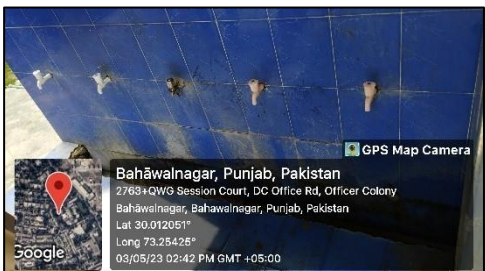
Integrated Development And Asset Management Plan (IDAMP)						
Municipal Committee Bahawalnagar						
Form: IDAMP-A4	Water Filtration Plant Asset Condition Assessment			Asset Code: _____ Date: 02-05-2023		
Name		Civil Court Filtration Plant		Pictures		
Location	Latitude	30.012041

Longitude	73.254364				
Address		Civil Court, Bahawalnagar				
Installation Year		2015				
Installing Agency		Session Court				
O&M Agency		MC				
Filtration Capacity (Liter/Hour)		2000				
Operational Hours		12				
No. of Taps		6				
Effluent Test (If Available)		Not Available				
Latest water quality analysis carried out?		-				
If yes, which lab and parameters?		-				
Findings of water quality analysis?		-				
In case of any parameter above the permissible limit, which steps are taken to provide safe water?		-				
Plant Type		RO	UV

Pumping Unit		Yes	No			
Control Panel		Yes	No			
Service Cable		Yes	No			
Ultraviolet Lamp/Chlorinator		Yes	No			
Takeaway Hall Condition		Good	Fair			Poor
Building Structure Condition		Good	Fair			Poor
Approach to Pump House		Good	Fair			Poor
Overall Rating						
Average Score	1	2	3	4	5	
Asset Condition	Excellent	Good	Fair	Poor	Failing	
Category	A	B	C	D	E	
Remarks / Requirements						
<ul style="list-style-type: none"> No remarks 						
<i>Data Collected By: Mr. Abdullah</i>		<i>Designation: Team Member</i>

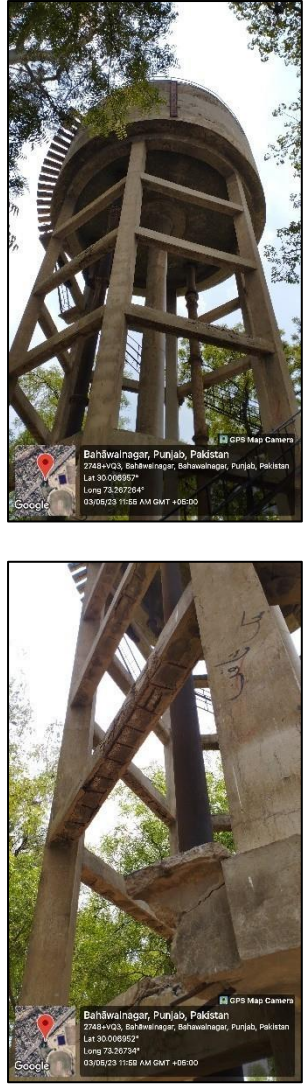
Integrated Development And Asset Management Plan (IDAMP)					
Municipal Committee Bahawalnagar					
Form: IDAMP-A2		Over Head Reservoir Asset Condition Assessment			Asset Code: _____
					Date: 02-05-2023
Name		Khadamabad Tanki			Pictures
Location	Latitude	30.006957

Longitude	73.267264			
Address		Khadamabad, Bahawalnagar			
Year of Construction		1983			
Capacity (UK Gallons)		50,000			
Cleaning Frequency (Per Year)		1			
Type of Structure		Frame, RCC			
Structure Condition		Good	Fair	Poor	
Tank Conditions		Good	Fair	Poor	
Number of Valves	Sluice Valve				
	Non-Returning Valve				
Working Status		Abandoned			
Rising Main	Dia				
	Material				
Delivery Main	Dia				
	Material				
Overflow & Scour Pipe	Dia				
	Material				
Sluice Valve	Rising Main	Yes	No		
	Delivery Main	Yes	No		
	Scour Pipe	Yes	No		
	Overflow Pipe	Yes	No		
Stair Case		Yes	No		
Apron Around OHR		Yes	No		
Tank Top Railing		Yes	No		
Top Indication Light		Yes	No

Lightening Arrester		Yes	No		
Boundary Wall & Gate		Yes	No		
Overflow Disposal Arrangements		Yes	No		
Approach to OHR		Good	Fair	Bad	
Overall Rating					
Average Score	1	2	3	4	5
Asset Condition	Excellent	Good	Fair	Poor	Failing
Category	A	B	C	D	E
Remarks / Requirements					
<ul style="list-style-type: none"> No remarks 					
<i>Data Collected By: Mr. Abdullah</i>		<i>Designation: Team Member</i>

Sr #	Name	Age (Years)	Capacity (Gallons)	Condition	Status	Book Value (PKR Mil)
1	Kadamabad Tanki	40	50,000	Failing	Abandoned	0
2	Al-Quresh Colony New	16	100,000	Poor	Non-Functional	1.8
3	Al-Quresh Colony Old	58	50,000	Failing	Abandoned	0
4	Model Town New	16	100,000	Poor	Non-Functional	1.8
5	Model Town Old	58	50,000	Failing	Abandoned	0
6	Shehzad Nagar	20	50,000	Good	Functional	0.9
7	Main Water Works	56	100,000	Fair	Functional	0
8	City Tanki	Not Available	50,000	Failing	Abandoned	0

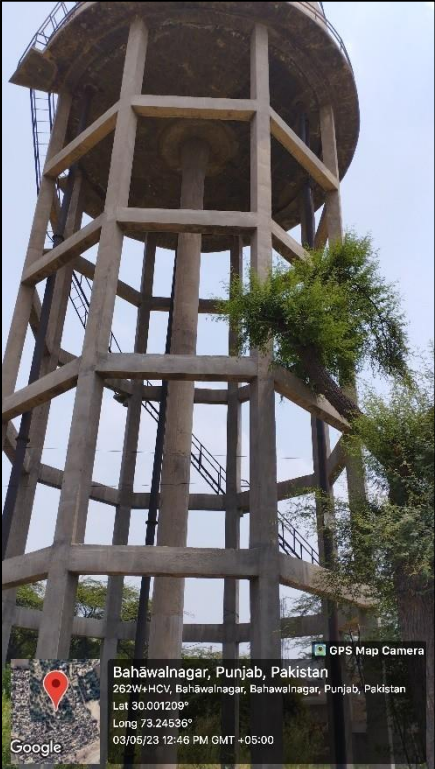
Integrated Development And Asset Management Plan (IDAMP)					
Municipal Committee Bahawalnagar					
Form: IDAMP-A2		Over Head Reservoir Asset Condition Assessment			Asset Code: _____ Date: 02-05-2023
Name		Al Quresh Colony New			Pictures
Location	Latitude	30.001209

Longitude	73.245360			
Address		Al Quresh Colony, Bahawalnagar			
Year of Construction		2007			
Capacity (UK Gallons)		100,000			
Cleaning Frequency (Per Year)		1			
Type of Structure		Frame, RCC			
Structure Condition		Good	Fair	Poor	
Tank Conditions		Good	Fair	Poor	
Number of Valves	Sluice Valve	4			
	Non-Returning Valve	1			
Working Status		Functional	Non-Functional		
Rising Main	Dia	8"			
	Material	MS			
Delivery Main	Dia	6"			
	Material	MS			
Overflow & Scour Pipe	Dia	6"			
	Material	MS			
Sluice Valve	Rising Main	Yes	No		
	Delivery Main	Yes	No		
	Scour Pipe	Yes	No		
	Overflow Pipe	Yes	No		
Stair Case		Yes	No		
Apron Around OHR		Yes	No		
Tank Top Railing		Yes	No

Top Indication Light		Yes	No		
Lightening Arrester		Yes	No		
Boundary Wall & Gate		Yes	No		
Overflow Disposal Arrangements		Yes	No		
Approach to OHR		Good	Fair	Bad	
Overall Rating					
Average Score	1	2	3	4	5
Asset Condition	Excellent	Good	Fair	Poor	Failing
Category	A	B	C	D	E
Remarks / Requirements					
<ul style="list-style-type: none"> Leakage 					
<i>Data Collected By: Mr. Abdullah</i>		<i>Designation: Team Member</i>

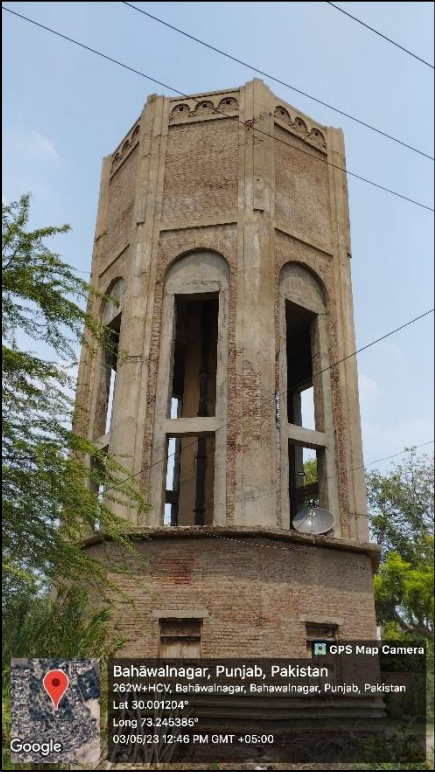
Sign & Date: 30 May 2023	
Integrated Development And Asset Management Plan (IDAMP)						
Municipal Committee Bahawalnagar						
Form: IDAMP-A2		Over Head Reservoir Asset Condition Assessment			Asset Code: _____ Date: 02-05-2023	
Name		Al Quresh Colony Old			Pictures	
Location	Latitude	30.001204

Longitude	73.245385				
Address		Al Quresh Colony, Bahawalnagar				
Year of Construction		1965				
Capacity (UK Gallons)						
Cleaning Frequency (Per Year)						
Type of Structure		Brick Masonry				
Structure Condition		Good	Fair	Poor		
Tank Conditions		Good	Fair	Poor		
Number of Valves	Sluice Valve					
	Non-Returning Valve					
Working Status		Abandoned				
Rising Main	Dia					
	Material					
Delivery Main	Dia					
	Material					
Overflow & Scour Pipe	Dia					
	Material					
Sluice Valve	Rising Main	Yes	No			
	Delivery Main	Yes	No			
	Scour Pipe	Yes	No

Overflow Pipe	Yes	No			
Stair Case		Yes	No			
Apron Around OHR		Yes	No			
Tank Top Railing		Yes	No			
Top Indication Light		Yes	No			
Lightening Arrester		Yes	No			
Boundary Wall & Gate		Yes	No			
Overflow Disposal Arrangements		Yes	No			
Approach to OHR		Good	Fair	Bad		
Overall Rating						
Average Score	1	2	3	4	5	
Asset Condition	Excellent	Good	Fair	Poor	Failing	
Category	A	B	C	D	E	
Remarks / Requirements						
<ul style="list-style-type: none"> No remarks

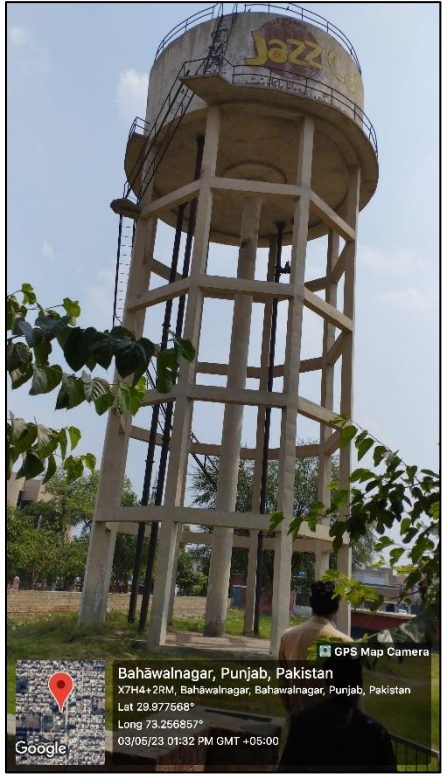
Sign & Date: 30 May 2023											
Integrated Development And Asset Management Plan (IDAMP)													
Municipal Committee Bahawalnagar													
Form: IDAMP-A2	Over Head Reservoir Asset Condition Assessment	Asset Code: _____ Date: 02-05-2023											
Name	Model Town New	Pictures											
Location	<table border="1" style="width: 100%; border-collapse: collapse;"> <tr> <td style="width: 30%; padding: 2px;">Latitude</td> <td style="padding: 2px;">29.977568</td> </tr> <tr> <td style="padding: 2px;">Longitude</td> <td style="padding: 2px;">73.256857</td> </tr> </table>	Latitude	29.977568	Longitude	73.256857

Latitude	29.977568												
Longitude	73.256857												
Address	Model Town, Bahawalnagar												
Year of Construction	2007

Capacity (UK Gallons)	100,000												
Cleaning Frequency (Per Year)	1												
Type of Structure	Frame, RCC												
Structure Condition	<table border="1" style="width: 100%; border-collapse: collapse;"> <tr> <td style="width: 33%; background-color: #d9ead3;">Good</td> <td style="width: 33%;">Fair</td> <td style="width: 33%;">Poor</td> </tr> </table>	Good	Fair	Poor									
Good	Fair	Poor											
Tank Conditions	<table border="1" style="width: 100%; border-collapse: collapse;"> <tr> <td style="width: 33%;">Good</td> <td style="width: 33%;">Fair</td> <td style="width: 33%; background-color: #d9ead3;">Poor</td> </tr> </table>	Good	Fair	Poor									
Good	Fair	Poor											
Number of Valves	<table border="1" style="width: 100%; border-collapse: collapse;"> <tr> <td style="width: 30%; padding: 2px;">Sluice Valve</td> <td style="padding: 2px;">4</td> </tr> <tr> <td style="padding: 2px;">Non-Returning Valve</td> <td style="padding: 2px;">1</td> </tr> </table>	Sluice Valve	4	Non-Returning Valve	1

Category	A	B	C	D	E	
Remarks / Requirements						
<ul style="list-style-type: none"> Leakage 						
Data Collected By: Mr. Abdullah		Designation: Team Member

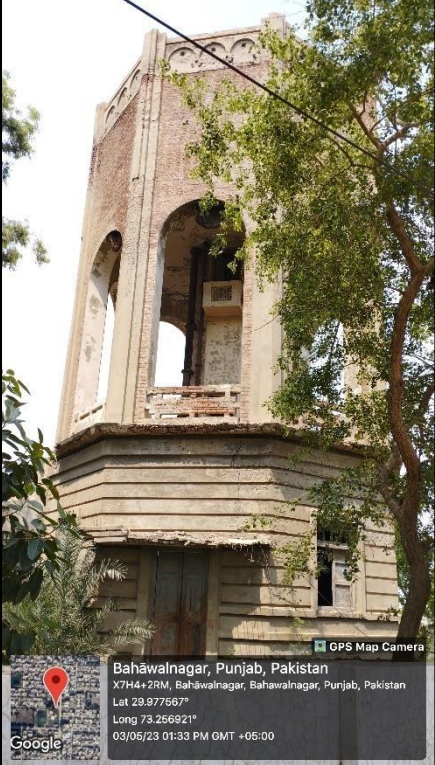
Sign & Date: 30 May 2023		
Integrated Development And Asset Management Plan (IDAMP)						
Municipal Committee Bahawalnagar						
Form: IDAMP-A2		Over Head Reservoir Asset Condition Assessment		Asset Code: _____ Date: 02-05-2023		
Name			Model Town Old		Pictures	
Location	Latitude		29.977567

Longitude		73.256921			
Address			Model Town, Bahawalnagar			
Year of Construction			1965			
Capacity (UK Gallons)						
Cleaning Frequency (Per Year)						
Type of Structure			Brick Masonry			
Structure Condition			Good	Fair		Poor
Tank Conditions			Good	Fair		Poor
Number of Valves	Sluice Valve					
	Non-Returning Valve					
Working Status			Abandoned			
Rising Main	Dia

Material					
Delivery Main	Dia					
	Material					
Overflow & Scour Pipe	Dia					
	Material					
Sluice Valve	Rising Main		Yes	No		
	Delivery Main		Yes	No		
	Scour Pipe		Yes	No		
	Overflow Pipe		Yes	No		
Stair Case			Yes	No		
Apron Around OHR			Yes	No		
Tank Top Railing			Yes	No		
Top Indication Light			Yes	No		
Lightening Arrester			Yes	No		
Boundary Wall & Gate			Yes	No		
Overflow Disposal Arrangements			Yes	No		
Approach to OHR			Good	Fair	Bad	
Overall Rating

Average Score	1	2	3	4	5
Asset Condition	Excellent	Good	Fair	Poor	Failing
Category	A	B	C	D	E
Remarks / Requirements					
<ul style="list-style-type: none"> No remarks 					
Data Collected By: Mr. Abdullah		Designation: Team Member

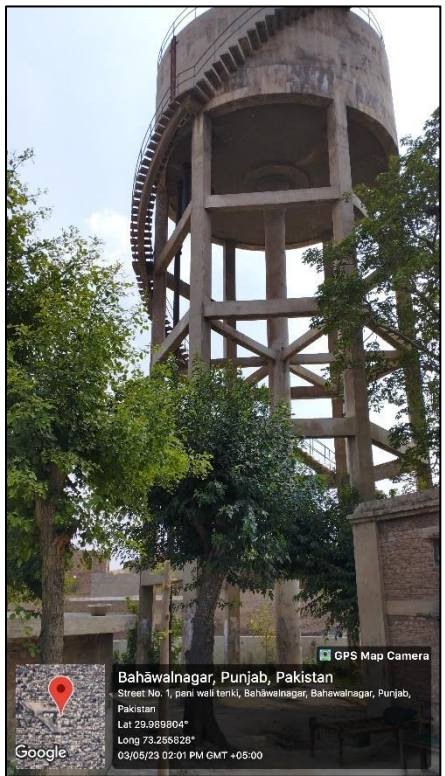
Integrated Development And Asset Management Plan (IDAMP)						
Municipal Committee Bahawalnagar						
Form: IDAMP-A2		Over Head Reservoir Asset Condition Assessment		Asset Code: _____ Date: 02-05-2023		
Name			Shehzad Nagar		Pictures	
Location	Latitude		29.989804

Longitude		73.255828			
Address			Shehzad Nagar, Bahawalnagar			
Year of Construction			2003			
Capacity (UK Gallons)			50,000			
Cleaning Frequency (Per Year)			1			
Type of Structure			Frame, RCC			
Structure Condition			Good	Fair		Poor
Tank Conditions			Good	Fair		Poor
Number of Valves	Sluice Valve		4			
	Non-Returning Valve		1			
Working Status			Functional	Non-Functional		
Rising Main	Dia		12"			
	Material		MS			
Delivery Main	Dia		8"			
	Material		MS			
Overflow & Scour Pipe	Dia		8"			
	Material		MS			
Sluice Valve	Rising Main		Yes	No		
	Delivery Main		Yes	No		
	Scour Pipe		Yes	No		
	Overflow Pipe		Yes	No		
Stair Case			Yes	No		
Apron Around OHR			Yes	No

Tank Top Railing			Yes	No		
Top Indication Light			Yes	No

Lightening Arrester	Yes	No			
Boundary Wall & Gate	Yes	No			
Overflow Disposal Arrangements	Yes	No			
Approach to OHR	Good	Fair	Bad		
Overall Rating					
Average Score	1	2	3	4	5
Asset Condition	Excellent	Good	Fair	Poor	Failing
Category	A	B	C	D	E
Remarks / Requirements					
<ul style="list-style-type: none"> No remarks 					
<i>Data Collected By: Mr. Abdullah</i>		<i>Designation: Team Member</i>

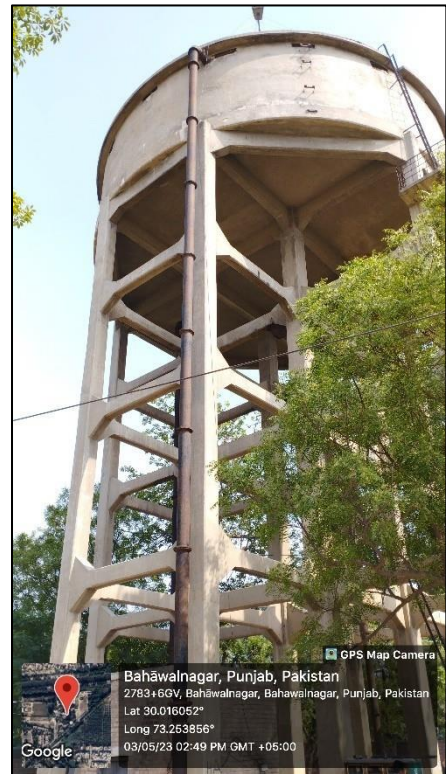
Integrated Development And Asset Management Plan (IDAMP)					
Municipal Committee Bahawalnagar					
Form: IDAMP-A2		Over Head Reservoir Asset Condition Assessment			Asset Code: _____
					Date: 02-05-2023
Name		Main Water Works Ford Wah			Pictures
Location	Latitude	30.016052			
	Longitude	73.253856			
Address		Ford Wah Canal, Bahawalnagar			
Year of Construction		1967			
Capacity (UK Gallons)		100,000			
Cleaning Frequency (Per Year)		1			
Type of Structure		Frame, RCC			
Structure Condition		Good	Fair	Poor	
Tank Conditions		Good	Fair	Poor	
Number of Valves	Sluice Valve	4			
	Non-Returning Valve	1			
Working Status		Functional	Non-Functional		
Rising Main	Dia	12"			
	Material	MS			
Delivery Main	Dia	8"			
	Material	MS			
Overflow & Scour Pipe	Dia	8"			
	Material	MS			
Sluice Valve	Rising Main	Yes	No		
	Delivery Main	Yes	No		
	Scour Pipe	Yes	No		
	Overflow Pipe	Yes	No		
Stair Case		Yes	No		
Apron Around OHR		Yes	No

Tank Top Railing		Yes	No		
Top Indication Light		Yes	No		
Lightening Arrester		Yes	No		
Boundary Wall & Gate		Yes	No		
Overflow Disposal Arrangements		Yes	No		
Approach to OHR		Good	Fair	Bad	
Overall Rating					
Average Score	1	2	3	4	5
Asset Condition	Excellent	Good	Fair	Poor	Failing
Category	A	B	C	D	E
Remarks / Requirements					
<ul style="list-style-type: none"> No remarks 					
<i>Data Collected By: Mr. Abdullah</i>		<i>Designation: Team Member</i>

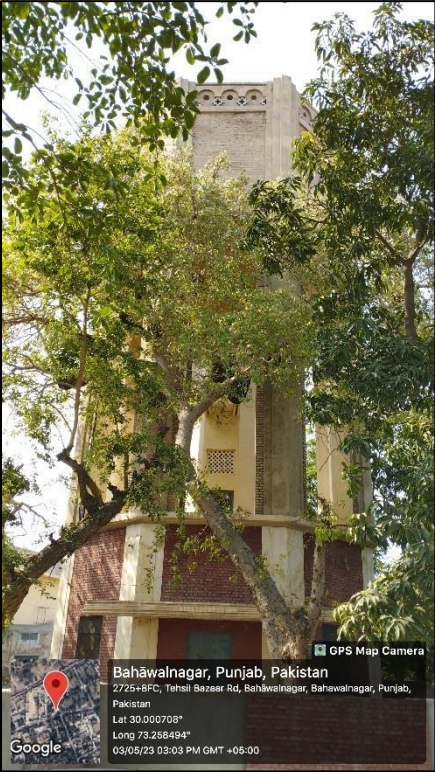
Integrated Development And Asset Management Plan (IDAMP)					
Municipal Committee Bahawalnagar					
Form: IDAMP-A2		Over Head Reservoir Asset Condition Assessment			Asset Code: _____
					Date: 02-05-2023
Name		City Water Tanki			Pictures
Location	Latitude	30.000708

Longitude	73.258494			
Address					
Year of Construction					
Capacity (UK Gallons)					
Cleaning Frequency (Per Year)					
Type of Structure		Masonry			
Structure Condition		Good	Fair	Poor	
Tank Conditions		Good	Fair	Poor	
Number of Valves	Sluice Valve				
	Non-Returning Valve				
Working Status		Abandoned			
Rising Main	Dia				
	Material				
Delivery Main	Dia				
	Material				
Overflow & Scour Pipe	Dia				
	Material				
Sluice Valve	Rising Main	Yes	No		
	Delivery Main	Yes	No		
	Scour Pipe	Yes	No		
	Overflow Pipe	Yes	No		
Stair Case		Yes	No		
Apron Around OHR		Yes	No		
Tank Top Railing		Yes	No		
Top Indication Light		Yes	No		
Lightening Arrester		Yes	No

Boundary Wall & Gate		Yes	No		
Overflow Disposal Arrangements		Yes	No		
Approach to OHR		Good	Fair	Bad	
Overall Rating					
Average Score	1	2	3	4	5
Asset Condition	Excellent	Good	Fair	Poor	Failing
Category	A	B	C	D	E
Remarks / Requirements					
<ul style="list-style-type: none"> No remarks 					
<i>Data Collected By: Mr. Abdullah</i>		<i>Designation: Team Member</i>

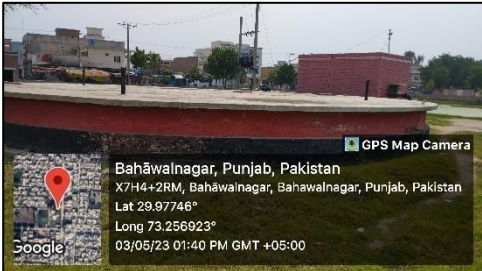
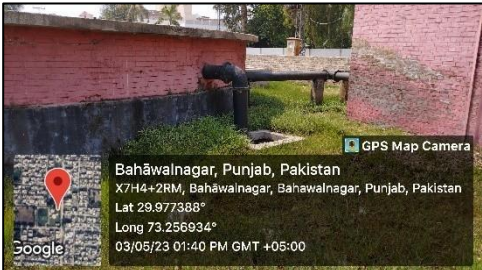
Integrated Development and Asset Management Plan (IDAMP)					
Municipal Committee Bahawalnagar					
Form: IDAMP-A3		Ground Storage Reservoir Asset Condition Assessment		Asset Code: _____ Date: 02-05-2023	
Name		Model Town 1		Pictures	
Location	Latitude	29.977460

Longitude	73.256923			
Address		Model Town, Bahawalnagar			
Year of Construction		2000			
Capacity (UK Gallons)		100,000			
Cleaning Frequency (Per Year)		1			
Type of Structure		Masonry			
Structure Condition		Good	Fair	Bad	
Number of Valves	Sluice Valve	4			
	Non-Returning Valve	1			
Working Status		Functional	Non-Functional

Incoming Main	Dia	8"			
	Material	MS			
Delivery Main	Dia	8"			
	Material	MS			
Cover Slab Condition		Good	Fair	Poor	
Approach Road Condition		Good	Fair	Poor	
Boundary Wall & Gate		Yes	No		
Overall Rating					
Average Score	1	2	3	4	5
Asset Condition	Excellent	Good	Fair	Poor	Failing
Category	A	B	C	D	E
Remarks / Requirements

Sr #	Name	Age (Years)	Capacity (Gallons)	Condition	Status	Book Value (PKR Mil)
1	Al-Quresh colony	16	100,000	Good	Functional	1.6
2	Model Town	23	100,000	Fair	Functional	1
3	Model Town	10	100,000	Good	Functional	2.1
4	Shahzad Nagar	16	100,000	Good	Functional	1.4
5	Degree College	16	100,000	Fair	Functional	1.5

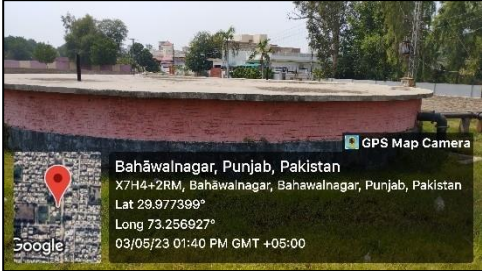
Integrated Development and Asset Management Plan (IDAMP)						
Municipal Committee Bahawalnagar						
Form: IDAMP-A3		Ground Storage Reservoir Asset Condition Assessment			Asset Code: _____	
					Date: 02-05-2023	
Name		Model Town 2		Pictures		
Location	Latitude	29.977460

Longitude	73.256923				
Address		Model Town, Bahawalnagar				
Year of Construction		2013				
Capacity (UK Gallons)		100,000				
Cleaning Frequency (Per Year)		1				
Type of Structure		Masonry				
Structure Condition		Good	Fair			Bad
Number of Valves	Sluice Valve+Air Valve	4+1				
	Non-Returning Valve	1				
Working Status		Functional	Non-Functional			
Incoming Main	Dia	10"				
	Material	MS				
Delivery Main	Dia	8"				
	Material	MS				
Cover Slab Condition		Good	Fair	Poor		
Approach Road Condition		Good	Fair	Poor		
Boundary Wall & Gate		Yes	No			
Overall Rating						
Average Score	1	2	3	4	5	
Asset Condition	Excellent	Good	Fair	Poor	Failing

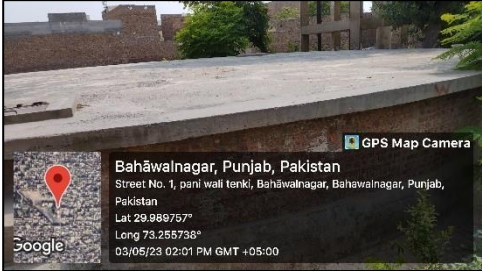
Integrated Development and Asset Management Plan (IDAMP)						
Municipal Committee Bahawalnagar						
Form: IDAMP-A3		Ground Storage Reservoir Asset Condition Assessment			Asset Code: _____ Date: 02-05-2023	
Name		Shahzad Nagar			Pictures	
Location	Latitude	29.989757

Longitude	73.255738				
Address		Shahzad Nagar, Bahawalnagar				
Year of Construction		2007				
Capacity (UK Gallons)		100,000				
Cleaning Frequency (Per Year)		1				
Type of Structure		Masonry				
Structure Condition		Good	Fair	Bad		
Number of Valves	Sluice Valve	4				
	Non-Returning Valve	1				
Working Status		Functional	Non-Functional			
Incoming Main	Dia	12"				
	Material	MS				
Delivery Main	Dia	8"				
	Material	MS				
Cover Slab Condition		Good	Fair	Poor		
Approach Road Condition		Good	Fair	Poor		
Boundary Wall & Gate		Yes	No			
Overall Rating						
Average Score	1	2	3	4	5	
Asset Condition	Excellent	Good	Fair	Poor	Failing	
Category	A	B	C	D	E

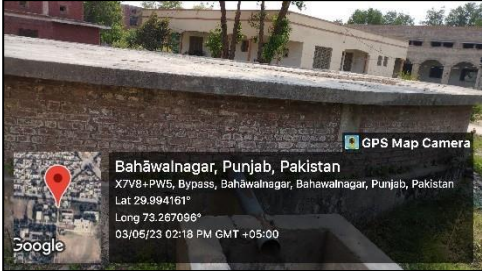
Integrated Development and Asset Management Plan (IDAMP)						
Municipal Committee Bahawalnagar						
Form: IDAMP-A3		Ground Storage Reservoir Asset Condition Assessment		Asset Code: _____ Date: 02-05-2023		
Name		Degree College		Pictures		
Location	Latitude	29.994161

Longitude	73.267096				
Address		Degree College, Bahawalnagar				
Year of Construction		2007				
Capacity (UK Gallons)		100,000				
Cleaning Frequency (Per Year)		1				
Type of Structure		Masonry				
Structure Condition		Good	Fair			Bad
Number of Valves	Sluice Valve	4				
	Non-Returning Valve	1				
Working Status		Functional	Non-Functional			
Incoming Main	Dia	10"				
	Material	MS				
Delivery Main	Dia	8"				
	Material	MS				
Cover Slab Condition		Good	Fair	Poor		
Approach Road Condition		Good	Fair	Poor		
Boundary Wall & Gate		Yes	No			
Overall Rating						
Average Score	1	2	3	4	5	
Asset Condition	Excellent	Good	Fair	Poor	Failing	
Category	A	B	C	D	E
