Punjab Municipal Development Fund Company

Hiring of Consulting Services for Preparation of Integrated Development and Asset Management Plan (IDAMP) for 16 selected MCs In Punjab under Punjab Cities Program (PCP)

**IDAMP – Municipal Committee Bahawalnagar
May 2024**

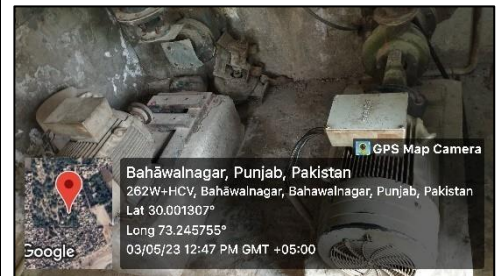
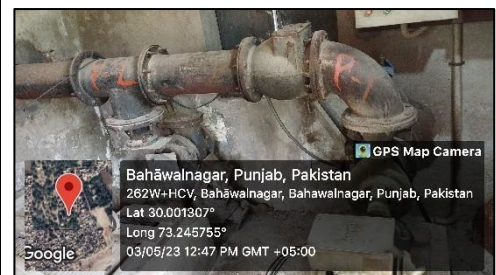
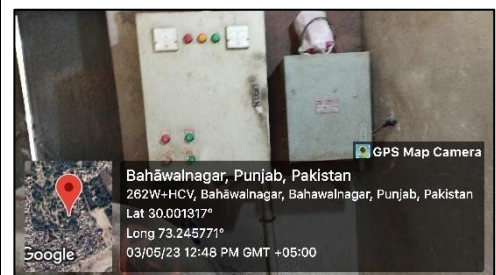
Integrated Development and Asset Management Plan (IDAMP)									
Municipal Committee Bahawalnagar									
Form: IDAMP-A1		Intermediate Pumping Station Asset Condition Assessment				Asset Code: _____ Date: 02-05-2023			
Asset Detail					Pictures				
Name		Al Quresh Colony							
Location	Latitude	30.001306							
	Longitude	73.245575							
Address		Al Quresh Colony, Bahawalnagar							
Area (Marla)		2							
Working Status		Functional			Non-Functional				
Construction Year of Water Works		2000							
Installation Year of Pump		2007			2007				
Capital Cost of Machinery									
Operational Hours		3			3				
Delivery Pipe	Dia	6"			6"				
	Material	MS			MS				
Apron Around Pump House		Yes			No				
Hoisting Girder		Yes			No				
Civil Structure Condition		Good		Fair		Poor			
Approach to Pump House		Good		Fair		Poor			
Pump Details									
		Pump A			Pump B				
Pump Type		Centrifugal			Centrifugal				
Pump Make		MECO			MECO

Discharge Capacity (Cusec)		2			2				
Rotational Speed (RPM)		1470			1470				
Head (ft.)		100			100				
Paint of Pumping Unit		Poor			Poor				
Number of Valves	Gate Valve	2			2				
	Non-Returning Valve	2			2

Integrated Development and Asset Management Plan (IDAMP)					
Municipal Committee Bahawalnagar					
Form: IDAMP-A1	Intermediate Pumping Station Asset Condition Assessment			Asset Code: _____ Date: 02-05-2023	
Base Plate	Yes	No	Yes	No	
Electro-Mechanical Equipment Details					
Transformer Capacity (kVA)	100				
Sanctioned Load (Kwh)	61				
Motor Power (HP)	50				50
Motor Make	Siemens		Siemens		
MCU	Yes				No
Earthing of Motor	Yes				No
Power Wiring	Yes				No
Service Cable	Yes				No
Earthing of MCU	Yes				No
Energy Meter	Yes				No
Water Meter	Yes				No
PFI Equipment	Yes				No
Generator	Yes				No
Change Over	Yes				No
Overall Rating					
Average Score	1	2	3	4	5
Asset Condition	Excellent	Good	Fair	Poor	Failing
Category	A	B	C	D	E
Remarks / Requirements					
<ul style="list-style-type: none"> No remarks 					
<i>Data Collected By: Mr. Abdullah</i>		<i>Designation: Team Member</i>

Sr. No.	Location	Total No. of pumps	Type	Capacity (cusecs)	Total capacity (cusecs)	Working hour per day	Age (Years)	Condition	Status
1	Al Quresh Colony	2	Centrifugal	3	6	3	23	Fair	Functional
2	Model Town 01	2	Centrifugal	1.5	3	3	16	Fair	Functional
3	Model Town 02	2 (1 Abandoned)	Centrifugal	2	4	3	10	Fair	Functional
4	Shahzad Nagar	4	Centrifugal	3	12	3	40	Fair	Functional
5	Degree College	2	Centrifugal	1.5	3	3	16	Fair	Functional

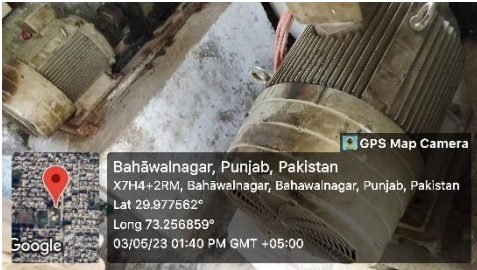
Integrated Development and Asset Management Plan (IDAMP)					
Municipal Committee Bahawalnagar					
Form: IDAMP-A1		Intermediate Pumping Station Asset Condition Assessment			Asset Code: _____
					Date: 02-05-2023
Asset Detail				Pictures	
Name		Model Town 01			
Location	Latitude	29.977460			
	Longitude	73.256923			
Address		Model Town, Bahawalnagar			
Area (Marla)		2			
Working Status		Functional	Non-Functional		
Construction Year of Water Works		2007			
Installation Year of Pump		2007	2007		
Capital Cost of Machinery					
Operational Hours		3	3		
Delivery Pipe	Dia	6"			
	Material	MS			
Apron Around Pump House		Yes	No		
Hoisting Girder		Yes	No		
Civil Structure Condition		Good	Fair	Poor	
Approach to Pump House		Good	Fair	Poor	
Pump Details					
		Pump A		Pump B	
Pump Type		Centrifugal		Centrifugal	
Pump Make		KSB		KSB	
Discharge Capacity (Cusec)		1.5		1.5	
Rotational Speed (RPM)		1470		1470	
Head (ft.)		100		100	
Paint of Pumping Unit		Fair		Fair

Number of Valves	Gate Valve	2		2	
	Non-Returning Valve	2		2	
Base Plate		Yes	No	Yes	No
Electro-Mechanical Equipment Details					
Transformer Capacity (kVA)		200 (Combined)			
Sanctioned Load (Kwh)		121			
Motor Power (HP)		40	40		
Motor Make		Siemens		Siemens	
MCU		Yes	No		
Earthing of Motor		Yes	No		
Power Wiring		Yes	No		
Service Cable		Yes	No		
Earthing of MCU		Yes	No		
Energy Meter		Yes	No		
Water Meter		Yes	No		
PFI Equipment		Yes	No		
Generator		Yes	No		
Change Over		Yes	No		
Overall Rating

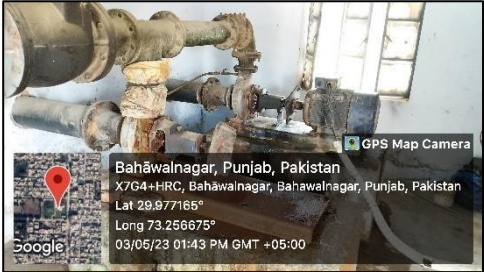
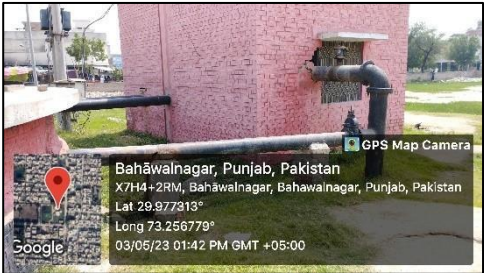
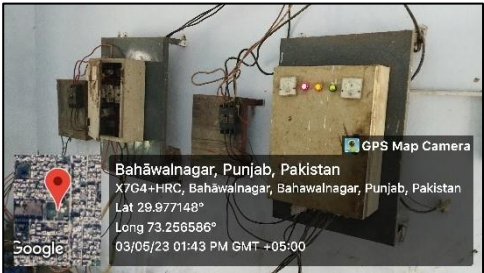
Integrated Development and Asset Management Plan (IDAMP)					
Municipal Committee Bahawalnagar					
Form: IDAMP-A1	Intermediate Pumping Station Asset Condition Assessment			Asset Code: _____ Date: 02-05-2023	
Asset Detail				Pictures	
Name		Model Town 02			
Location	Latitude	29.977460			
	Longitude	73.256923			
Address		Model Town, Bahawalnagar			
Area (Marla)		2			
Working Status		Functional	Non-Functional		
Construction Year of Water Works		2013			
Installation Year of Pump		2013	2013		
Capital Cost of Machinery					
Operational Hours		3	Abandoned		
Delivery Pipe	Dia	6"			
	Material	MS			
Apron Around Pump House		Yes	No		
Hoisting Girder		Yes	No		
Civil Structure Condition		Good	Fair	Poor	
Approach to Pump House		Good	Fair	Poor	
Pump Details					
		Pump A	Pump B		
Pump Type		Centrifugal			
Pump Make		MECO			
Discharge Capacity (Cusec)		2			
Rotational Speed (RPM)		1470			
Head (ft.)		100			
Paint of Pumping Unit		Fair

Number of Valves	Gate Valve	2			
	Non-Returning Valve	2			
Base Plate		Yes	No		
Electro-Mechanical Equipment Details					
Transformer Capacity (kVA)		200 (Combined)			
Sanctioned Load (Kwh)		121			
Motor Power (HP)		50	50		
Motor Make		Siemens	Siemens		
MCU		Yes	No		
Earthing of Motor		Yes	No		
Power Wiring		Yes	No		
Service Cable		Yes	No		
Earthing of MCU		Yes	No		
Energy Meter		Yes	No		
Water Meter		Yes	No		
PFI Equipment		Yes	No		
Generator		Yes	No		
Change Over		Yes	No		
Overall Rating

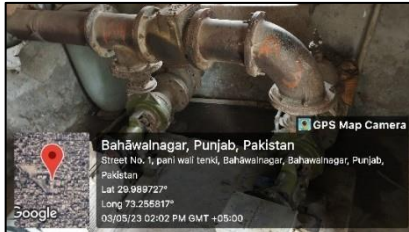
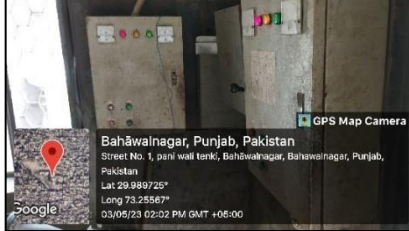
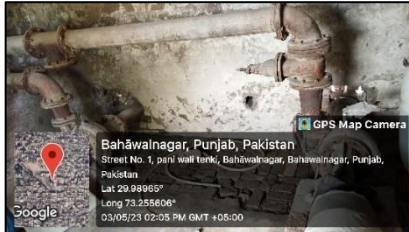
Integrated Development and Asset Management Plan (IDAMP)						
Municipal Committee Bahawalnagar						
Form: IDAMP-A1	Intermediate Pumping Station Asset Condition Assessment			Asset Code: _____ Date: 02-05-2023		
Asset Detail				Pictures		
Name		Shahzad Nagar

Location	Latitude	29.989757				
	Longitude	73.255738				
Address		Shahzad Nagar, Bahawalnagar				
Area (Marla)		2				
Working Status		Functional	Non- Functional			
Construction Year of Water Works		1983				
Installation Year of Pump		2005	2005	1993	1993	
Capital Cost of Machinery						
Operational Hours		3	3	3	3	
Delivery Pipe	Dia	6"	6"	6"	6"	
	Material	MS	MS	MS	MS	
Apron Around Pump House		Yes		No		
Hoisting Girder		Yes		No		
Civil Structure Condition		Good	Fair	Poor		
Approach to Pump House		Good	Fair	Poor		
Pump Details						
		Pump A	Pump B	Pump C	Pump D

Pump Type		Centrifugal	Centrifugal	Centrifugal	Centrifugal	
Pump Make		MECO	MECO	BECO	BECO

Discharge Capacity (Cusec)		3	3	3	3	
Rotational Speed (RPM)		1470	1470	1470	1470	
Head (ft.)		100	100	100	100	
Paint of Pumping Unit		Fair	Fair	Fair	Fair	
Number of Valves	Gate Valve	2	2	2	2	
	Non-Returning Valve	2	2	2	2	
Base Plate		Yes	Yes	Yes	Yes	
Electro-Mechanical Equipment Details						
Transformer Capacity (kVA)		200				
Sanctioned Load (Kwh)		179				
Motor Power (HP)		60	60	60	60	
Motor Make		Siemens	Siemens	BECO	BECO	
MCU		Yes		No		
Earthing of Motor		Yes		No		
Power Wiring		Yes		No		
Service Cable		Yes		No		
Earthing of MCU		Yes		No		
Energy Meter		Yes		No		
Water Meter		Yes		No		
PFI Equipment		Yes		No		
Generator		Yes		No		
Electro-Mechanical Equipment Details

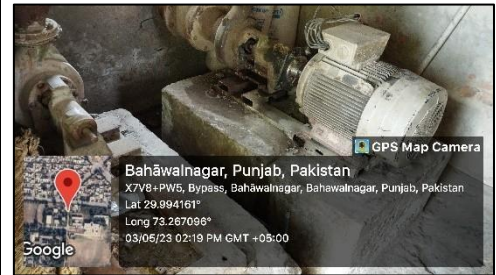
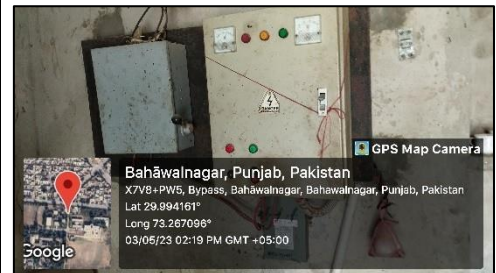
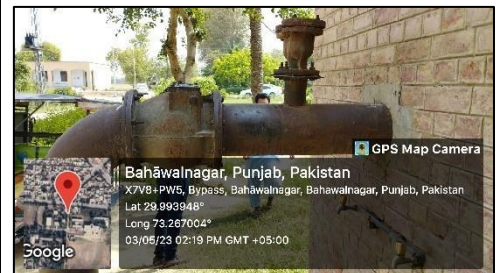
Integrated Development and Asset Management Plan (IDAMP)				
Municipal Committee Bahawalnagar				
Form: IDAMP-A1	Intermediate Pumping Station Asset Condition Assessment			Asset Code: _____ Date: 02-05-2023
Asset Detail			Pictures	
Name		Degree College		
Location	Latitude	29.994161		
	Longitude	73.267096		
Address		Degree College, Bahawalnagar		
Area (Marla)		2		
Working Status		Functional	Non-Functional	
Construction Year of Water Works		2007		
Installation Year of Pump		2007	2007	
Capital Cost of Machinery				
Operational Hours		3	3	
Delivery Pipe	Dia	6"		
	Material	MS		
Apron Around Pump House		Yes	No	
Hoisting Girder		Yes	No	
Civil Structure Condition		Good	Fair	Poor
Approach to Pump House		Good	Fair	Poor
Pump Details				
		Pump A	Pump B	
Pump Type		Centrifugal	Centrifugal	
Pump Make		MECO	MECO	
Discharge Capacity (Cusec)		1.5	1.5	
Rotational Speed (RPM)		1470	1470	
Head (ft.)		100	100	
Paint of Pumping Unit		Poor	Poor

Number of Valves	Gate Valve	2	2	
	Non-Returning Valve	2	2	
Base Plate		Yes	Yes	
Electro-Mechanical Equipment Details				
Transformer Capacity (kVA)		100		
Sanctioned Load (Kwh)		61		
Motor Power (HP)		40	40	
Motor Make		Siemens	Siemens	
MCU		Yes	No	
Earthing of Motor		Yes	No	
Power Wiring		Yes	No	
Service Cable		Yes	No	
Earthing of MCU		Yes	No	
Energy Meter		Yes	No	
Water Meter		Yes	No	
PFI Equipment		Yes	No	
Generator		Yes	No	
Change Over		Yes	No

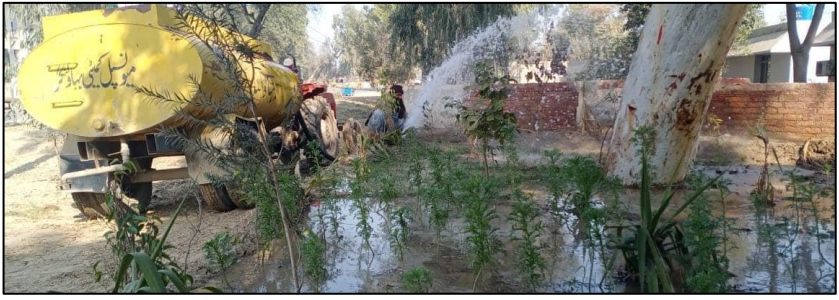
Integrated Development and Asset Management Plan (IDAMP)		
Municipal Committee Bahawalnagar		
Form: IDAMP-A16	Moveable Asset Asset Condition Assessment	Asset Code: _____ Date: 02-05-2023
Type of Vehicle / Machinery	Pictures	
Water Bowser

Capacity	500 Gallons	
Purpose	Water Supply	
Year of Manufacturing	2006	
Model	MF 240	
Capital Cost	Not Available	
Fuel Consumption (Lt)	356	
Condition	Fair	
Engine Capacity	50 HP	
Maintenance Cost	Not Available	
Oiling /Fitness	Yes	
Fitness Certificate	No	
Registered	BNH 4081	
Overall Rating	Fair	
Remarks / Requirements		
<ul style="list-style-type: none"> No remarks 		
Data Collected By: Mr. Abdullah	Designation: Team Member

Sr #	Name	Registration Number	Age (Years)	Condition	Capacity	Status	Book Value (PKR Mil)
1	Water Bowser	BNH 4081	17	Fair	50 HP	Functional	0.8

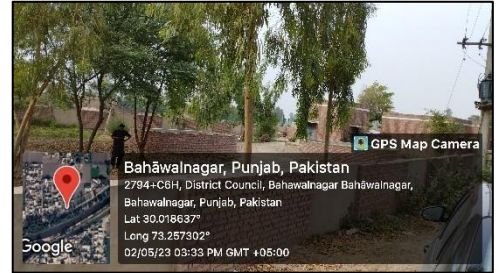
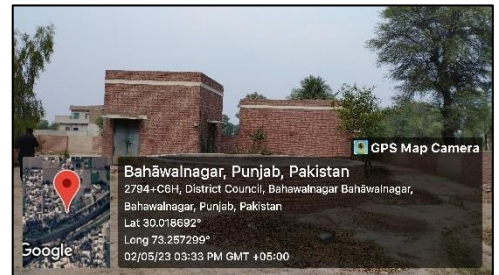
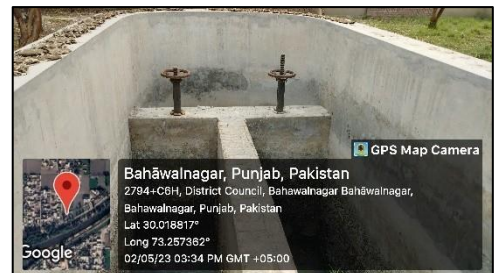
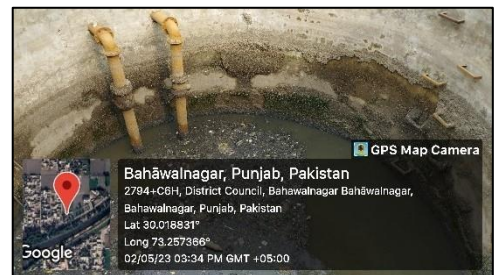
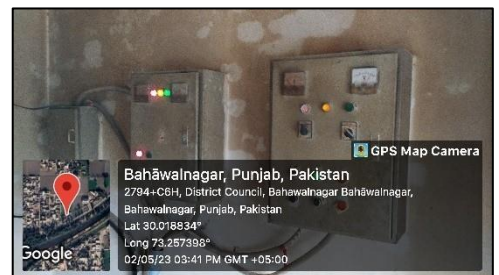
Integrated Development and Asset Management Plan (IDAMP)					
Municipal Committee Bahawalnagar					
Form: IDAMP-A7		Sewerage Disposal Station Asset Condition Assessment			Asset Code: _____
					Date: 02-05-2023
Asset Detail				Pictures	
Name		Fordwah Disposal Station			
Location	Latitude	30.018637			
	Longitude	73.257302			
Address		Fordwah Canal, Bahawalnagar			
Area (Acres)		0.3			
Installation Year		2016			
Capital Cost of Machinery					
Outfall Sewer	Drain	Dia	24"		
		Material	RCC		
Screening Chamber		No. of Screens	1		
		Screen Condition	Good	Fair	Poor
		Chamber Structure	Masonry		
Wet Wells		Number	1		
		Shape	Rectangular	Circular	
		Size	25'		
		Structure	Masonry	RCC	
		Railing	Yes	No	
Force Main		No. of force mains	1		
		Dia	10"		
		Material	PVC		
		Starting Point	Disposal Station		
		Ending Point	Seepage Drain		
Sullage Carrier		Length	3 km		
		Size	No Sullage Carrier		
		Shape			
		Length			
	Condition				
Delivery Pipe		Dia	8"

Material	C.I		
Suction Pipe		Dia	8"		
		Material	C.I		
Number of Valves		Sluice Valves	2		
		Non-Return Valves	2		
		Penstock Valves	2		
Ultimate Disposal		Seepage Drain			
Civil Structure Condition		Good	Fair	Poor	
Control Room Structure		Good	Fair	Poor	
Discharge Box Structure		Good	Fair	Poor	
Approach to Pump House		Good	Fair	Poor

Integrated Development and Asset Management Plan (IDAMP)					
Hoisting Girder	Yes	No			
Boundary Wall & Gate	Yes	No			
Treatment of Sewage	Yes	No			
Wastewater daily discharge in m ³ /day? (based on available information at MC)	1227				
Ultimate disposal of wastewater?					
Electro-Mechanical Equipment Details					
Number of WAPDA Feeders	1				
Transformer Capacity (kVA)	25				
Number of MCU	2				
Sanctioned Load (kWh)	23				
Power Factor Improvement Equipment	Yes	No			
Service Cable	Yes	No			
Power Wiring	Yes	No			
Earthing of Motor	Yes	No			
Earthing of MCU	Yes	No			
Generator Availability	Yes	No			
Light Wiring of Pump House	Yes	No			
Change Over	Yes	No			
Pump Detail					
	Pump A		Pump B		
Pump Type	Submersible		Submersible		
Pump Brand	HMA		HMA		
Pump Paint	Good		Good		
Motor Brand	MECO		MECO		
Installation Year of Pump	2016		2016		
Discharge Capacity (Cusecs)	1.5		1.5		
Rotational Speed (RPM)	960		960		
Head (ft.)	40		40

Motor Power (HP)	20		20		
Pump Daily Running Time (Hours)	4		4		
Base Plate	Yes	No	Yes	No	
Number of Valves	Sluice Valve	2			
	Non-Returning Valve	2			
Overall Rating					
Average Score	1	2	3	4	5
Asset Condition	Excellent	Good	Fair	Poor	Failing
Category	A	B	C	D	E
Remarks / Requirements					
<ul style="list-style-type: none"> No remarks 					
Data Collected By: Mr. Abdullah		Designation: Team Member

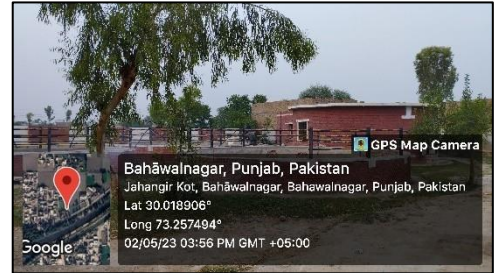
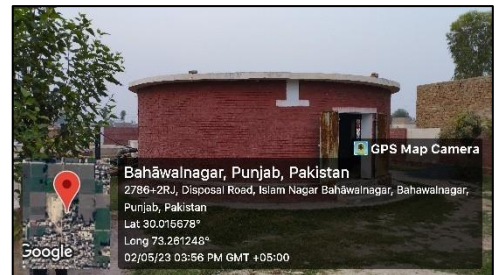
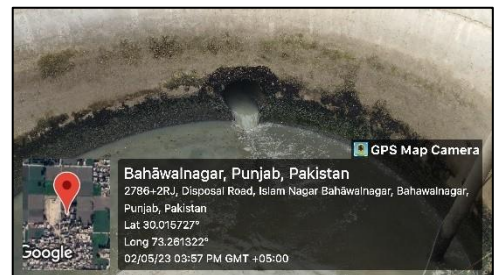
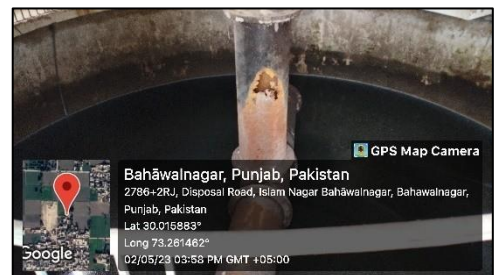
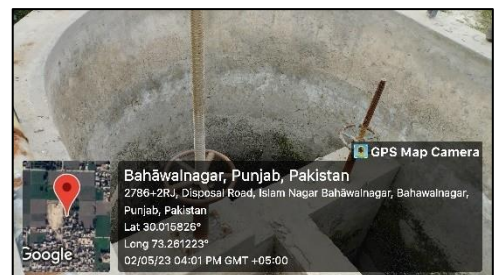
Integrated Development and Asset Management Plan (IDAMP)					
Municipal Committee Bahawalnagar					
Form: IDAMP-A7		Sewerage Disposal Station Asset Condition Assessment			Asset Code: _____
					Date: 02-05-2023
Asset Detail				Pictures	
Name		Islam Nagar			
Location	Latitude	30.015678			
	Longitude	73.261248			
Address		Islam Nagar, Bahawalnagar			
Area (Acres)		0.35			
Installation Year		2016			
Capital Cost of Machinery					
Outfall Sewer	Drain	Dia	36"		
		Material	RCC		
Screening Chamber	No. of Screens		2		
	Screen Condition	Good	Fair	Poor	
	Chamber Structure	Masonry			
Wet Wells	Number		2		
	Shape	Rectangular	Circular		
	Size	35'			
	Structure	Masonry	RCC		
Force Main	Railing	Yes	No		
	No. of force mains	1			
Force Main	Dia	24"			
	Material	AC			
	Starting Point	Disposal Station			
	Ending Point	Seepage Drain			
	Length	1500'			
Sullage Carrier	Size	No Sullage Carrier			
	Shape				
	Length				
	Condition				
Delivery Pipe	Dia	10"

Material	C.I			
Suction Pipe	Dia	10"			
	Material	C.I			
Number of Valves	Sluice Valves	9			
	Non-Return Valves	5			
	Penstock Valves	2			
Ultimate Disposal		Seepage Drain			
Civil Structure Condition		Good	Fair	Poor	
Control Room Structure		Good	Fair	Poor	
Discharge Box Structure		Good	Fair	Poor	
Approach to Pump House		Good	Fair	Poor	
Hoisting Girder		Yes	No

Integrated Development and Asset Management Plan (IDAMP)											
Boundary Wall & Gate		Yes		No							
Treatment of Sewage		Yes		No							
Wastewater daily discharge in m ³ /day? (based on available information at MC)		4602									
Ultimate disposal of wastewater?											
Electro-Mechanical Equipment Details											
Number of WAPDA Feeders		1									
Transformer Capacity (kVA)		200									
Number of MCU		5									
Sanctioned Load (kWh)		158									
Power Factor Improvement Equipment		Yes		No							
Service Cable		Yes		No							
Power Wiring		Yes		No							
Earthing of Motor		Yes		No							
Earthing of MCU		Yes		No							
Generator Availability		Yes		No							
Light Wiring of Pump House		Yes		No							
Change Over		Yes		No							
Pump Detail											
		Pump A		Pump B		Pump C		Pump D		Pump E	
Pump Type		Submersible		Centrifugal /Non-Clogging		Centrifugal /Non-Clogging		Centrifugal /Non-Clogging		Centrifugal /Non-Clogging

Pump Brand		HMA		Master		MECO		MECO		MECO	
Pump Paint		Fair		Fair		Fair		Fair		Fair	
Motor Brand		MECO		MECO		MECO		MECO		MECO	
Installation Year of Pump		2016		2016		2016		2016		2016	
Discharge Capacity (Cusecs)		1.5		3		3		3		3	
Rotational Speed (RPM)		960		960		960		960		960	
Head (ft.)		50		50		50		50		50	
Motor Power (HP)		20		40		40		40		40	
Pump Daily Running Time (Hours)		10		10		Non-Functional		Non-Functional		Non-Functional	
Base Plate		Yes	No	Yes	No	Yes	No	Yes	No	Yes	No
Number of Valves		Sluice Valve		9							
		Non-Returning Valve		5							
Overall Rating											
Average Score		1		2		3		4		5	
Asset Condition		Excellent		Good		Fair		Poor		Failing	
Category		A		B		C		D		E	
Remarks / Requirements											
<ul style="list-style-type: none"> No remarks 											
Data Collected By: Mr. Abdullah				Designation: Team Member

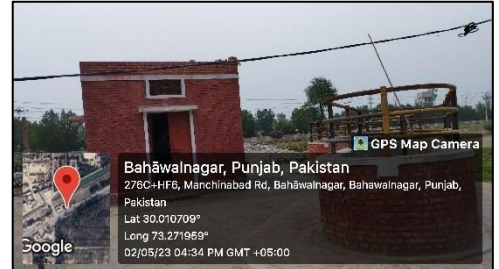
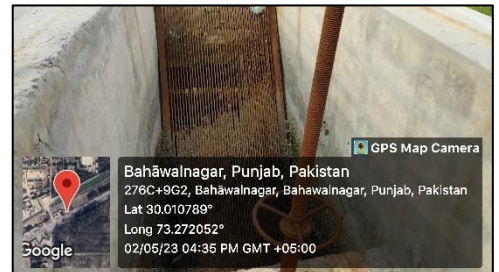
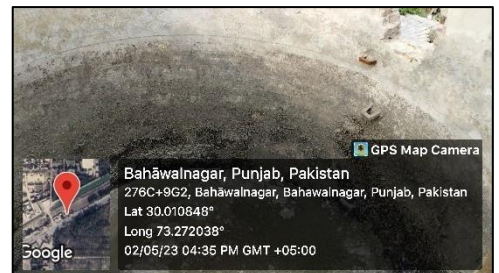
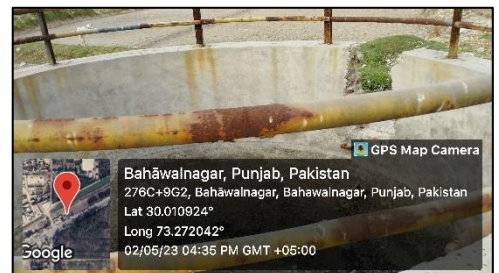
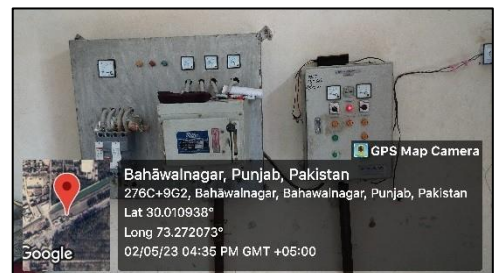
Integrated Development and Asset Management Plan (IDAMP)					
Municipal Committee Bahawalnagar					
Form: IDAMP-A7		Sewerage Disposal Station Asset Condition Assessment			Asset Code: _____
					Date: 02-05-2023
Asset Detail				Pictures	
Name		Karmanwala Disposal Station			
Location	Latitude	30.010709			
	Longitude	73.271959			
Address		Karmanwala, Bahawalnagar			
Area (Acres)		0.15			
Installation Year		2016			
Capital Cost of Machinery					
Outfall Sewer	Drain	Dia	15"		
		Material	RCC		
Screening Chamber		No. of Screens	1		
		Screen Condition	Good	Fair	Poor
		Chamber Structure	Masonry		
Wet Wells		Number	1		
		Shape	Rectangular	Circular	
		Size	20'		
		Structure	Masonry	RCC	
		Railing	Yes	No	
Force Main		No. of force mains	1		
		Dia	18"		
		Material	AC		
		Starting Point	Disposal Station		
		Ending Point	Seepage Drain		
Sullage Carrier		Length	5700'		
		Size			
		Shape			
		Condition	No Sullage Carrier		
Delivery Pipe		Dia	8"

Material	C.I		
Suction Pipe		Dia	8"		
		Material	C.I		
Number of Valves		Sluice Valves	1		
		Non-Return Valves	1		
		Penstock Valves	1		
Ultimate Disposal		Seepage Drain			
Civil Structure Condition		Good	Fair	Poor	
Control Room Structure		Good	Fair	Poor	
Discharge Box Structure		Good	Fair	Poor	
Approach to Pump House		Good	Fair	Poor

Integrated Development and Asset Management Plan (IDAMP)					
Hoisting Girder	Yes	No			
Boundary Wall & Gate	Yes	No			
Treatment of Sewage	Yes	No			
Wastewater daily discharge in m ³ /day? (based on available information at MC)	1841				
Ultimate disposal of wastewater?					
Electro-Mechanical Equipment Details					
Number of WAPDA Feeders	1				
Transformer Capacity (kVA)	25				
Number of MCU	1				
Sanctioned Load (kWh)	20				
Power Factor Improvement Equipment	Yes	No			
Service Cable	Yes	No			
Power Wiring	Yes	No			
Earthing of Motor	Yes	No			
Earthing of MCU	Yes	No			
Generator Availability	Yes	No			
Light Wiring of Pump House	Yes	No			
Change Over	Yes	No			
Pump Detail					
			Pump A		
Pump Type	Submersible				
Pump Brand	HMA				
Pump Paint	Fair				
Motor Brand	MECO				
Installation Year of Pump	2016				
Discharge Capacity (Cusecs)	1.5				
Rotational Speed (RPM)	960				
Head (ft.)	50				
Motor Power (HP)	20				
Pump Daily Running Time (Hours)	12

Base Plate	Yes		No		
Number of Valves	Sluice Valve	1			
	Non-Returning Valve	1			
Overall Rating					
Average Score	1	2	3	4	5
Asset Condition	Excellent	Good	Fair	Poor	Failing
Category	A	B	C	D	E
Remarks / Requirements					
<ul style="list-style-type: none"> No remarks 					
Data Collected By: Mr. Abdullah		Designation: Team Member

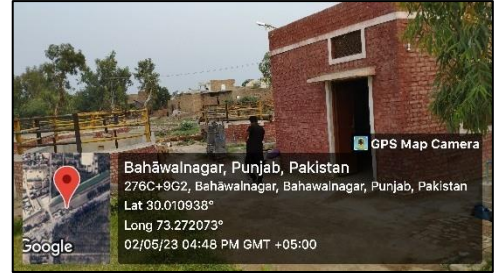
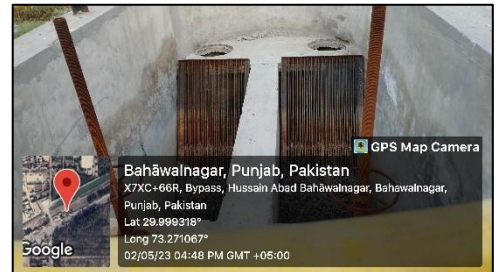
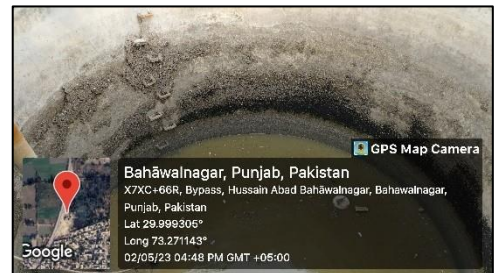
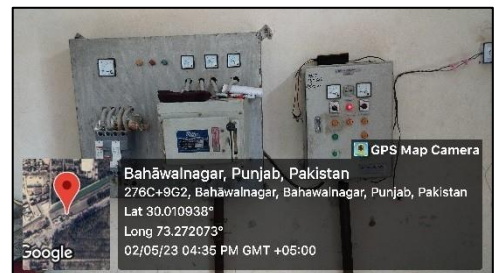
Integrated Development and Asset Management Plan (IDAMP)				
Municipal Committee Bahawalnagar				
Form: IDAMP-A7	Sewerage Disposal Station Asset Condition Assessment			Asset Code: _____ Date: 02-05-2023
Asset Detail			Pictures	
Name		Hussainabad Disposal Station		
Location	Latitude	29.999318		
	Longitude	73.271067		
Address		Hussainabad, Bahawalnagar		
Area (Acres)		0.35		
Installation Year		2016		
Capital Cost of Machinery				
Outfall Sewer	Drain Dia	27"		
	Material	RCC		
Screening Chamber	No. of Screens	2		
	Screen Condition	Good	Fair	Poor
	Chamber Structure	Masonry		
Wet Wells	Number	2		
	Shape	Rectangular	Circular	
	Size	25'		
	Structure	Masonry	RCC	
	Railing	Yes	No	
Force Main	No. of force mains	1		
	Dia	16"		
	Material	AC		
	Starting Point	Disposal Station		
	Ending Point	Karmanwala Disposal		
Sullage Carrier	Size	No Sullage Carrier		
	Shape			
	Length			
	Condition			
Delivery Pipe	Dia	8"		
	Material	C.I		
Suction Pipe	Dia	8"

Material	C.I		
Number of Valves	Sluice Valves	1		
	Non-Return Valves	1		
	Penstock Valves	2		
Ultimate Disposal		Karmanwala Disposal		
Civil Structure Condition		Good	Fair	Poor
Control Room Structure		Good	Fair	Poor
Discharge Box Structure		Good	Fair	Poor

Integrated Development and Asset Management Plan (IDAMP)					
Approach to Pump House	Good	Fair	Poor		
Hoisting Girder	Yes		No		
Boundary Wall & Gate	Yes		No		
Treatment of Sewage	Yes		No		
Wastewater daily discharge in m ³ /day? (based on available information at MC)	1841				
Ultimate disposal of wastewater?					
Electro-Mechanical Equipment Details					
Number of WAPDA Feeders	1				
Transformer Capacity (kVA)	200				
Number of MCU	1				
Sanctioned Load (kWh)	20				
Power Factor Improvement Equipment	Yes		No		
Service Cable	Yes		No		
Power Wiring	Yes		No		
Earthing of Motor	Yes		No		
Earthing of MCU	Yes		No		
Generator Availability	Yes		No		
Light Wiring of Pump House	Yes		No		
Change Over	Yes		No		
Pump Detail					
			Pump A		
Pump Type	Submersible				
Pump Brand	HMA				
Pump Paint	Fair				
Motor Brand	MECO				
Installation Year of Pump	2016				
Discharge Capacity (Cusecs)	1.5				
Rotational Speed (RPM)	960				
Head (ft.)	50

Motor Power (HP)	20				
Pump Daily Running Time (Hours)	12				
Base Plate	Yes		No		
Number of Valves	Sluice Valve	1			
	Non-Returning Valve	1			
Overall Rating					
Average Score	1	2	3	4	5
Asset Condition	Excellent	Good	Fair	Poor	Failing
Category	A	B	C	D	E
Remarks / Requirements					
<ul style="list-style-type: none"> No remarks 					
Data Collected By: Mr. Abdullah		Designation: Team Member

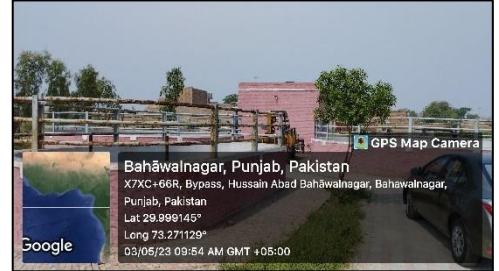
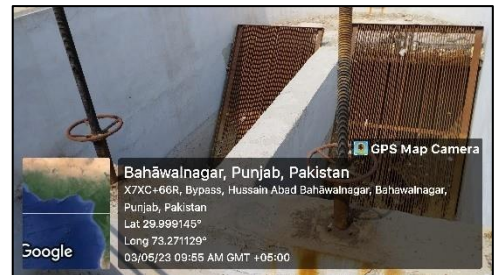
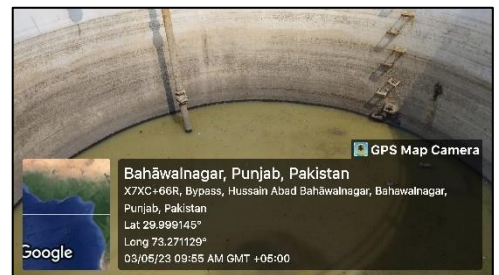
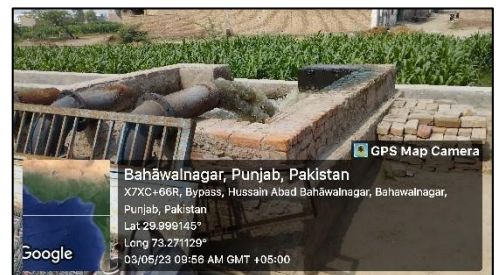
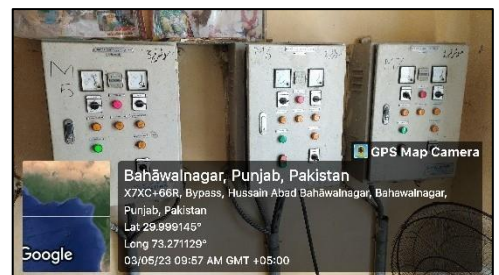
Integrated Development and Asset Management Plan (IDAMP)					
Municipal Committee Bahawalnagar					
Form: IDAMP-A7		Sewerage Disposal Station Asset Condition Assessment			Asset Code: _____
					Date: 02-05-2023
Asset Detail				Pictures	
Name		Madina Town New			
Location	Latitude	29.992812			
	Longitude	73.240822			
Address		Madina Town, Bahawalnagar			
Area (Acres)		3.8			
Installation Year		2016			
Capital Cost of Machinery					
Outfall Sewer	Drain	Dia	36"		
		Material	RCC		
Screening Chamber	No. of Screens		2		
	Screen Condition		Good	Fair	Poor
	Chamber Structure		Masonry		
Wet Wells	Number		2		
	Shape		Rectangular	Circular	
	Size		35'		
	Structure		Masonry	RCC	
Railing		Yes	No		
Force Main	No. of force mains		1		
	Dia		24"		
	Material		AC		
	Starting Point		Disposal Station		
	Ending Point		Broad Irrigation		
Sullage Carrier	Size		3'x4'		
	Shape		Rectangular		
	Length		900'		
	Condition		Good		
Delivery Pipe	Dia		8"

Material		C.I		
Suction Pipe	Dia		8"		
	Material		C.I		
Number of Valves	Sluice Valves		14		
	Non-Return Valves		7		
	Penstock Valves		2		
Ultimate Disposal		Broad Irrigation			
Civil Structure Condition		Good	Fair	Poor	
Control Room Structure		Good	Fair	Poor	
Discharge Box Structure		Good	Fair	Poor	
Approach to Pump House		Good	Fair	Poor	
Hoisting Girder		Yes	No

Integrated Development and Asset Management Plan (IDAMP)											
Boundary Wall & Gate		Yes	No								
Treatment of Sewage		Yes	No								
Wastewater daily discharge in m ³ /day? (based on available information at MC)		6750									
Ultimate disposal of wastewater?											
Electro-Mechanical Equipment Details											
Number of WAPDA Feeders		1									
Transformer Capacity (kVA)		200									
Number of MCU		8									
Sanctioned Load (kWh)		160									
Power Factor Improvement Equipment		Yes	No								
Service Cable		Yes	No								
Power Wiring		Yes	No								
Earthing of Motor		Yes	No								
Earthing of MCU		Yes	No								
Generator Availability		Yes	No								
Light Wiring of Pump House		Yes	No								
Change Over		Yes	No								
Pump Detail											
		Pump A		Pump B		Pump C		Pump D			
Pump Type		Centrifugal/Non-Clogging		Centrifugal/Non-Clogging		Centrifugal/Non-Clogging		Centrifugal/Non-Clogging

Pump Brand		Master		HMA		HMA		HMA			
Pump Paint		Fair									
Motor Brand		Siemens		HMA		HMA		HMA			
Installation Year of Pump		2016									
Discharge Capacity (Cusecs)		3		3		3		3			
Rotational Speed (RPM)		960									
Head (ft.)		50									
Motor Power (HP)		60		60		60		60			
Pump Daily Running Time (Hours)		22		Non-Functional		Non-Functional		Non-Functional			
Base Plate		Yes	No	Yes	No	Yes	No	Yes	No		
		Pump E		Pump F		Pump G					
Pump Type		Centrifugal/Non-Clogging		Centrifugal/Non-Clogging		Centrifugal/Non-Clogging					
Pump Brand		HMA		HMA		HMA					
Pump Paint											
Motor Brand		HMA		HMA		HMA					
Installation Year of Pump											
Discharge Capacity (Cusecs)		3		3		3					
Rotational Speed (RPM)											
Head (ft.)											
Motor Power (HP)		60		60		60					
Pump Daily Running Time (Hours)		Non-Functional		Non-Functional		Non-Functional					
Base Plate		Yes	No	Yes	No	Yes	No				
Number of Valves		Sluice Valve		14

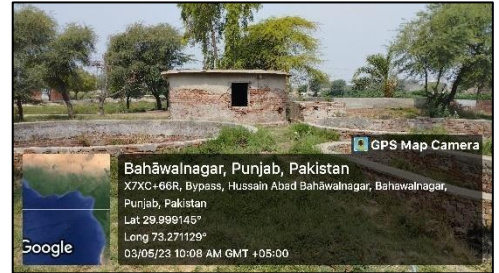
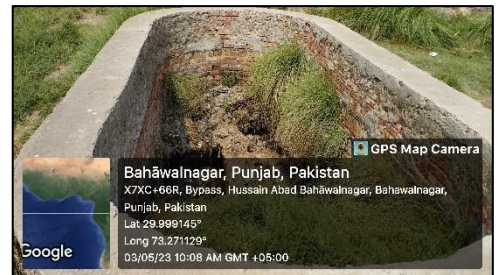
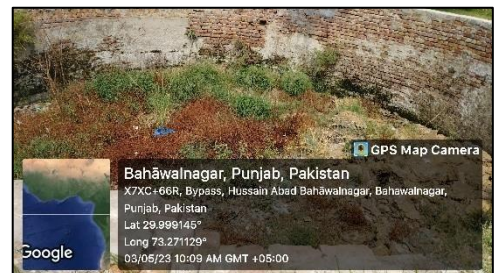
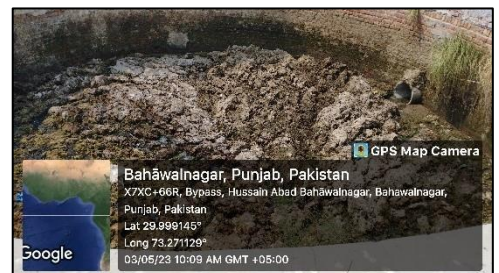
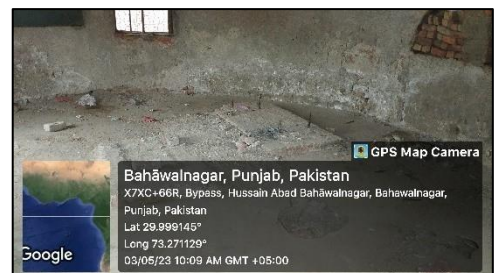
Integrated Development and Asset Management Plan (IDAMP)										
Municipal Committee Bahawalnagar										
Form: IDAMP-A7		Sewerage Disposal Station Asset Condition Assessment					Asset Code: _____			Date: 02-05-2023
Asset Detail					Pictures					
Name		Madina Town Old								
Location		Latitude		29.992812						
		Longitude		73.240822						
Address		Madina Town, Bahawalnagar								
Area (Acres)		1.8								
Installation Year		Not Available								
Capital Cost of Machinery										
Outfall Sewer	Drain	Dia								
		Material								
Screening Chamber	No. of Screens									
	Screen Condition		Good		Fair		Poor			
	Chamber Structure									
Wet Wells	Number									
	Shape		Rectangular			Circular				
	Size									
	Structure		Masonry			RCC				
Force Main	Railing		Yes		No					
	No. of force mains									
	Dia									
	Material									
	Starting Point									
Sullage Carrier	Ending Point									
	Length

Size									
	Shape									
Delivery Pipe	Length									
	Condition									
	Dia									
Suction Pipe	Material									
	Dia									
Number of Valves	Sluice Valves									
	Non-Return Valves									
	Penstock Valves									
Ultimate Disposal										
Civil Structure Condition		Good		Fair		Poor				
Control Room Structure		Good		Fair		Poor				
Discharge Box Structure		Good		Fair		Poor				
Approach to Pump House		Good		Fair		Poor				
Hoisting Girder		Yes			No

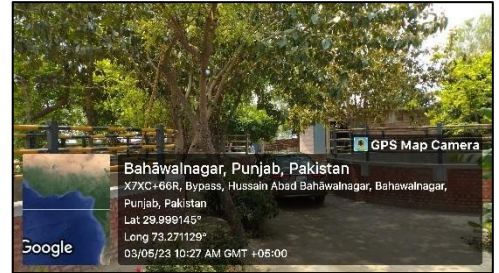
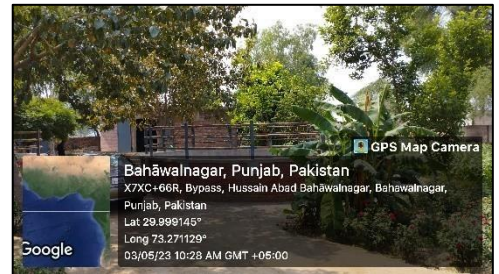
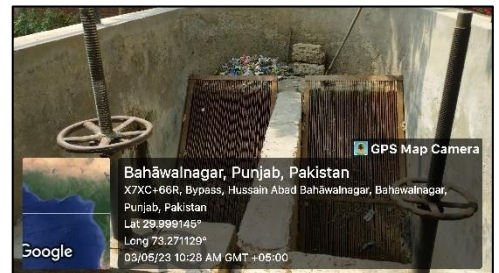
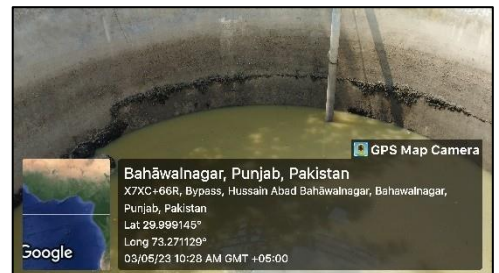
Integrated Development and Asset Management Plan (IDAMP)					
Municipal Committee Bahawalnagar					
Form: IDAMP-A7		Sewerage Disposal Station Asset Condition Assessment		Asset Code: _____ Date: 02-05-2023	
Asset Detail			Pictures		
Name		Madni Colony			
Location	Latitude	29.986374			
	Longitude	73.262014			
Address		Madni Colony, Bahawalnagar			
Area (Acres)		0.85			
Installation Year		2011			
Capital Cost of Machinery					
Outfall Sewer	Drain	Dia	36"		
		Material	RCC		
Screening Chamber	No. of Screens		2		
	Screen Condition		Good	Fair	Poor
	Chamber Structure		Masonry		
Wet Wells	Number		2		
	Shape		Rectang ular	Circular	
	Size		25"		
	Structure		Masonry	RCC	
	Railing		Yes	No	
Force Main	No. of force mains		1		
	Dia		20"		
	Material		PVC		
	Starting Point		Disposal Station		
	Ending Point		Seepage Drain		
	Length		5600'		
Sullage Carrier	Size		2.5'x4'		
	Shape		Rectangular		
	Length		700'		
	Condition		Fair		
Delivery Pipe	Dia		8"

Material		C.I		
Suction Pipe	Dia		8"		
	Material		C.I		
Number of Valves	Sluice Valves		8		
	Non-Return Valves		4		
	Penstock Valves		2		
Ultimate Disposal		Seepage Drain			
Civil Structure Condition		Good	Fair	Poor	
Control Room Structure		Good	Fair	Poor	
Discharge Box Structure		Good	Fair	Poor	
Approach to Pump House		Good	Fair	Poor	
Hoisting Girder		Yes	No		
Boundary Wall & Gate		Yes	No		
Treatment of Sewage		Yes	No		
Wastewater daily discharge in m ³ /day? (based on available information at MC)		4909			
Ultimate disposal of wastewater?

Integrated Development and Asset Management Plan (IDAMP)										
Electro-Mechanical Equipment Details										
Number of WAPDA Feeders		1								
Transformer Capacity (kVA)		200								
Number of MCU		5								
Sanctioned Load (kWh)		143								
Power Factor Improvement Equipment		Yes	No							
Service Cable		Yes	No							
Power Wiring		Yes	No							
Earthing of Motor		Yes	No							
Earthing of MCU		Yes	No							
Generator Availability		Yes	No							
Light Wiring of Pump House		Yes	No							
Change Over		Yes	No							
Pump Detail										
		Pump A		Pump B		Pump C		Pump D		
Pump Type		Centrifugal/No n-Clogging		Centrifugal/No n-Clogging		Centrifugal/No n-Clogging		Centrifugal/No n-Clogging		
Pump Brand		KSB		MECO		MECO		MECO		
Pump Paint		Fair								
Motor Brand		Siemens		MECO		MECO		MECO		
Installation Year of Pump		2020								
Discharge Capacity (Cusecs)		3								
Rotational Speed (RPM)		960								
Head (ft.)		50

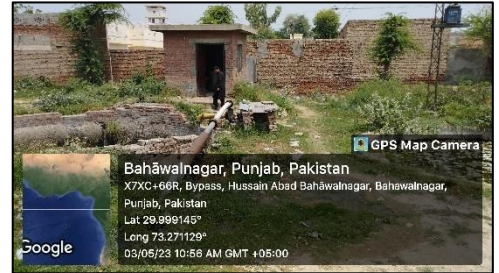
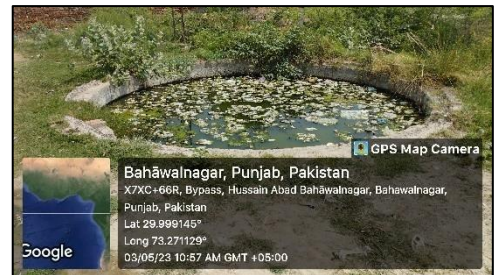
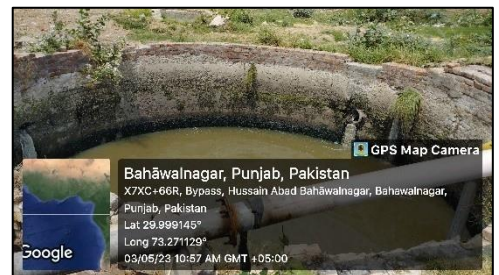
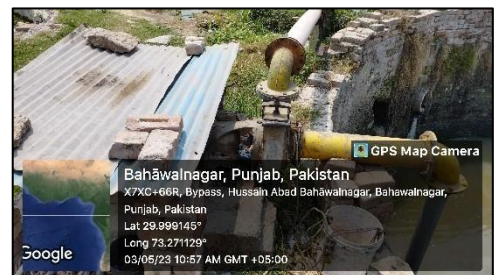
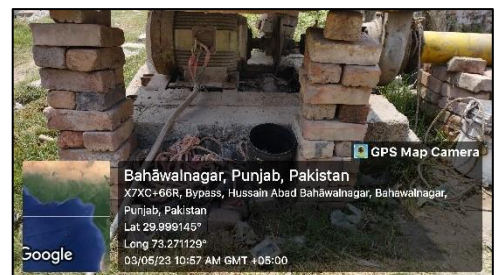
Integrated Development and Asset Management Plan (IDAMP)						
Municipal Committee Bahawalnagar						
Form: IDAMP-A7		Sewerage Disposal Station Asset Condition Assessment			Asset Code: _____	
					Date: 02-05-2023	
Asset Detail				Pictures		
Name		Model Town				
Location	Latitude		29.976654			
	Longitude		73.261130			
Address		Model Town, Bahawalnagar				
Area (Acres)		0.3				
Installation Year		1965				
Capital Cost of Machinery						
Outfall Sewer	Drain	Dia		18"		
		Material		RCC		
Screening Chamber	No. of Screens		0			
	Screen Condition		Good	Fair	Poor	
	Chamber Structure					
Wet Wells	Number		1			
	Shape		Rectangular	Circular		
	Size		25'			
	Structure		Masonry	RCC		
	Railing		Yes	No		
Force Main	No. of force mains		1			
	Dia		8"			
	Material		PVC			
	Starting Point		Disposal Station			
	Ending Point		Seepage Drain			
Sullage Carrier	Size		No Sullage Carrier			
	Shape					
	Length					
	Condition					
Delivery Pipe	Dia		6"

Material		C.I			
Suction Pipe	Dia		6"			
	Material		C.I			
Number of Valves	Sluice Valves		2			
	Non-Return Valves		1			
	Penstock Valves		0			
Ultimate Disposal		Seepage Drain				
Civil Structure Condition		Good	Fair	Poor		
Control Room Structure		Good	Fair	Poor		
Discharge Box Structure		Good	Fair	Poor		
Approach to Pump House		Good	Fair	Poor		
Hoisting Girder		Yes	No

Integrated Development and Asset Management Plan (IDAMP)					
Boundary Wall & Gate		Yes	No		
Treatment of Sewage		Yes	No		
Wastewater daily discharge in m ³ /day? (based on available information at MC)		1841			
Ultimate disposal of wastewater?					
Electro-Mechanical Equipment Details					
Number of WAPDA Feeders		1			
Transformer Capacity (kVA)		25			
Number of MCU		1			
Sanctioned Load (kWh)		20			
Power Factor Improvement Equipment		Yes	No		
Service Cable		Yes	No		
Power Wiring		Yes	No		
Earthing of Motor		Yes	No		
Earthing of MCU		Yes	No		
Generator Availability		Yes	No		
Light Wiring of Pump House		Yes	No		
Change Over		Yes	No		
Pump Detail					
			Pump A		
Pump Type		Centrifugal/Non-Clogging			
Pump Brand		Shehzad Pump			
Pump Paint		Good			
Motor Brand		Siemens			
Installation Year of Pump		2021			
Discharge Capacity (Cusecs)		1.5			
Rotational Speed (RPM)		960			
Head (ft.)		50			
Motor Power (HP)		20			
Pump Daily Running Time (Hours)		12

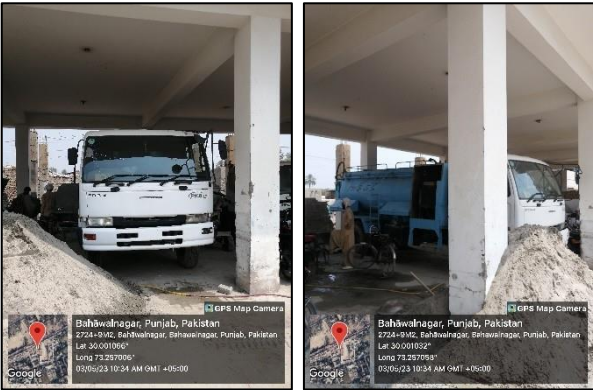
Integrated Development and Asset Management Plan (IDAMP)		
Municipal Committee Bahawalnagar		
Form: IDAMP-A16	Moveable Asset Asset Condition Assessment	Asset Code: _____ Date: 02-05-2023
Type of Vehicle / Machinery	Pictures	
Sucker & Jetting Machine

Capacity	Suction Machine 4500 liters	Jetting Machine 4500 liters

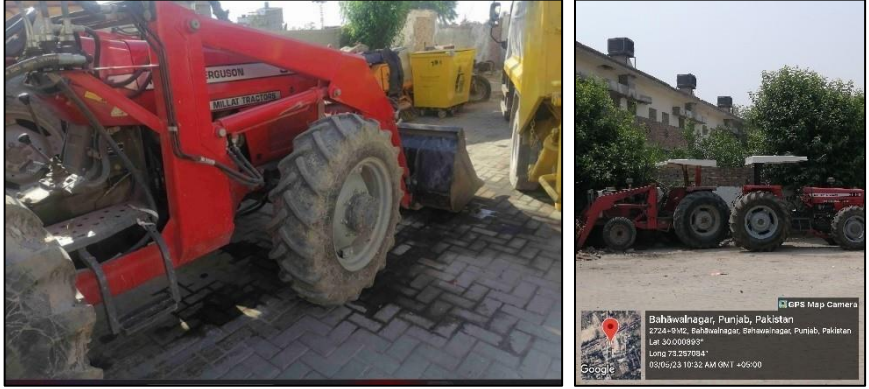
Integrated Development and Asset Management Plan (IDAMP)								
Municipal Committee Bahawalnagar								
Form: IDAMP-A16	Moveable Asset Asset Condition Assessment					Asset Code: _____ Date: 02-05-2023		
Type of Vehicle / Machinery	Pictures							
Tractor-Millat

Tractor -Millat 1	Tractor -Millat 2	Tractor -Millat 3	Tractor -Millat 4	Tractor -Millat 5	Tractor -Millat 6	Tractor -Millat 7	Tractor -Millat 8
Capacity	50HP	50HP	85HP	50HP	50HP	50HP	50HP	50HP
Purpose	SWM	SWM	SWM	SWM	SWM	SWM	SWM	SWM
Year of Manufacturing	1999	1999	2012	2012	2011	1999	2011	2009
Model	MF240	MF240	MF385	MF240	MF240	MF240	MF240	MF240
Capital Cost								
Fuel Consumption (Lt)	Non-Functional	Non-Functional	Non-Functional	507	549	244	310	307
Condition	Poor	Poor	Fair	Fair	Fair	Poor	Fair	Fair
Engine Capacity	50HP	50HP	85HP	50HP	50HP	50HP	50HP	50HP
Maintenance Cost	Not Available	Not Available	Not Available	Not Available	Not Available	Not Available	Not Available	Not Available

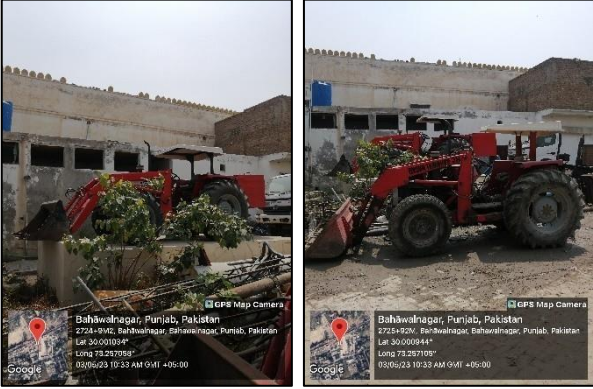
Integrated Development and Asset Management Plan (IDAMP)			
Municipal Committee Bahawalnagar			
Form: IDAMP-A16	Moveable Asset Asset Condition Assessment	Asset Code: _____ Date: 02-05-2023	
Type of Vehicle / Machinery	Pictures		
Tractor

Front Blade Tractor	Front End Loader 1	Front End Loader 2
Capacity	85HP	85HP	85HP
Purpose	SWM	SWM	SWM
Year of Manufacturing	2012	2011	2012
Model	MF385	MF385	MF385
Capital Cost			
Fuel Consumption (Lt)	245	225	260
Condition	Fair	Fair	Fair
Engine Capacity	85HP	55HP	55HP
Maintenance Cost	Not Available	Not Available	Not Available
Oiling /Fitness	Yes	No	Yes
Fitness Certificate	No	No	No
Registered	Not Registered	BNJ 1021	Not Registered
Overall Rating	Fair	Fair	Fair
Remarks / Requirements			
<ul style="list-style-type: none"> No remarks 			
<i>Data Collected By: Mr. Abdullah</i>	<i>Designation: Team Member</i>

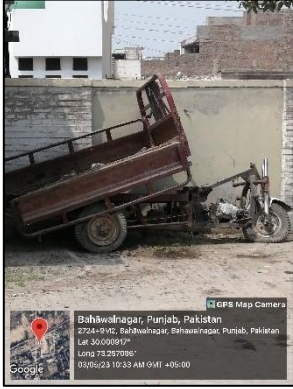
Integrated Development and Asset Management Plan (IDAMP)						
Municipal Committee Bahawalnagar						
Form: IDAMP-A16	Moveable Asset Asset Condition Assessment				Asset Code: _____ Date: 02-05-2023	
Type of Vehicle / Machinery	Pictures					
Loader Rickshaw

Loader Rickshaw 6	Loader Rickshaw 7	Loader Rickshaw 8	Loader Rickshaw 9	Loader Rickshaw 10	Loader Rickshaw 11
Capacity	1.5 m ³	1.5 m ³	1.5 m ³	1.5 m ³	1.5 m ³	1.5 m ³
Purpose	SWM	SWM	SWM	SWM	SWM	SWM
Year of Manufacturing	2017	2017	2017	2017	2017	2000
Model	RP150-LD	RP150-LD	RP150-LD	RP150-LD	RP150-LD	Not Available
Capital Cost						
Fuel Consumption (Lt)	82	82	85	86	82	158
Condition	Good	Good	Good	Good	Good	Poor
Engine Capacity	150 CC	150 CC	150 CC	150 CC	150 CC	16 HP
Maintenance Cost	Not Available	Not Available	Not Available	Not Available	Not Available	Not Available
Oiling /Fitness	Yes	Yes	Yes	Yes	Yes	Yes
Fitness Certificate	No	No	No	No	No	No

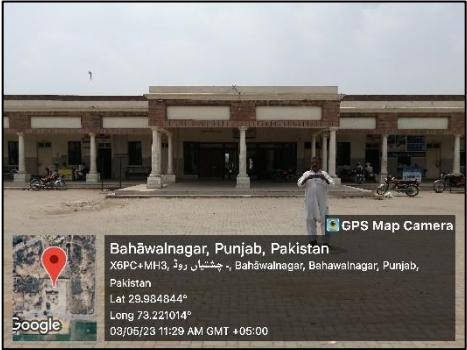
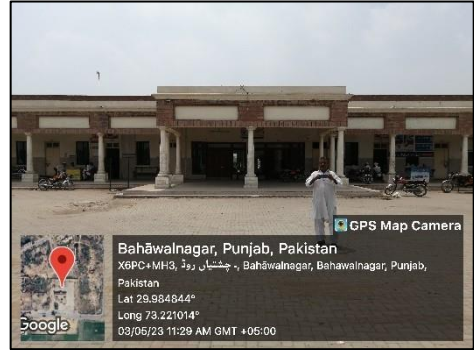
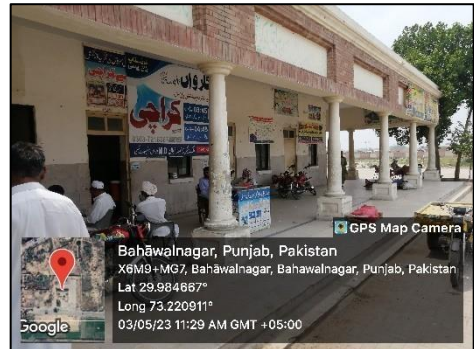
Integrated Development and Asset Management Plan (IDAMP)							
Municipal Committee Bahawalnagar							
Form: IDAMP-A12		Bus Stand		Asset Code: _____			
		Asset Condition Assessment		Date: 02-05-2023			
Name		General Bus Stand		Pictures			
Location	Latitude	29.983809

Longitude	73.220986					
Address		Mouza Rabnawaz pura, Bahawalnagar					
Year of Construction		2013					
Last Major Renovation		Not Available					
Area (Acres)		16					
Ownership		District Govt.					
Class		A	B			C	D
Designed Capacity of Vehicles	Buses	Not Available					
	Coasters	Not Available					
	Wagons	Not Available					
Daily parking of vehicles (based on information provided by MC)	Buses	260					
	Coasters	25					
	Wagons	45					
	Rickshaws	50					
Distance from the urban area		4 km					
Security	At Entry	Yes	No				
	At Exit	Yes	No				
Gate	At Entry	Yes	No				
	At Exit	Yes	No				
Waiting Area	Men	Yes	No				
	Families	Yes	No				
Washroom	Male	Yes	No

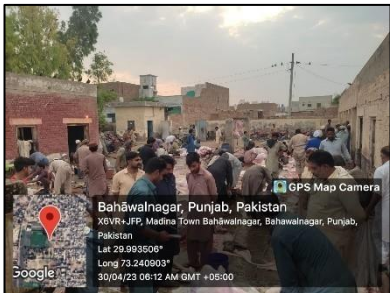
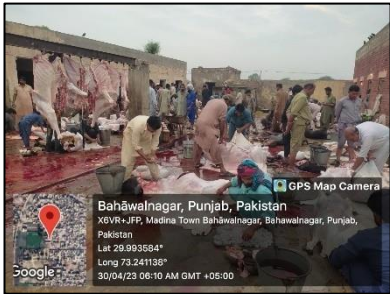
Integrated Development and Asset Management Plan (IDAMP)							
Municipal Committee Bahawalnagar							
Form: IDAMP-A15	Slaughterhouse Asset Condition Assessment			Asset Code: _____ Date: 02-05-2023			
Name		Slaughter House		Pictures			
Location	Latitude	29.993523

Longitude	73.245412					
Address		Mouza Amar Singh CTN Road, Bahawalnagar					
Year of Construction		Not Available					
Total Area (Acres)		1					
Ownership		MC					
Slaughter Capacity (Per Day)	Larger Animals	50					
	Smaller Animals	80					
Supervisor		Yes	No

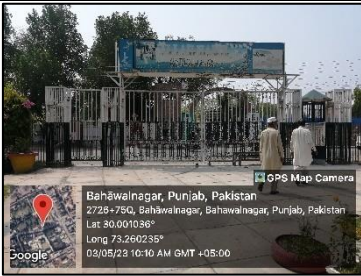
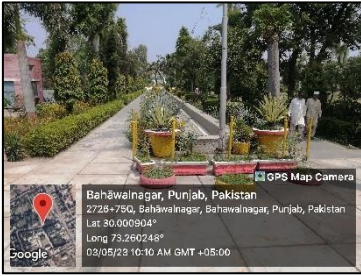
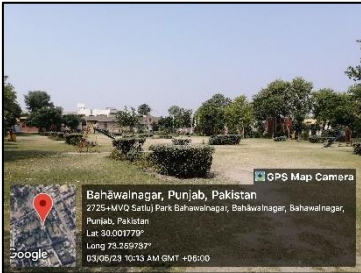
Integrated Development and Asset Management Plan (IDAMP)				
Municipal Committee Bahawalnagar				
Form: IDAMP-A10	Park Asset Condition Assessment	Asset Code: _____ Date: 02-05-2023		
Name		Satluj Park		Pictures
Location	Latitude	30.000904

Bahawalnagar, Punjab, Pakistan 2726+750, Bahawalnagar, Bahawalnagar, Punjab, Pakistan Lat 30.001036° Long 73.260235° 03/05/23 10:10 AM GMT +05:00
	Longitude	73.260248		
Area In Acres		9.5		
Ownership-Owned by MC or possession allocated to MC by any other department (documents available)		MC		
Turfing Condition	Good	Fair	Poor	
Approach Road	Good	Fair	Poor	
Parking Lots	Yes		No	
Canteen Availability	Yes		No	
Average number of daily visitors (based on the assessment of MC staff)	1500-2000

Bahawalnagar, Punjab, Pakistan 2726+750, Bahawalnagar, Bahawalnagar, Punjab, Pakistan Lat 30.000904° Long 73.260248° 03/05/23 10:10 AM GMT +05:00	
Any illegal occupants or encroachments observed-if yes, type	No

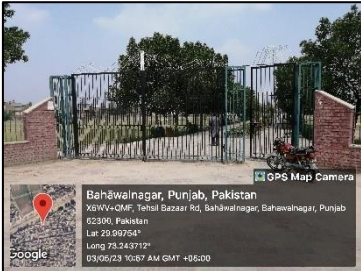
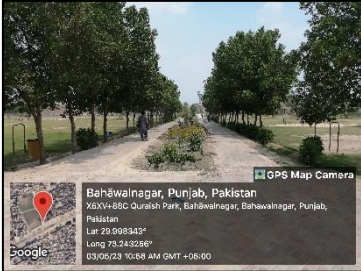
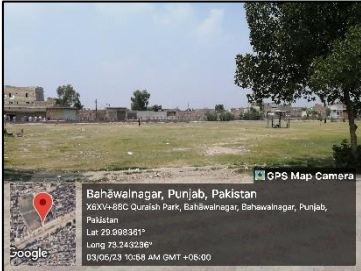
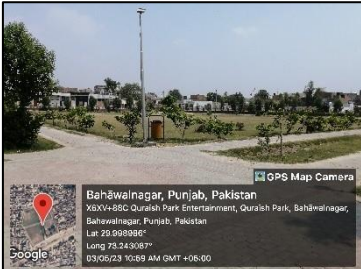
Integrated Development and Asset Management Plan (IDAMP)				
Municipal Committee Bahawalnagar				
Form: IDAMP-A10	Park Asset Condition Assessment			Asset Code: _____ Date: 02-05-2023
Name	Khalid Maqbool			Pictures
Location	Latitude	29.998343

Longitude	73.243256		
Area In Acres	7.5

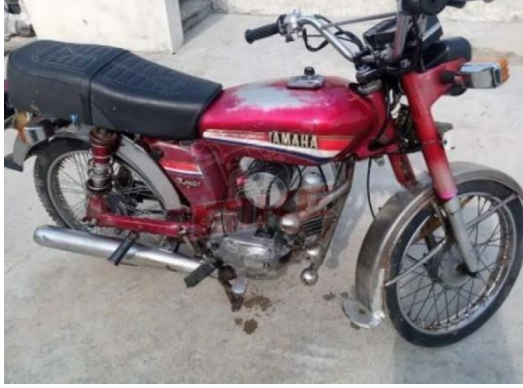
Integrated Development and Asset Management Plan (IDAMP)		
Municipal Committee Bahawalnagar		
Form: IDAMP-A16	Moveable Asset Asset Condition Assessment	Asset Code: _____ Date: 02-05-2023
Type of Vehicle / Machinery	Pictures	
Bike-Yamaha

Capacity	100 CC	
Purpose	Staff	
Year of Manufacturing	1990	
Model	YB-100	
Capital Cost		
Fuel Consumption (Lt)	Non-Functional	
Condition	Poor	
Engine Capacity	100 CC	
Maintenance Cost	Not Available	
Oiling /Fitness	No	
Fitness Certificate	No	
Registered	Bike# 6646	
Overall Rating	Poor	
Remarks / Requirements		
<ul style="list-style-type: none"> No remarks 		
<i>Data Collected By: Mr. Abdullah</i>	<i>Designation: Team Member</i>

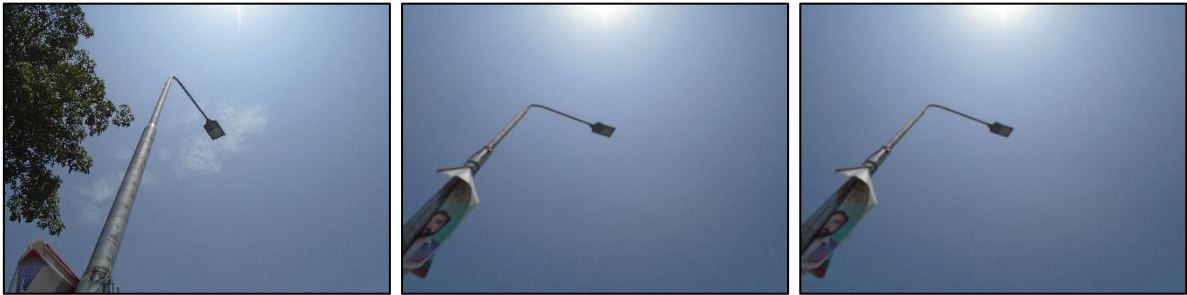
Integrated Development and Asset Management Plan (IDAMP)			
Municipal Committee Bahawalnagar			
Form: IDAMP-A9	Street Lights Asset Condition Assessment	Asset Code: _____	Date: 02-05-2023
Pictures

Area	Total	Operational Status	Poles Type (WAPDA Pole / MC Pole)
Dak khana Chowk	14	Not Available	Not Available
Larri Adda Chowk	19	Not Available	Not Available
Manchanabad Road	62	Not Available	Not Available
Manchanabad Cantt Road	112	Not Available	Not Available
Degree College Road	34	Not Available	Not Available
Bahawali Chowk	46	Not Available	Not Available
Hussainabad Chowk	40	Not Available	Not Available
Jalwala Road	28	Not Available	Not Available
Mahajar Colony	5	Not Available	Not Available
Fire Brigades Road	17	Not Available	Not Available
Urdu Bazar	13	Not Available	Not Available
Circular Road 1	25	Not Available	Not Available
Circular Road 2	15	Not Available	Not Available
Madni Colony	14	Not Available	Not Available
